## **Delayed Shear Crack Formation of Shallow RC Box Culverts in Service**

N. Chijiwa<sup>1</sup>, X. Zhu<sup>2</sup>, H. Ohno<sup>3</sup>, S. Tanabe<sup>4</sup>, K. Nakarai<sup>5</sup> and K. Maekawa<sup>6</sup>

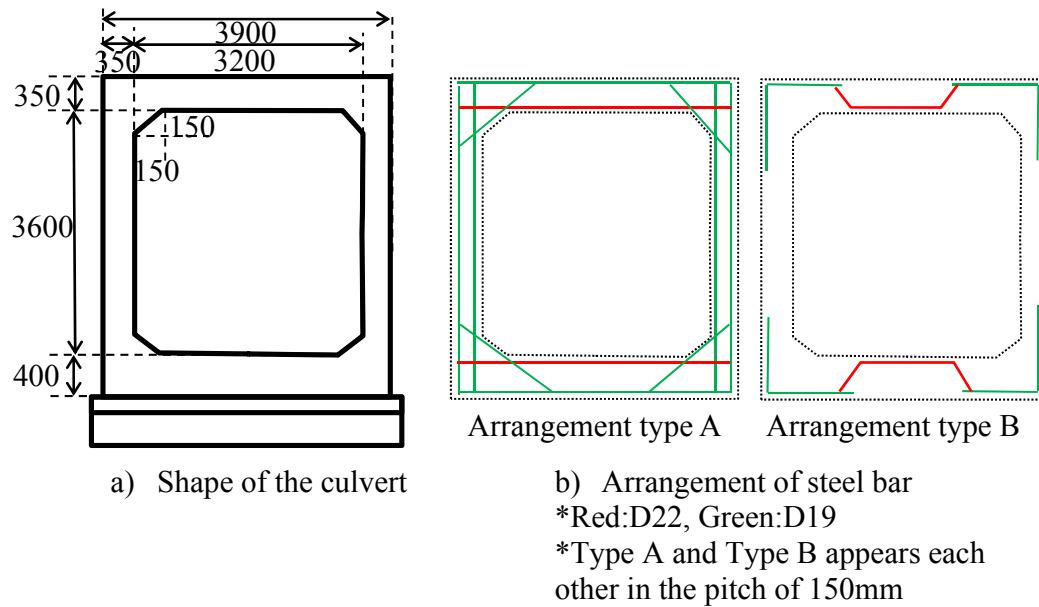
The dimensioning and detailing of the tunnel section suffering from excessive deflection are shown in Figure 2. This culvert was constructed in 1982. The thickness of the top slab is 35cm and the height of the fill above the culvert is relatively low, ranging from 5.04m to 6.98m. The dry sand is used as for backfilling material. This culvert has been used for urban utility and cabling, and it is in service as well. In order to keep the stable local ambient conditions, air ventilation is conducted with blower fan machines, and the temperature is kept about  $25 \pm 2$  degree Celsius. Then, the internal surfaces of the culvert have been exposed to continuous drying ( $RH=30 \pm 10\%$ ). The outer surface exposed to soil foundation was kept almost wet during its whole life and the ground water level is about at half of the side walls. It is

Figure 2 Design detail of the culvert
