## Delayed Shear Crack Formation of Shallow RC Box Culverts in Service

N. Chijiwa<sup>1</sup>, X. Zhu<sup>2</sup>, H. Ohno<sup>3</sup>, S. Tanabe<sup>4</sup>, K. Nakarai<sup>5</sup> and K. Maekawa<sup>6</sup>

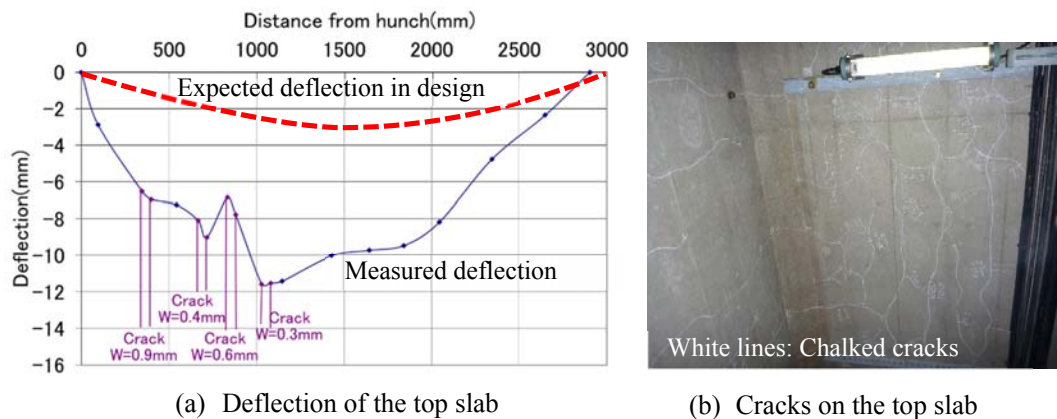
Kunieda et al (2014) reported that top slabs of shallow underground RC box culverts were seriously deformed with numerous cracking. After a few decades of service, the deflection of the top slab exceeded approximately 3 to 10 times the design prediction by the conventional codes for practice as shown in Figure 1(a). Large numbers of cracks at the inner surfaces of tunnel have also been observed as shown in Figure 1(b). The largest crack width near the haunch is 0.9mm, which is more than three times the allowable value specified (Standard Specifications for Concrete Structures – 2007 (2007)). Through the analytical approach in consideration of migration of moisture and associated shrinkage, the authors reported that long-term excessive

Figure 1 Excessive deflection and cracks of the culvert

deformation may attribute to synergy effects accompanying delayed shear failure owing to the vertical soil pressure, which can be accelerated by shrinkage and creep of structural concrete.

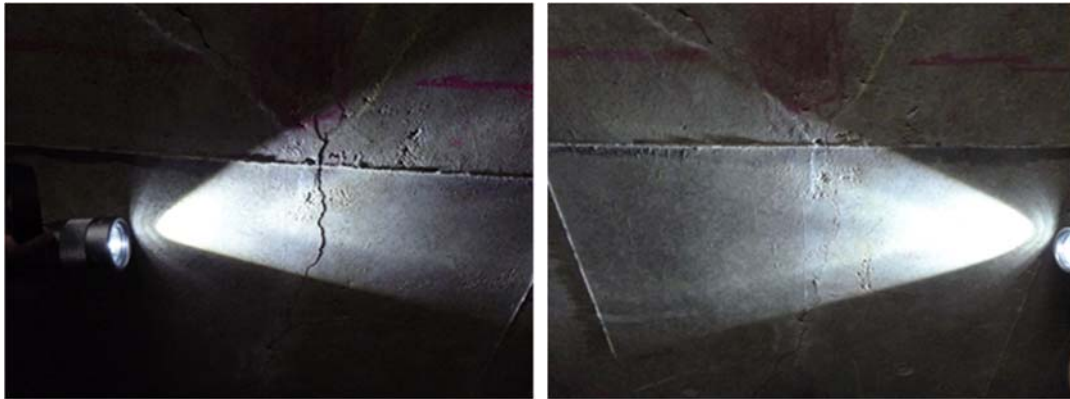
Figure 3 Transverse gap on the crack in the top slab

(a) Light from the span center                      (b) Light from the hunch side  
 → Same crack is shoot, but shade appears only in (a) because of the gap.

out-of-plane deformation of cracked concrete as shown in Figure 3. This gap was observed larger near the hunch side where the greater shear force is thought to be applied than the center span. Then, this crack is highly estimated to be an extreme end of diagonal crack planes.

This transverse gap can be easily detected as well by shadows of the skew illumination as shown in Figure 3. In the case of flexural cracks without the transverse gap, no shadow is made no matter how much directions the illumination is applied. This is some sort of visual inspection to detect the out-of-plane alone.

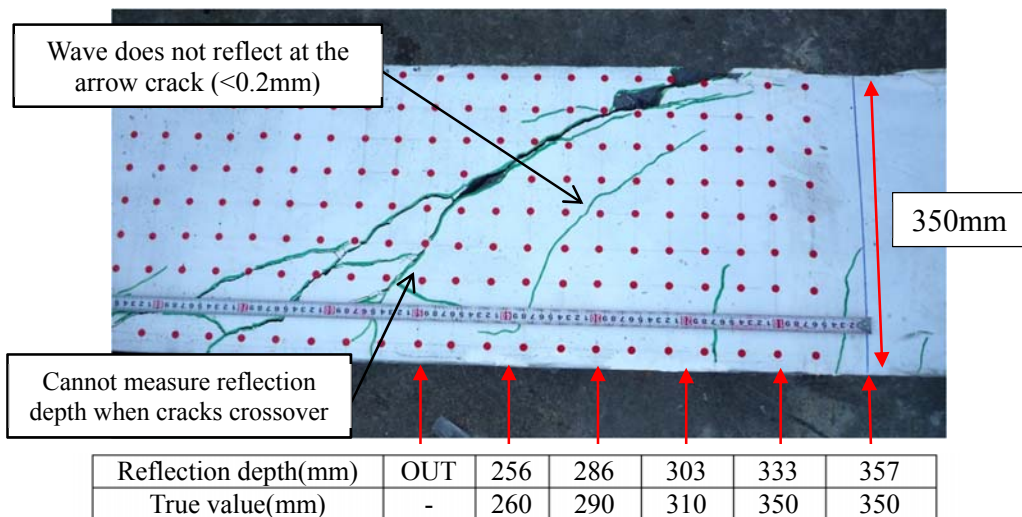
Figure 4 Verification of the elastic wave reflection test

The elastic wave reflection test (e.g. Schabowicz et al. (2012)) was also conducted at several points on the line normal to the culvert axis. If the crack is vertical bending one, the acoustic wave should reflect at about 350mm depth (opposite side of the slab thickness). But, if the crack would be inclined to the centroid axis of the slab, the reflecting depth will be smaller. Validity of the method was examined in advance by using the beam which failed in the mode of shear. Figure 4 shows the depth of wave reflection point which agrees well with the crack depth from the bottom side of the beam.

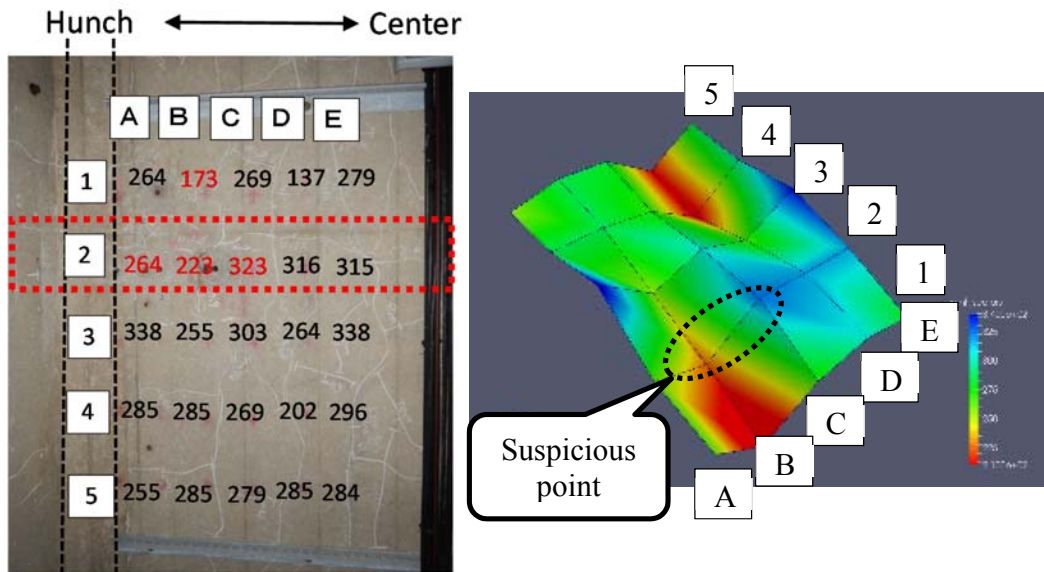
Figure 5 Contour map of the wave reflection depth in the culvert

Figure 5 is the detected height map of the wave reflection depth in the culvert, and it is found that there exist some points where the wave reflection changes significantly around the point. At these points, diagonal shear crack is suspected to be present. Around the most suspicious point between 2-B to 2-C as shown in Figure 5, several micro-bore holes were drilled in about 300mm depth, and the inner surfaces were scanned by the stick scanner (Zacoeb et al. (2007)). The scanned images are shown in Figure 6, and a crack across the hole is found from this image. The enclosed shape of the crack plane is expected from the depth where the crack intersects the hole. This seems to be a typical diagonal shear crack, and it does not reach the flexural compression zone.

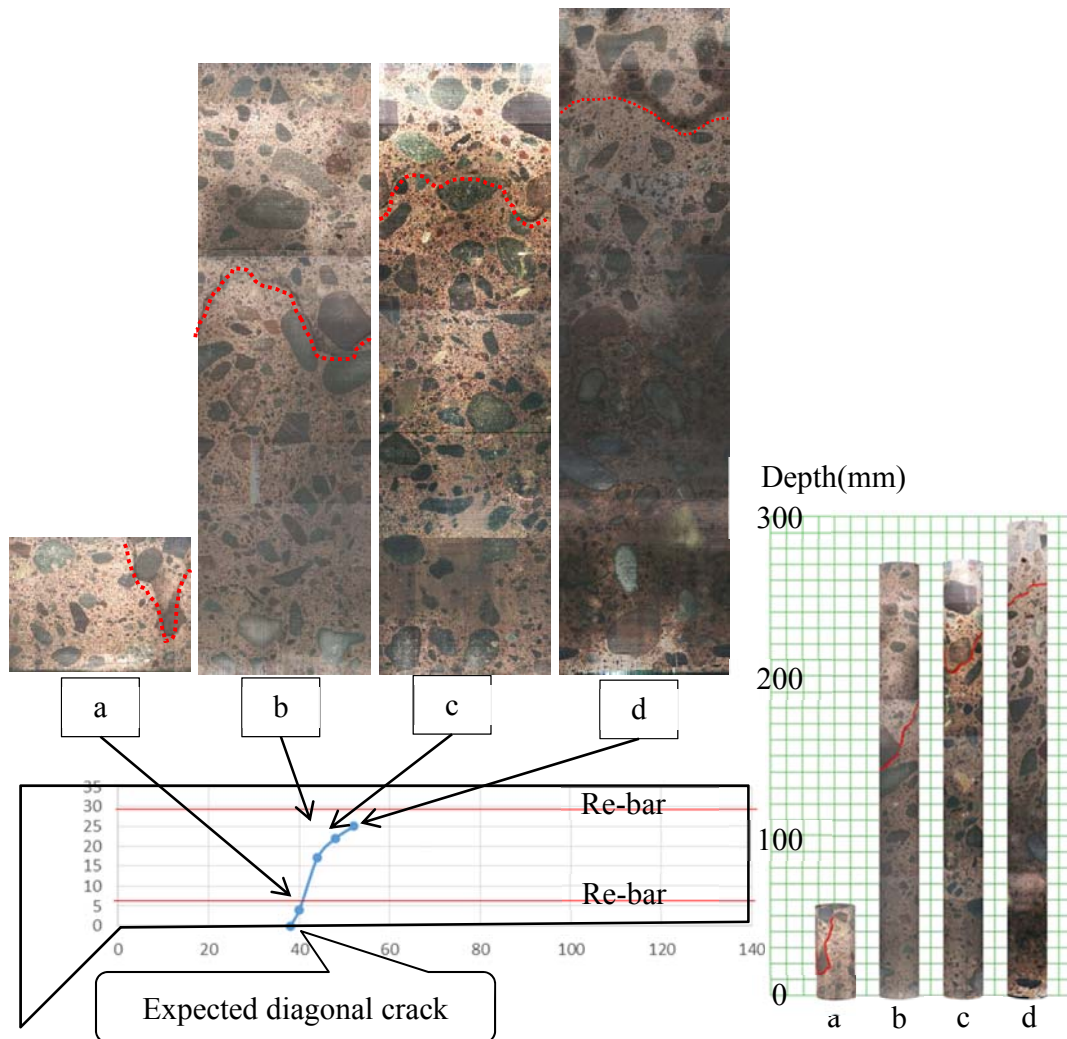
Figure 6 Image of the inner surface of the hole and expected diagonal shear crack in the top slab

With these observations, it can be concluded that the excessive deflection is caused not only by the flexural deformation associated with shrinkage and creep of concrete, but also by the propagation of diagonal shear cracks which lead to out-of-plane displacement. It is assumed that the diagonal shear crack gradually extends for about 30 years, accompanying the top slab deflection.
