Title	Delayed Shear Crack Formation of Shallow RC Box Culverts in Service
Author	N. Chijiwa, X. Zhu, H. Ohno, S. Tanabe, K. Nakarai, K. Maekawa
Journal/Book name	Mechanics and Physics of Creep, Shrinkage and Durability of Concrete and Concrete Structures (CONCREEP-10), , , pp. 1579-1586
Issue date	2015, 9
URL	<a href="http://dx.doi.org/10.1061/9780784479346.184">http://dx.doi.org/10.1061/9780784479346.184</a>
Note	このファイルは著者（最終）版です。 This file is author (final) version

## **Delayed Shear Crack Formation of Shallow RC Box Culverts in Service**

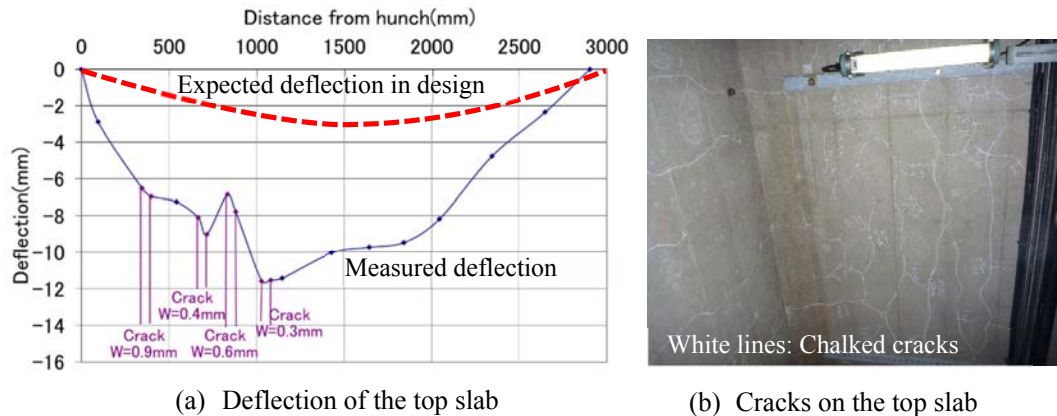
Kunieda et.al (2014) reported that top slabs of shallow underground RC box culverts were seriously deformed with numerous cracking. After a few decades of service, the deflection of the top slab exceeded approximately 3 to 10 times the design prediction by the conventional codes for practice as shown in Figure 1(a). Large numbers of cracks at the inner surfaces of tunnel have also been observed as shown in Figure 1(b). The largest crack width near the haunch is 0.9mm, which is more than three times the allowable value specified (Standard Specifications for Concrete Structures – 2007 (2007)). Through the analytical approach in consideration of migration of moisture and associated shrinkage, the authors reported that long-term excessive

Figure 1 Excessive deflection and cracks of the culvert

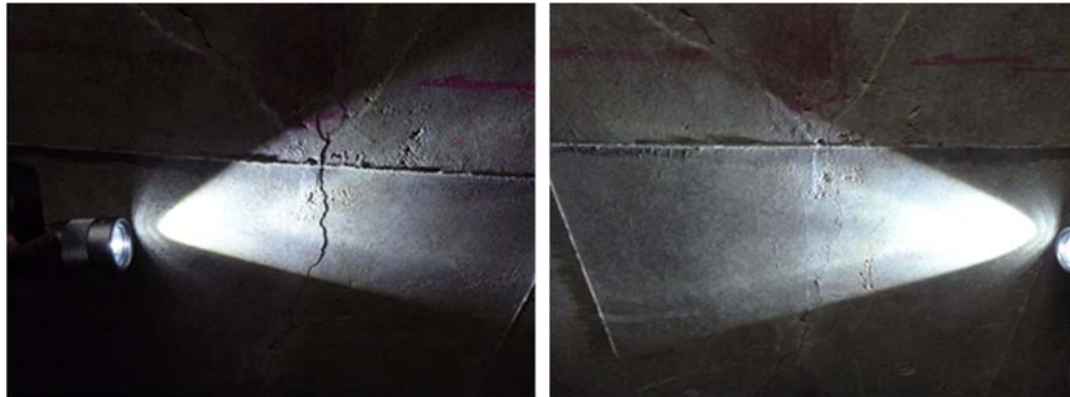
(a) Light from the span center (b) Light from the hunch side  
 → Same crack is shoot, but shade appears only in (a) because of the gap.

Figure 3 Transverse gap on the crack in the top slab

out-of-plane deformation of cracked concrete as shown in Figure 3. This gap was observed larger near the hunch side where the greater shear force is thought to be applied than the center span. Then, this crack is highly estimated to be an extreme end of diagonal crack planes.

This transverse gap can be easily detected as well by shadows of the skew illumination as shown in Figure 3. In the case of flexural cracks without the transverse gap, no shadow is made no matter how much directions the illumination is applied. This is some sort of visual inspection to detect the out-of-plane alone.

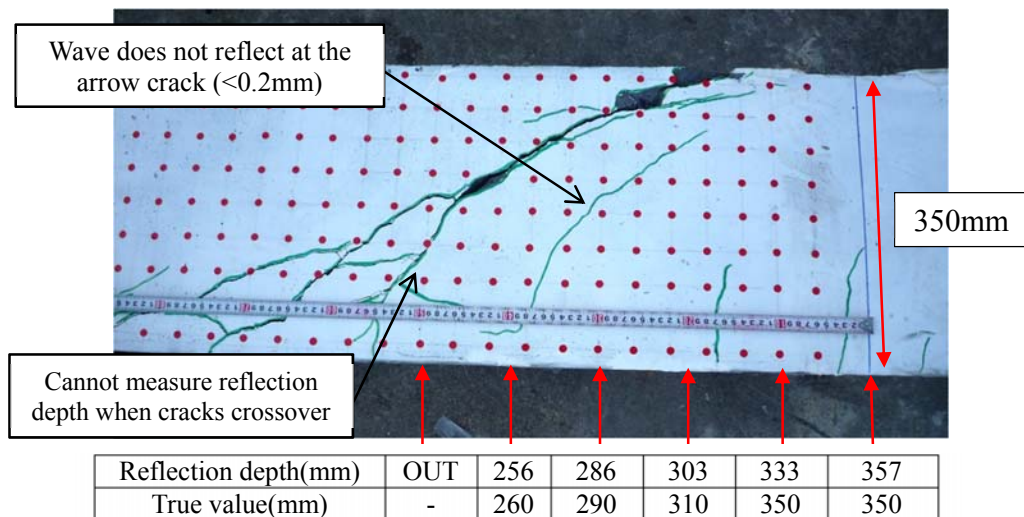
Figure 4 Verification of the elastic wave reflection test

The elastic wave reflection test (e.g. Schabowicz et al. (2012)) was also conducted at several points on the line normal to the culvert axis. If the crack is vertical bending one, the acoustic wave should reflect at about 350mm depth (opposite side of the slab thickness). But, if the crack would be inclined to the centroid axis of the slab, the reflecting depth will be smaller. Validity of the method was examined in advance by using the beam which failed in the mode of shear. Figure 4 shows the depth of wave reflection point which agrees well with the crack depth from the bottom side of the beam.

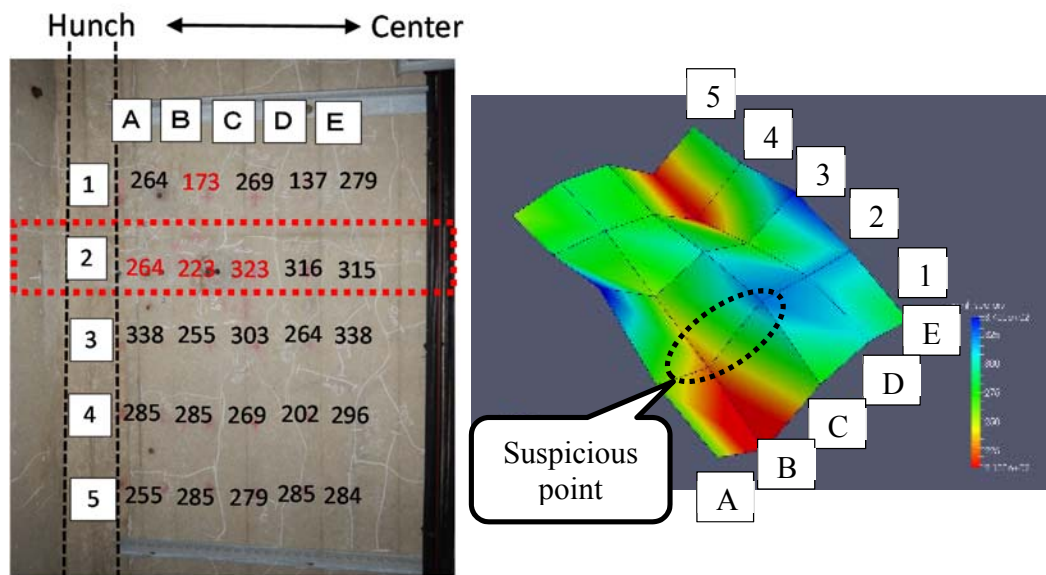
Figure 5 Contour map of the wave reflection depth in the culvert

Figure 5 is the detected height map of the wave reflection depth in the culvert, and it is found that there exist some points where the wave reflection changes significantly around the point. At these points, diagonal shear crack is suspected to be present. Around the most suspicious point between 2-B to 2-C as shown in Figure 5, several micro-bore holes were drilled in about 300mm depth, and the inner surfaces were scanned by the stick scanner (Zacoeb et al. (2007)). The scanned images are shown in Figure 6, and a crack across the hole is found from this image. The enclosed shape of the crack plane is expected from the depth where the crack intersects the hole. This seems to be a typical diagonal shear crack, and it does not reach the flexural compression zone.

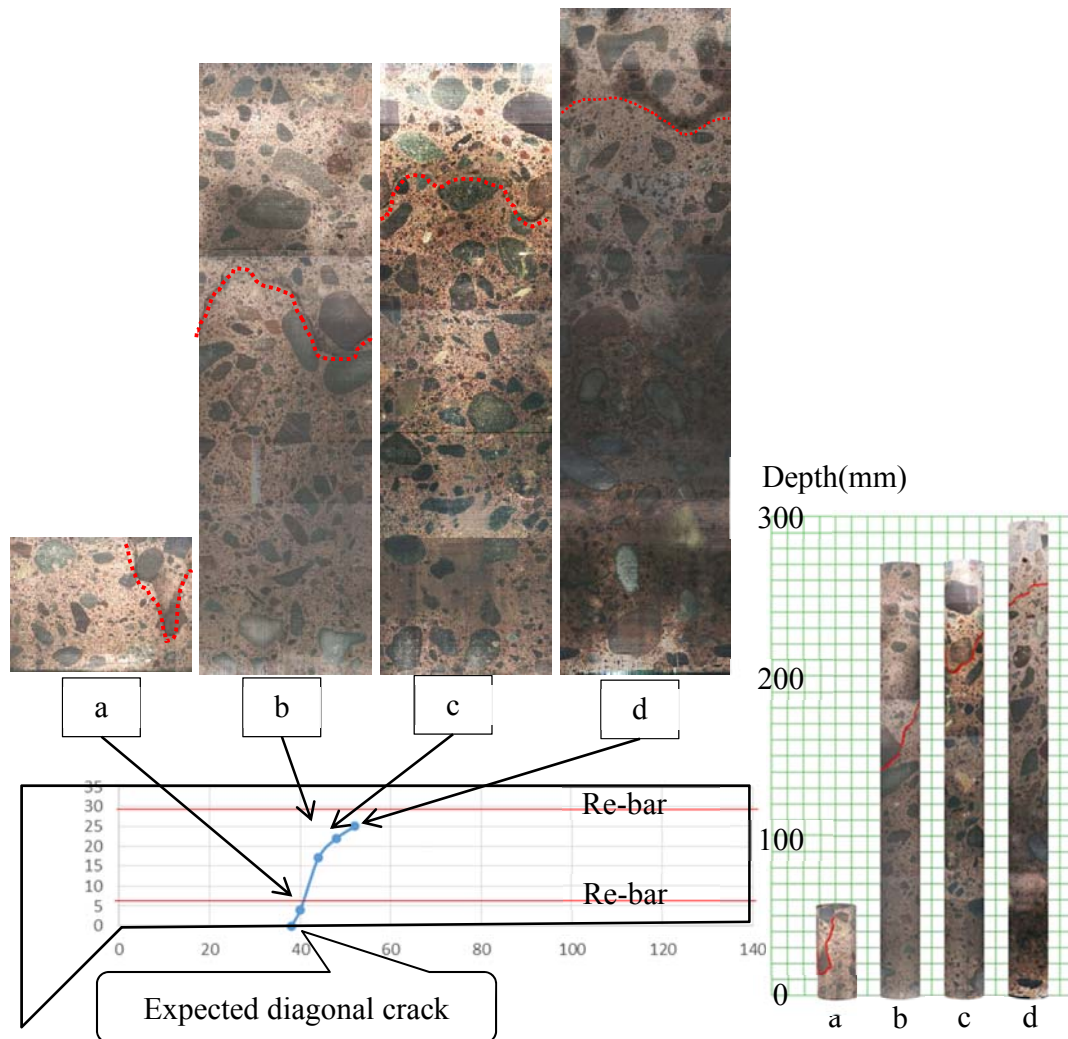
Figure 6 Image of the inner surface of the hole and expected diagonal shear crack in the top slab

With these observations, it can be concluded that the excessive deflection is caused not only by the flexural deformation associated with shrinkage and creep of concrete, but also by the propagation of diagonal shear cracks which lead to out-of-plane displacement. It is assumed that the diagonal shear crack gradually extends for about 30 years, accompanying the top slab deflection.
