Geo-Disaster Report

Levee damage and bridge scour by 2019 typhoon Hagibis in Kanto Region, Japan

Keywords: Typhoon Hagibis; Levee breach; Overtopping; Inland flooding; Bridge scour

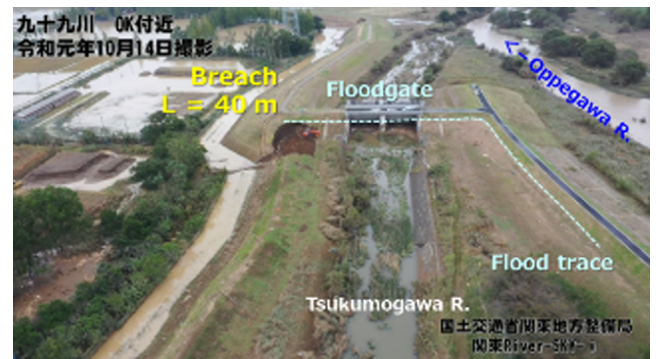
Fig. 6. Breach at 7.6 k on left levee of Opegawa River. The drone image was obtained from the database maintained by the Ministry of Land, Infrastructure, Transport and Tourism, Japan (<https://www.ktr.mlit.go.jp/bousai/index00000051.html>).

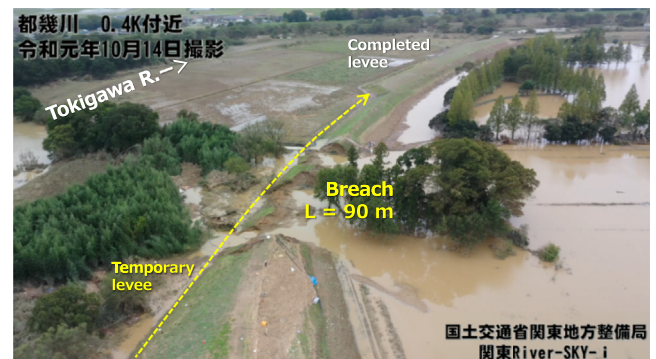
Fig. 7. Breach at 0.4 k on right levee of Tokigawa River. The drone image was obtained from the database maintained by the Ministry of Land, Infrastructure, Transport and Tourism, Japan (<https://www.ktr.mlit.go.jp/bousai/index00000051.html>).

levee being made of a silt-based clay soil and the foundation ground being made of an alluvial soft clay soil. The cause of the failure was considered to be the erosion of the levee due to overtopping.

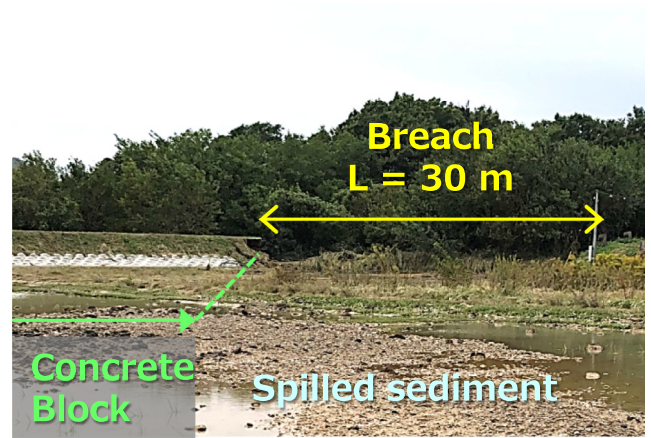
Fig. 10. Breach at 5.6 k on left levee of Tokigawa River.

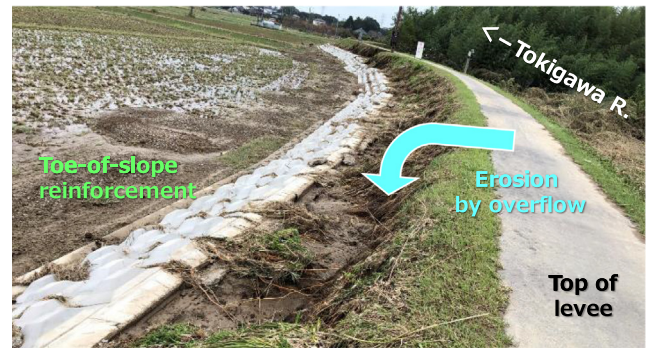
Fig. 11. Levee that survived erosion by overflow.

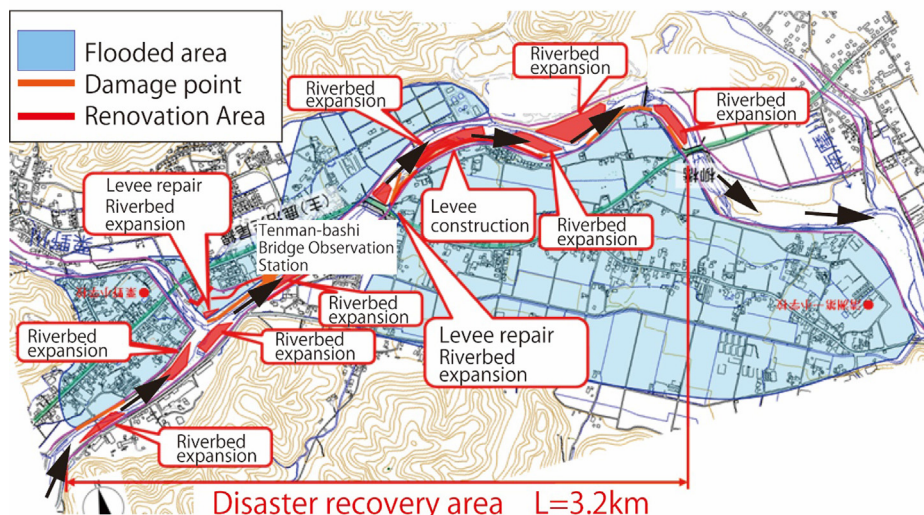
Fig. 16. Overview of plan for restoration and repair services for damaged areas on Omoigawa River (Map provided by Tochigi Prefectural Office with English translation).

Fig. 16 shows the repair works laid out by the Tochigi Prefectural Government for the surrounding areas. There is a plan to widen the beds upstream and downstream of the river, in the vicinity of the flooded area, to secure the flow of water and to repair the levees.

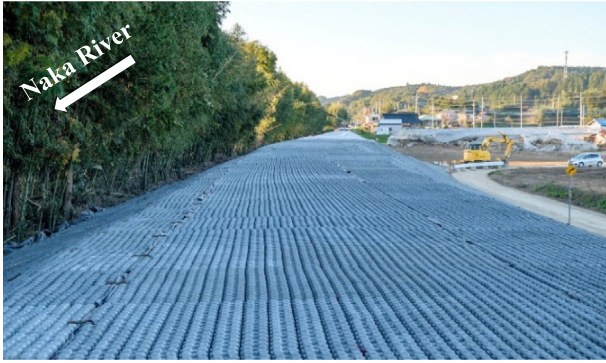
At Noguchi in Hitachi-ohmiya City, Ibaraki Prefecture, the left levee at 40.0 k was breached for about 200 m. Temporary restoration works for the breached levee were started immediately after the event, as shown in Fig. 18. The original levee section was about 3.0 m in height with a 1:2.0 slope. The crest was covered with asphalt pavement, about 3.0 m in width, as part of the temporary restoration works. The Investigation Committee for the Levee Breach by the 2019 Typhoon Hagibis in the Kanto Region (2020) surveyed the cause of the breach and concluded that over-

topping was a major cause, but that seepage and erosion also had the potential to be complex causes.

The depth of the overtopping was more than 0.60 m at the section of the levee that breached and became less than 0.60 m at the downstream section of the levee that did not breach. A trace of overtopping could be observed at the downstream section of the levee. From the field survey, the process of erosion by overtopping was classified into the following four steps:

Fig. 18. Temporary restoration works of left levee at 40.0 k of Naka River.

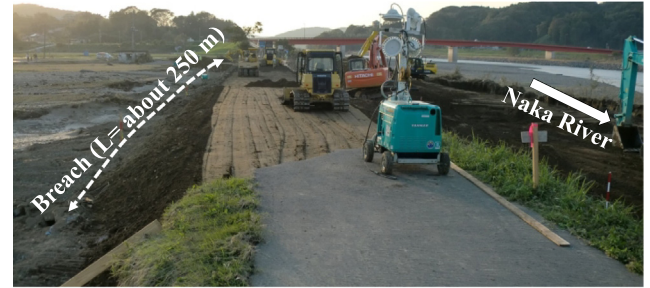
At Shimoisehata in Hitachi-ohmiya City, Ibaraki Prefecture, the failure of the right levee at 41.2 k occurred. The scene of the temporary restoration works is shown in Fig. 20. The collapsed section was about 250 m in length, 4.9 m in slope length, and 3.7 m in crest width. Fig. 21 shows the river-side and land-side slopes adjacent to the collapsed section. The river-side slope had no damage, while marked traces of erosion were found on the land-side slope despite the fact that it has been protected by revetment blocks before the typhoon. According to the construction blueprint by the MLIT, the whole area around the breached section had crest pavements and revetment blocks for the river-side slope, while the land-side slope may have been covered with revetment blocks,

Fig. 20. Temporary restoration works of right levee at 41.2 k of Naka River.

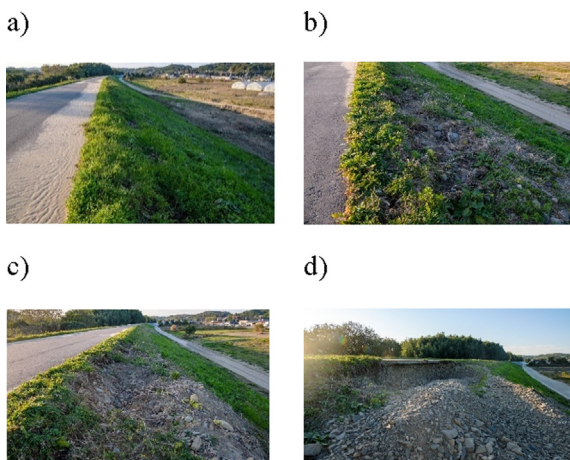
- Step 1: The beginning of vegetation erosion due to overtopping was seen at the shoulder of the levee (Fig. 19a)).
- Step 2: Small grain size soil began to flow out due to the overtopped water (Fig. 19b)).
- Step 3: Then, larger grain size soil was washed away (Fig. 19c)).
- Step 4: The failure of the levee by erosion took place at its shoulder (Fig. 19d)).

Fig. 19. Process of erosion of land-side slope by overtopping: (a) Step 1, (b) Step 2, (c) Step 3, and (d) Step 4.

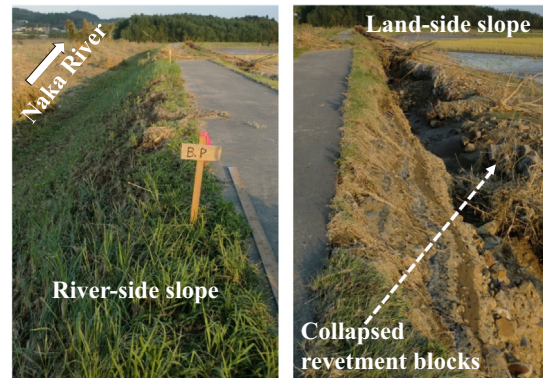
about 30 m in length, at the downstream side of the collapsed section which was about 250 m in length. On the other hand, no signs of sand boils or piping were found during the field survey conducted five days after the event. Considering these results, the breach may have been caused by the erosion of the land-side slope, without revetment blocks, brought about by overtopping. In particular, the failure of the section with revetment blocks, with a land-side slope 30 m in length, may have occurred subsequently due to the flow-out of fill materials after the collapse of the section without revetment blocks (i.e., a progressive failure). The breach at this location suggests that the effects of crest pavements and revetment blocks on reducing the overtopping-induced damage to both side slopes are still unclear. Further studies will need to be conducted to clarify these effects in the future.

Fig. 21. River-side and land-side slopes adjacent to collapsed section at 41.2 k of Naka River.

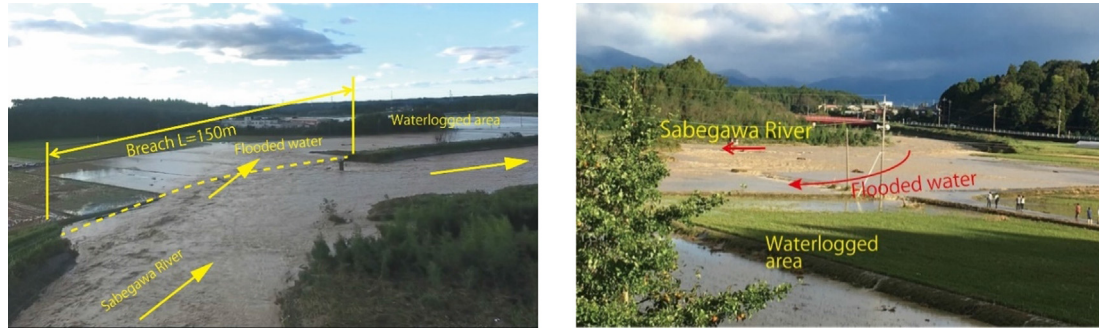
Fig. 22. Breached point on Sabigawa River (in Naka River system) in Kita-owagu area, Otawara City, Tochigi Prefecture. Left photo: View from upstream side, Right photo: View from left levee (Photos provided by Tochigi Prefectural Office with English translation).

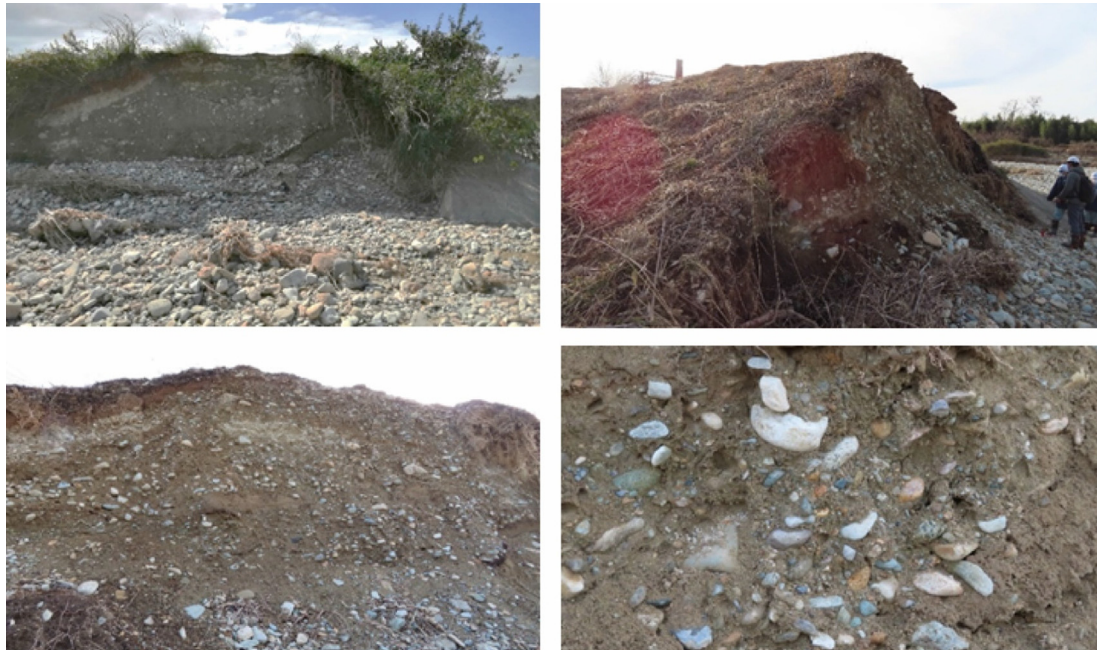
ment material is sandy soil, containing a large amount of cobbles the size of a fist. Fig. 25 shows the damaged levee at the breached point. Along with sandy soil, the embankment also contains many boulders. The cross-section of the damaged levee shows that the embankment was made of sandy soil and there was no core made of low-permeability material. Based on the conditions of the breached levee, soil of the embankment, surrounding topography, and river, the flood-induced wetting of the levee presumably made the levee unstable and resulted in its collapse due to external forces, such as increased water pressure. Most of the levees in the surrounding area are also old. As the material of the levees in this area comprise sandy soil with cobbles/boulders, they are prone to collapse depending on the topography and rainfall conditions. The emergency response to this breach was completed in about 10 days and consisted of constructing a temporary water barrier using large sandbags. Repairs to the levee, including the damaged sections, are planned for the future.

Fig. 25. Damage to levee at breach point. The embankment contains many boulders along with the soil. The embankment was presumably constructed from the surrounding sediment (Photos taken by Unno on December 2, 2019).

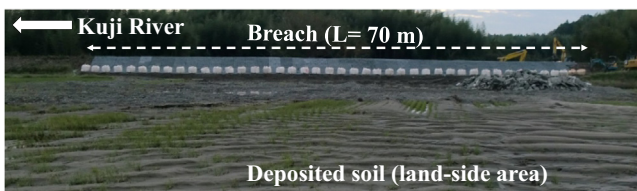
At Onuki in Hitachi-ohmiya City, Ibaraki Prefecture, the failure of the left levee at 34.0 k occurred at a length of about 60 m. The slope length of the collapsed section was about 5 m. As shown in Fig. 27, large sandbags were placed on the levee toe in the temporary restoration works. Considering the facts that (1) no traces of sand boils or piping were found in the field investigations conducted about two weeks after the event and (2) soils were deposited behind the collapsed section, as shown in Fig. 27, the

breach might have been caused by the erosion of the land-side slope due to overtopping. As seen in Fig. 28, both side surfaces of the undamaged levee that was adjacent to the breached section has been covered with crest pavements and revetment blocks. According to the aerial photograph, most of the breached section had also been covered with the pavements and blocks prior to the typhoon. As mentioned earlier (i.e., the right levee of 41.2 k on the Naka River), the effects of the crest pavements and revetment blocks for both side slopes on reducing overtopping-induced damage are still unclear.

Fig. 27. Temporary restoration works of left levee at 34.0 k of Kuji River and deposited soils in land-side area.

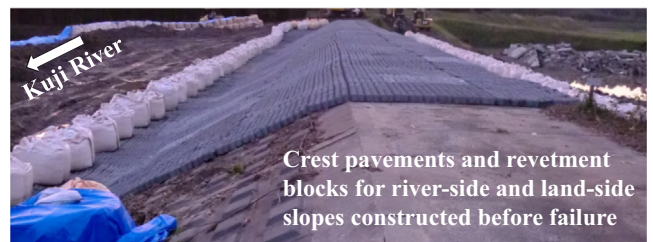
Fig. 28. Crest pavements and revetment blocks for river-side and land-side slopes constructed before failure at 34.0 k of the Kuji River.

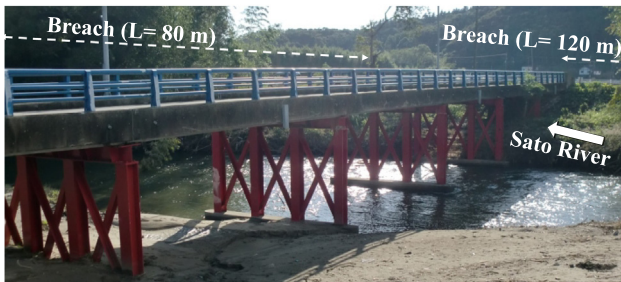
occurred across the Akasu Bridge, as shown in Fig. 30. These two damaged sections were about 80 and 120 m in length, respectively, 2–3 m in slope length, and 4–4.5 m in crest width. As seen in Fig. 31, the Akasu Bridge has six spans in spite of its short length. According to photos taken by a neighbourhood resident, the bridge girder and piers caught driftwood generated by this flood, suggesting that the rise in the river was accelerated locally by the trapped driftwood and might have led to the breach attributed to the erosion of the land-side slope caused by overtopping.

Fig. 31. Akasu Bridge constructed across Sato River.

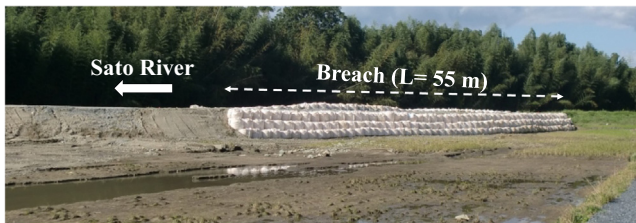
On the upstream side, about 400 m from Point C (i.e., at Point D in Fig. 29), the failure of the left levee occurred at a length of about 55 m (Fig. 32). The slope length and crest width of the collapsed section were about 4.5 and 3 m, respectively. Large sandbags were used to temporarily fill in the breached section as part of the restoration works.

Fig. 32. Temporary restoration works of left levee of Sato River at Point D in Fig. 29.

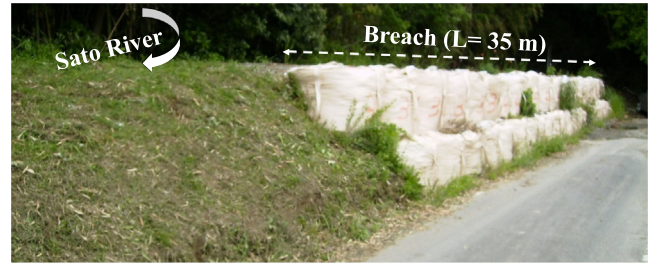
At Point B, indicated in Fig. 29, which corresponds to the downstream side from Point C, the failure of the left levee took place at a length of about 35 m, as shown in Fig. 33. The slope length and crest width of the collapsed section were about 2.5 and 3.5 m, respectively. The main cause of the breach at Point B might have been the erosion of the land-side slope caused by the overtopping attributed to the sharp curve of the river channel (see Fig. 29). As demonstrated by this case, a sharp curve in a river channel can be one of the most important factors causing overtopping-induced damage to a levee.

Fig. 33. Temporary restoration works of left levee of Sato River at Point B in Fig. 29.

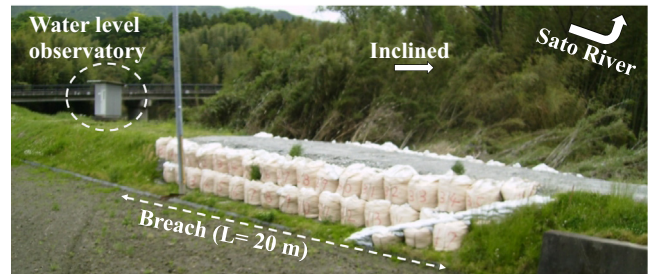
At the downstream side, about 500 m from Point B (i.e., at Point A in Fig. 29), the failure of the right levee, about 20 m in length, 4 m in slope length, and 3.5 m in crest width, occurred as shown in Fig. 34. The foundation of the water level observatory, constructed on the river-side shoulder and located on the downstream side about 16 m from the breached area, shown in Fig. 34, was severely damaged by scour. On the downstream side of the observatory, traces of the erosion of the river-side shoulder were found at a length of 22 m, as shown in Fig. 35. Moreover, as seen in Figs. 34 and 35, bamboo bushes on the river-side shoulder were inclined toward the river-side. When considering these factors, the possible process of the breach could be explained as follows.

- (1) The overtopping occurred possibly due to the sharp curve of the river channel (Fig. 29).
- (2) The river water flowed back to the river channel after overtopping.
- (3) The backwater, whose water level on the protected side was higher than that in the river channel, caused the erosion of the river-side slope. The cross-section of the levee was gradually reduced, and finally, the breach occurred.

Fig. 34. Temporary restoration works of right levee of Sato River at Point A in Fig. 29.

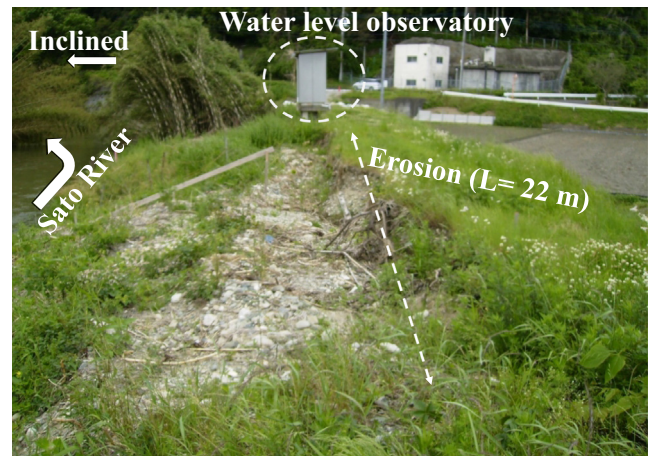
Fig. 35. Traces of erosion of river-side shoulder observed at downstream side from Point A in Fig. 29.

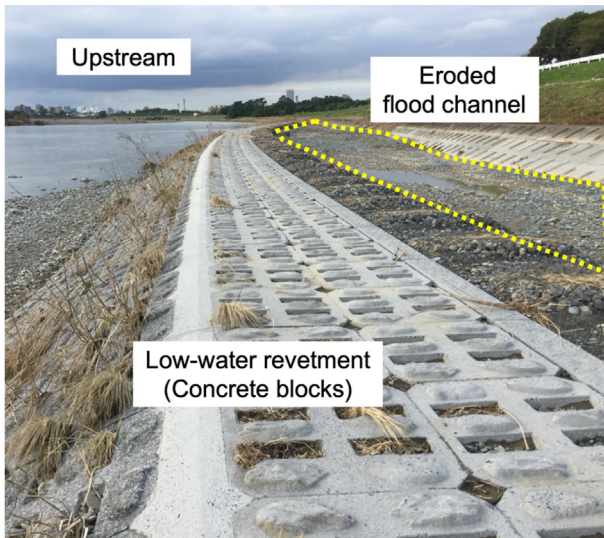
Fig. 38. Levee damage on left levee at 23.4 k on Tamagawa River.

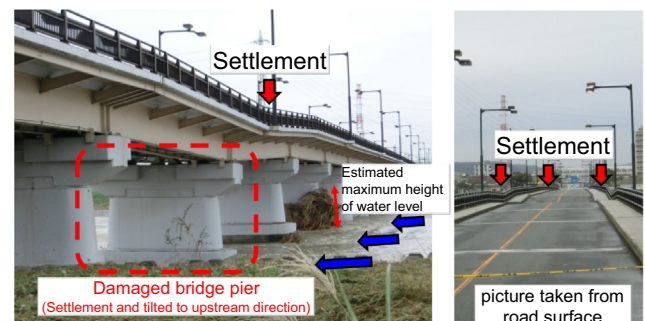
Fig. 41 shows the damaged Hino Bridge (see Fig. 2 for the location). The Hino Bridge was constructed in 1926 as a bridge that crosses the Tamagawa River. The foundation type was an open caisson made of reinforced concrete with a width of about 3.3 m and a depth of about 5.4 m. This bridge used to be along an important road that was employed as National Route 20 until March 2007. As shown in Fig. 41, the pier settled and tilted in the upstream

Fig. 41. Damaged river bridge pier caused by scour.

direction due to scour, and it took about seven months to repair it. To carry out the restoration work of the damaged pier, it was necessary to secure a construction approach road and construction yard around the damaged pier, so

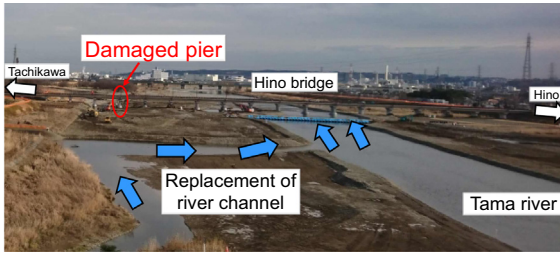
Fig. 42. River channel replacement for restoration work of Hino Bridge.

that a large-scale river channel replacement could be carried out (Fig. 42). It can be learned from this case that, once a scouring disaster occurs, the recovery work often takes a long time. Thus, it is important to take measures to prevent such disasters, as much as possible, by establishing a practical method for distinguishing the piers at high risk for scouring. As a characteristic of the recent scour damage to river bridges, bridge piers located in high water beds, which are supposed to have a low risk of scouring damage, are often damaged. The aforementioned Hino Bridge followed this exact disaster pattern, and details on it are provided in the next subsection.

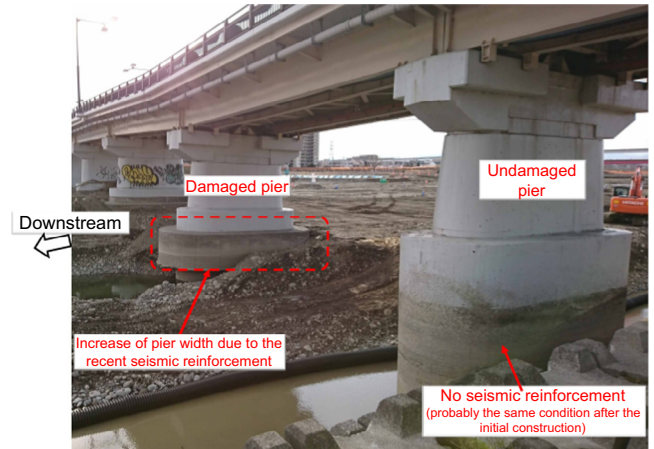
Fig. 44. Damaged pier during the restoration work (from downstream).

As mentioned above, the foundation of the damaged pier was an open caisson with a width of about 3.3 m and a depth of about 5.4 m, but it will be verified here whether local scour of 5 m or more can occur with a single flood. Jones (1984) summarised several empirical equations that describe the relationship between the local scour depth normalised by the pier width and the average water depth normalised by the pier width. According to the empirical equations, the local scour depth can reach up to about 1.5 times the pier width when the water depth exceeds the pier width. In the case of the Hino Bridge, the embedded depth of the foundation (5.4 m) was about 1.6 times the width of the pier (3.3 m), so local scour could reach the bottom surface of the pier foundation according to past cases.
