| Citation | Soils and Foundations, Vol. 61, Issue 2, pp. 566-585 |

Geo-Disaster Report

# Levee damage and bridge scour by 2019 typhoon Hagibis in Kanto Region, Japan

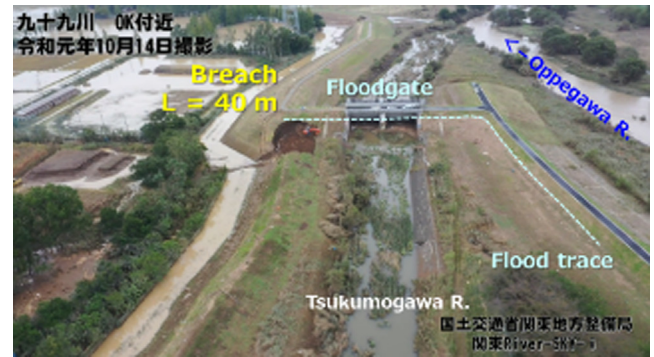
The failure in these two areas is attributed to overtopping due to scouring on the protected side by overflow

Fig. 6. Breach at 7.6 k on left levee of Opegawa River. The drone image was obtained from the database maintained by the Ministry of Land, Infrastructure, Transport and Tourism, Japan (<https://www.ktr.mlit.go.jp/bousai/index00000051.html>).

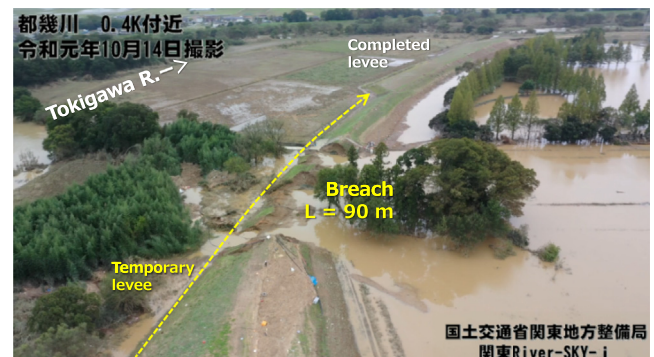
Fig. 7. Breach at 0.4 k on right levee of Tokigawa River. The drone image was obtained from the database maintained by the Ministry of Land, Infrastructure, Transport and Tourism, Japan (<https://www.ktr.mlit.go.jp/bousai/index00000051.html>).

levee being made of a silt-based clay soil and the foundation ground being made of an alluvial soft clay soil. The cause of the failure was considered to be the erosion of the levee due to overtopping.

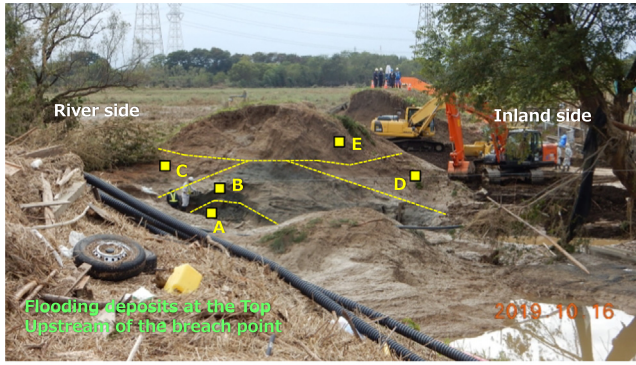
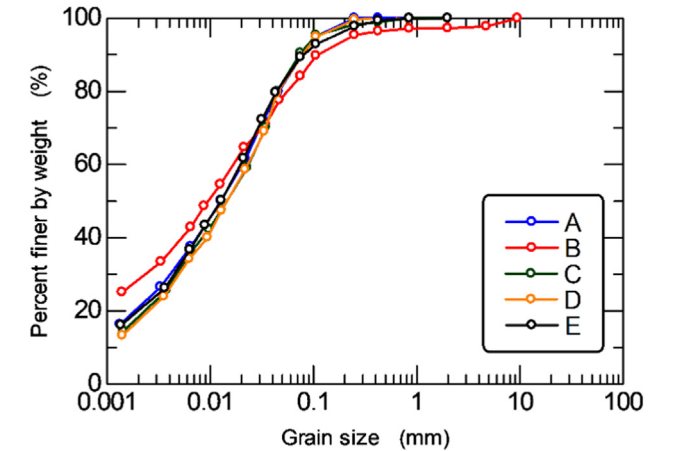
Fig. 8. Cross-section of breached levee at R0.4 k and grain size distribution curves for soils taken from points shown in picture. The data were obtained from the report by the Investigation Committee for the Levee Breach by the 2019 Typhoon Hagibis in the Kanto Region (2020).

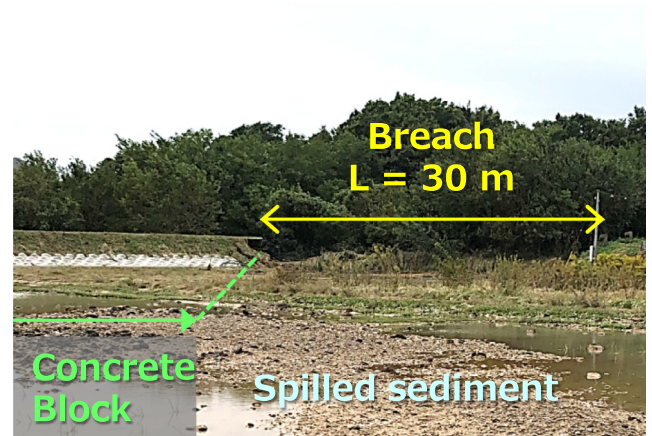
Fig. 10. Breach at 5.6 k on left levee of Tokigawa River.

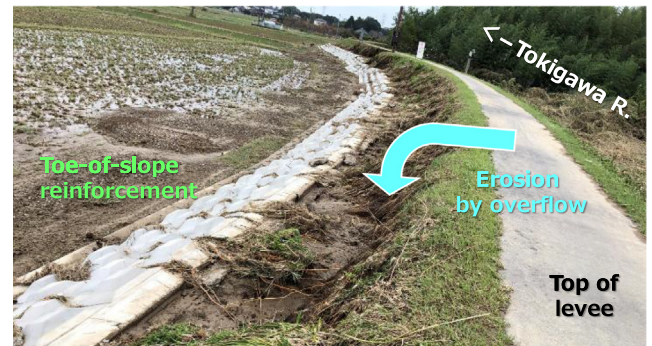
Fig. 11. Levee that survived erosion by overflow.

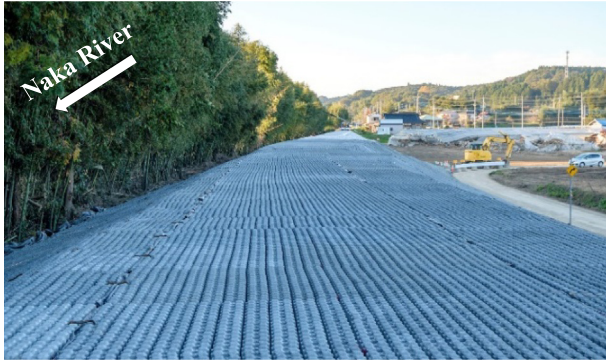
At Noguchi in Hitachi-ohmiya City, Ibaraki Prefecture, the left levee at 40.0 k was breached for about 200 m. Temporary restoration works for the breached levee were started immediately after the event, as shown in Fig. 18. The original levee section was about 3.0 m in height with a 1:2.0 slope. The crest was covered with asphalt pavement, about 3.0 m in width, as part of the temporary restoration works. The Investigation Committee for the Levee Breach by the 2019 Typhoon Hagibis in the Kanto Region (2020) surveyed the cause of the breach and concluded that over-

topping was a major cause, but that seepage and erosion also had the potential to be complex causes.

Fig. 18. Temporary restoration works of left levee at 40.0 k of Naka River.

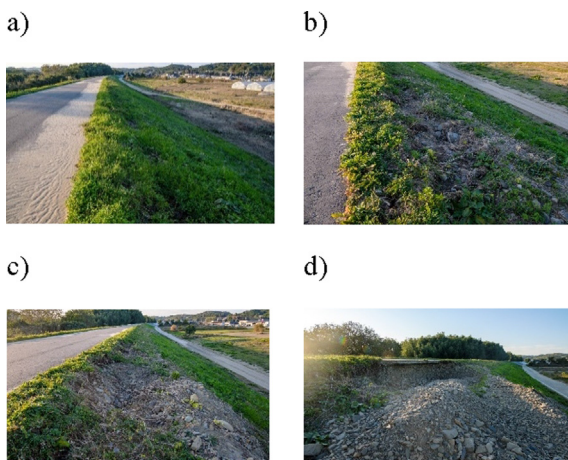
- Step 1: The beginning of vegetation erosion due to overtopping was seen at the shoulder of the levee (Fig. 19a)).
- Step 2: Small grain size soil began to flow out due to the overtopped water (Fig. 19b)).
- Step 3: Then, larger grain size soil was washed away (Fig. 19c)).
- Step 4: The failure of the levee by erosion took place at its shoulder (Fig. 19d)).

Fig. 19. Process of erosion of land-side slope by overtopping: (a) Step 1, (b) Step 2, (c) Step 3, and (d) Step 4.

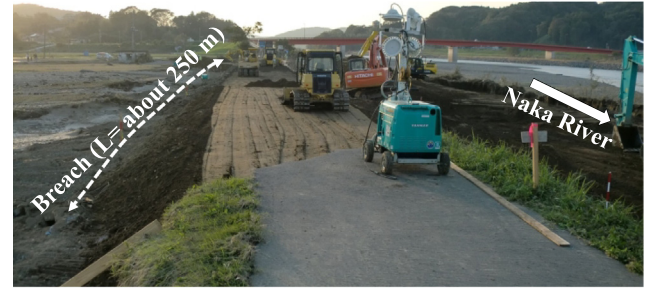
At Shimoishata in Hitachi-ohmiya City, Ibaraki Prefecture, the failure of the right levee at 41.2 k occurred. The scene of the temporary restoration works is shown in Fig. 20. The collapsed section was about 250 m in length, 4.9 m in slope length, and 3.7 m in crest width. Fig. 21 shows the river-side and land-side slopes adjacent to the collapsed section. The river-side slope had no damage, while marked traces of erosion were found on the land-side slope despite the fact that it has been protected by revetment blocks before the typhoon. According to the construction blueprint by the MLIT, the whole area around the breached section had crest pavements and revetment blocks for the river-side slope, while the land-side slope may have been covered with revetment blocks,

Fig. 20. Temporary restoration works of right levee at 41.2 k of Naka River.

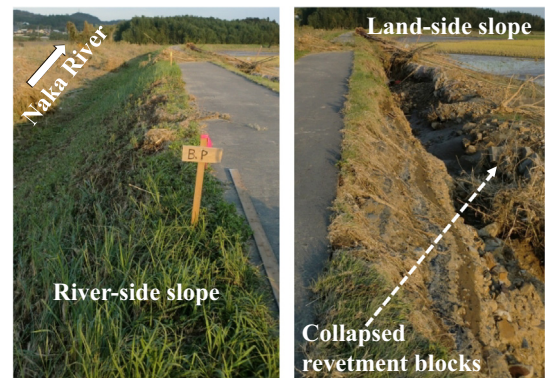
about 30 m in length, at the downstream side of the collapsed section which was about 250 m in length. On the other hand, no signs of sand boils or piping were found during the field survey conducted five days after the event. Considering these results, the breach may have been caused by the erosion of the land-side slope, without revetment blocks, brought about by overtopping. In particular, the failure of the section with revetment blocks, with a land-side slope 30 m in length, may have occurred subsequently due to the flow-out of fill materials after the collapse of the section without revetment blocks (i.e., a progressive failure). The breach at this location suggests that the effects of crest pavements and revetment blocks on reducing the overtopping-induced damage to both side slopes are still unclear. Further studies will need to be conducted to clarify these effects in the future.

Fig. 21. River-side and land-side slopes adjacent to collapsed section at 41.2 k of Naka River.

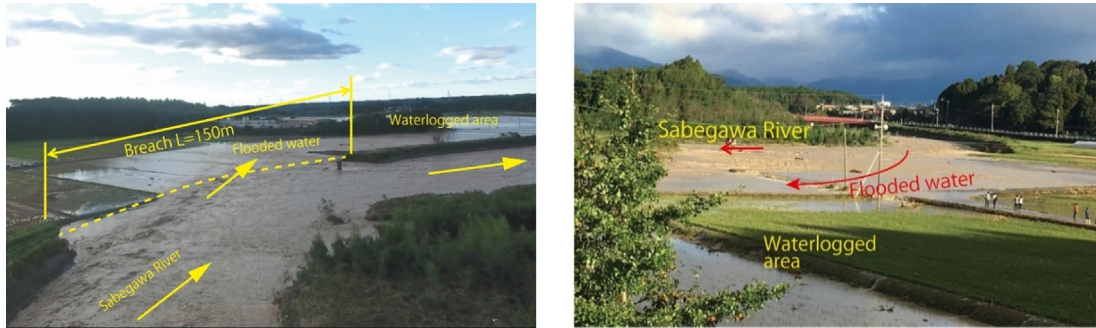
Fig. 22. Breached point on Sabigawa River (in Naka River system) in Kita-owagu area, Otawara City, Tochigi Prefecture. Left photo: View from upstream side, Right photo: View from left levee (Photos provided by Tochigi Prefectural Office with English translation).

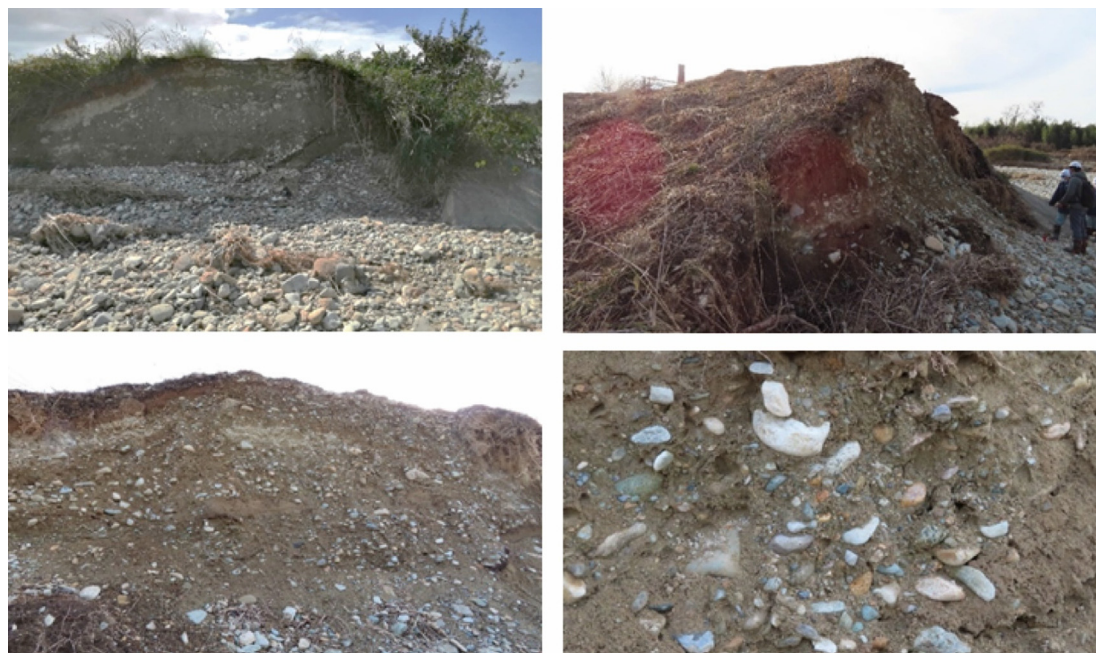
ment material is sandy soil, containing a large amount of cobbles the size of a fist. Fig. 25 shows the damaged levee at the breached point. Along with sandy soil, the embankment also contains many boulders. The cross-section of the damaged levee shows that the embankment was made of sandy soil and there was no core made of low-permeability material. Based on the conditions of the breached levee, soil of the embankment, surrounding topography, and river, the flood-induced wetting of the levee presumably made the levee unstable and resulted in its collapse due to external forces, such as increased water pressure. Most of the levees in the surrounding area are also old. As the material of the levees in this area comprise sandy soil with cobbles/boulders, they are prone to collapse depending on the topography and rainfall conditions. The emergency response to this breach was completed in about 10 days and consisted of constructing a temporary water barrier using large sandbags. Repairs to the levee, including the damaged sections, are planned for the future.

Fig. 25. Damage to levee at breach point. The embankment contains many boulders along with the soil. The embankment was presumably constructed from the surrounding sediment (Photos taken by Unno on December 2, 2019).

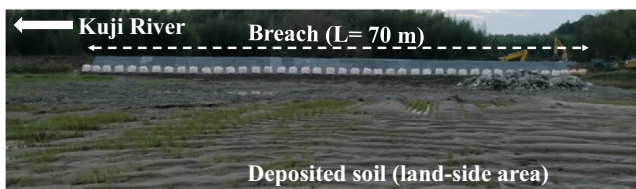
At Onuki in Hitachi-ohmiya City, Ibaraki Prefecture, the failure of the left levee at 34.0 k occurred at a length of about 60 m. The slope length of the collapsed section was about 5 m. As shown in Fig. 27, large sandbags were placed on the levee toe in the temporary restoration works. Considering the facts that (1) no traces of sand boils or piping were found in the field investigations conducted about two weeks after the event and (2) soils were deposited behind the collapsed section, as shown in Fig. 27, the

breach might have been caused by the erosion of the land-side slope due to overtopping. As seen in Fig. 28, both side surfaces of the undamaged levee that was adjacent to the breached section has been covered with crest pavements and revetment blocks. According to the aerial photograph, most of the breached section had also been covered with the pavements and blocks prior to the typhoon. As mentioned earlier (i.e., the right levee of 41.2 k on the Naka River), the effects of the crest pavements and revetment blocks for both side slopes on reducing overtopping-induced damage are still unclear.

Fig. 27. Temporary restoration works of left levee at 34.0 k of Kuji River and deposited soils in land-side area.

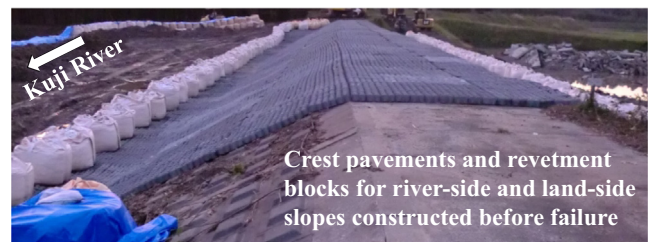
Fig. 28. Crest pavements and revetment blocks for river-side and land-side slopes constructed before failure at 34.0 k of the Kuji River.

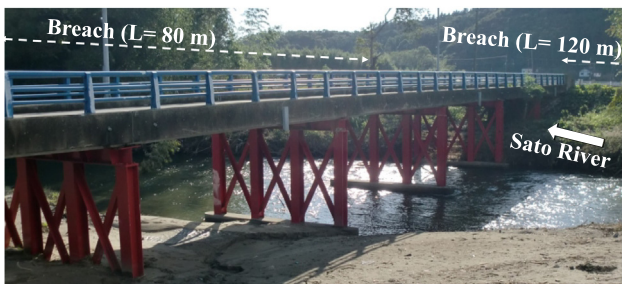
occurred across the Akasu Bridge, as shown in Fig. 30. These two damaged sections were about 80 and 120 m in length, respectively, 2–3 m in slope length, and 4–4.5 m in crest width. As seen in Fig. 31, the Akasu Bridge has six spans in spite of its short length. According to photos taken by a neighbourhood resident, the bridge girder and piers caught driftwood generated by this flood, suggesting that the rise in the river was accelerated locally by the trapped driftwood and might have led to the breach attributed to the erosion of the land-side slope caused by overtopping.

Fig. 31. Akasu Bridge constructed across Sato River.

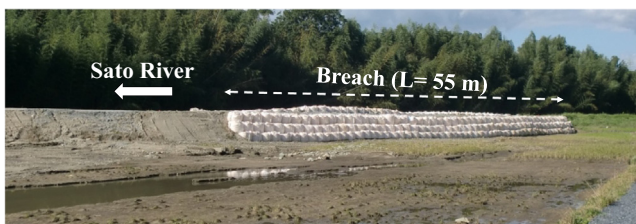
On the upstream side, about 400 m from Point C (i.e., at Point D in Fig. 29), the failure of the left levee occurred at a length of about 55 m (Fig. 32). The slope length and crest width of the collapsed section were about 4.5 and 3 m, respectively. Large sandbags were used to temporarily fill in the breached section as part of the restoration works.

Fig. 32. Temporary restoration works of left levee of Sato River at Point D in Fig. 29.

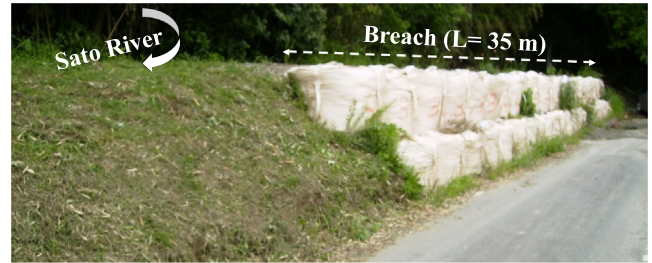
At Point B, indicated in Fig. 29, which corresponds to the downstream side from Point C, the failure of the left levee took place at a length of about 35 m, as shown in Fig. 33. The slope length and crest width of the collapsed section were about 2.5 and 3.5 m, respectively. The main cause of the breach at Point B might have been the erosion of the land-side slope caused by the overtopping attributed to the sharp curve of the river channel (see Fig. 29). As demonstrated by this case, a sharp curve in a river channel can be one of the most important factors causing overtopping-induced damage to a levee.

Fig. 33. Temporary restoration works of left levee of Sato River at Point B in Fig. 29.

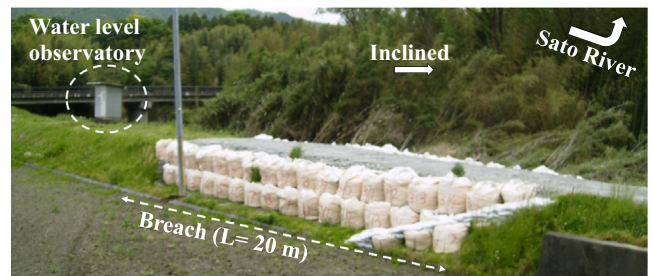
At the downstream side, about 500 m from Point B (i.e., at Point A in Fig. 29), the failure of the right levee, about 20 m in length, 4 m in slope length, and 3.5 m in crest width, occurred as shown in Fig. 34. The foundation of the water level observatory, constructed on the river-side shoulder and located on the downstream side about 16 m from the breached area, shown in Fig. 34, was severely damaged by scour. On the downstream side of the observatory, traces of the erosion of the river-side shoulder were found at a length of 22 m, as shown in Fig. 35. Moreover, as seen in Figs. 34 and 35, bamboo bushes on the river-side shoulder were inclined toward the river-side. When considering these factors, the possible process of the breach could be explained as follows.

- (1) The overtopping occurred possibly due to the sharp curve of the river channel (Fig. 29).
- (2) The river water flowed back to the river channel after overtopping.
- (3) The backwater, whose water level on the protected side was higher than that in the river channel, caused the erosion of the river-side slope. The cross-section of the levee was gradually reduced, and finally, the breach occurred.

Fig. 34. Temporary restoration works of right levee of Sato River at Point A in Fig. 29.

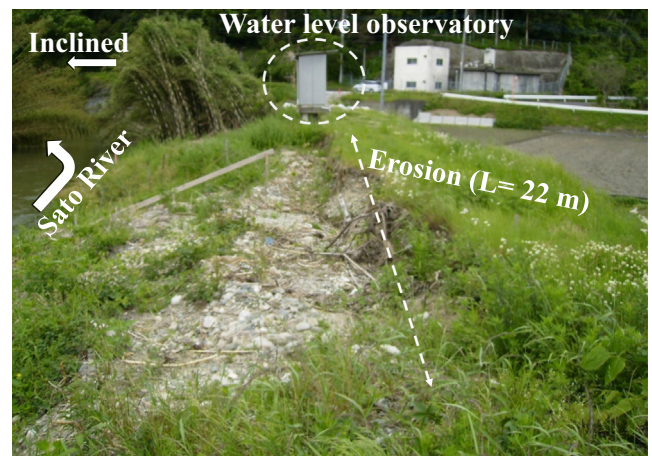
Fig. 35. Traces of erosion of river-side shoulder observed at downstream side from Point A in Fig. 29.

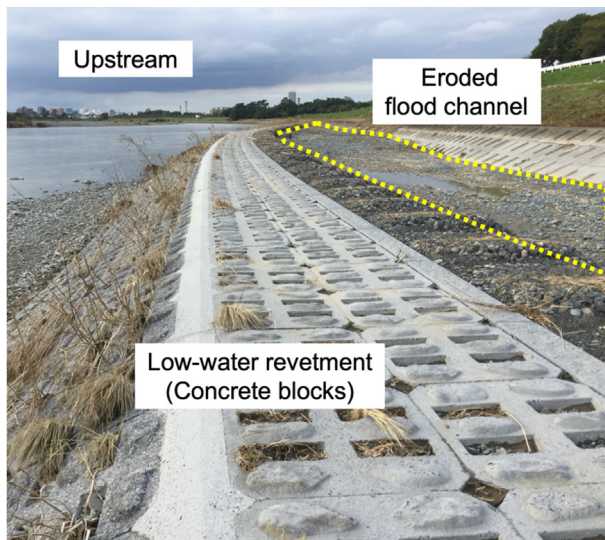
Fig. 38. Levee damage on left levee at 23.4 k on Tamagawa River.

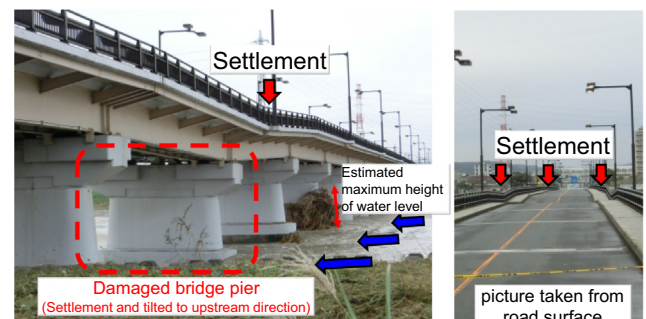
Fig. 41 shows the damaged Hino Bridge (see Fig. 2 for the location). The Hino Bridge was constructed in 1926 as a bridge that crosses the Tamagawa River. The foundation type was an open caisson made of reinforced concrete with a width of about 3.3 m and a depth of about 5.4 m. This bridge used to be along an important road that was employed as National Route 20 until March 2007. As shown in Fig. 41, the pier settled and tilted in the upstream

Fig. 41. Damaged river bridge pier caused by scour.

direction due to scour, and it took about seven months to repair it. To carry out the restoration work of the damaged pier, it was necessary to secure a construction approach road and construction yard around the damaged pier, so

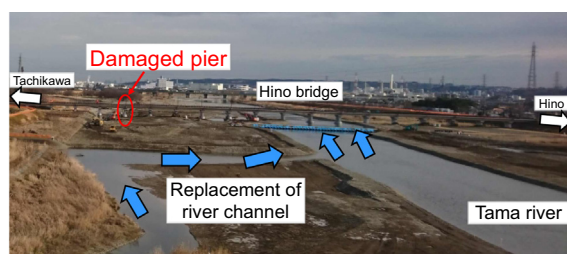
Fig. 42. River channel replacement for restoration work of Hino Bridge.

that a large-scale river channel replacement could be carried out (Fig. 42). It can be learned from this case that, once a scouring disaster occurs, the recovery work often takes a long time. Thus, it is important to take measures to prevent such disasters, as much as possible, by establishing a practical method for distinguishing the piers at high risk for scouring. As a characteristic of the recent scour damage to river bridges, bridge piers located in high water beds, which are supposed to have a low risk of scouring damage, are often damaged. The aforementioned Hino Bridge followed this exact disaster pattern, and details on it are provided in the next subsection.

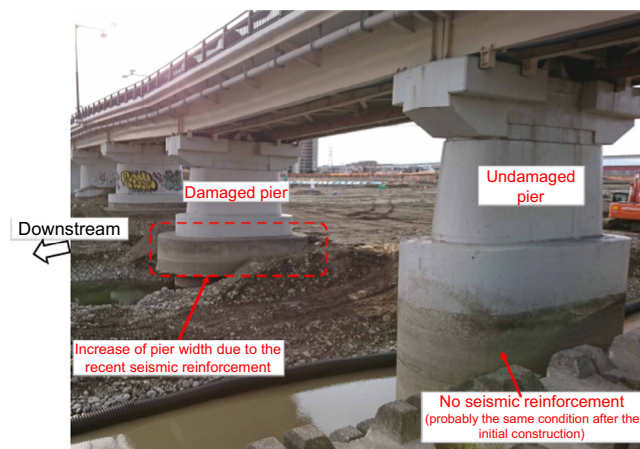
In the 1990s, the river flow of the Tamagawa River was on the opposite side (right side) of the damaged pier (Fig. 43), and countermeasures, such as riverbed protection works, were mainly taken on the right side, which was considered to be at high risk for scouring. However, around 2010, water began to flow on the left side of the river where the damaged pier exists. This was probably due to the slow movement of a sandbar. Maintenance (general inspections) of river bridge structures is conducted in accordance with the standards or technical guidelines, and measures and reinforcement are carried out as necessary. However, it is difficult for field engineers to predict the increase in scour risk due to changes in the river flow conditions, as seen in the case of the Hino Bridge.

Fig. 44. Damaged pier during the restoration work (from downstream).
