Performance recovery of a repaired 4-storey reinforced concrete structure subjected to shake-table testing

Understanding the effects of repair on reinforced concrete (RC) structures is critical to evaluating their performance in future earthquakes. In this research, a system-level approach is taken by repairing a previously damaged ¼ scale 4-storey RC structure and subjecting it to a series of dynamic excitations via shake table testing. The repair was undertaken using common construction materials with the primary motivation of restoring original performance. The performance of the repaired structure was compared to that of the original structure prior to repairs. It was found that overall initial stiffness of the structure was recovered to 66% of the original initial stiffness and was generally higher in floors where more intensive repair works were undertaken. Damping capacity was quantified via equivalent viscous damping ratio using three different methods. Regardless of the calculation method, the damping capacity recovery was around 80% for low-moderate drifts and 100% for high drifts. While collapse was not induced in the structure, drift ratio demands of over 5% could be a

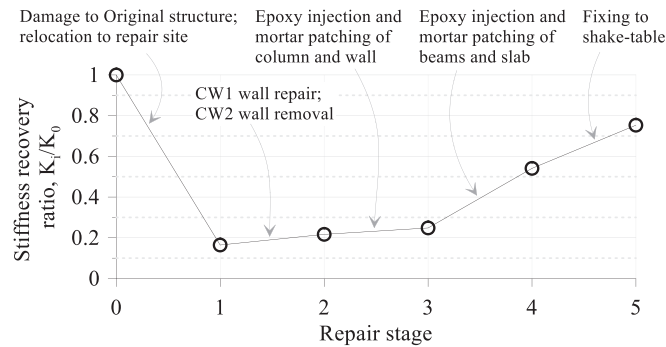
FIGURE 7 Estimated stiffness recovery factor from natural period measurements at each repair stage

where K_0 is the stiffness of the Original undamaged structure and K_i is the stiffness of the Repaired structure following the i th repair stage. The results of Equation (3) for each repair stage are plotted in Figure 7. From Figure 7 it can be observed that repairs to the wall (stage 2) and columns (stage 3) resulted in incremental increases in structural stiffness of 32% and 17% (relative to stage 1), respectively. Repair of the beams and slabs, (stage 4; corresponding to the largest volume of crack epoxy injection), resulted in the largest increase of stiffness relative to stage 1 of 151%. After re-attaching the structure to the shake-table (stage 5), the final Repaired structure's natural period was measured to have recovered to 87% of the Original structure's natural period (i.e., relative to stage 0), suggesting an overall stiffness recovery of 75%. This is considerably higher than the 70% recovery of natural period (50% stiffness recovery) achieved in a full-scale, 7-storey, repaired structure in a previous study.¹⁷ It is thought that the comprehensive epoxy injection repair policy adopted in the

present study (compared to¹⁷ where only “major cracks” were injected) is the main reason for the higher stiffness recovery achieved.

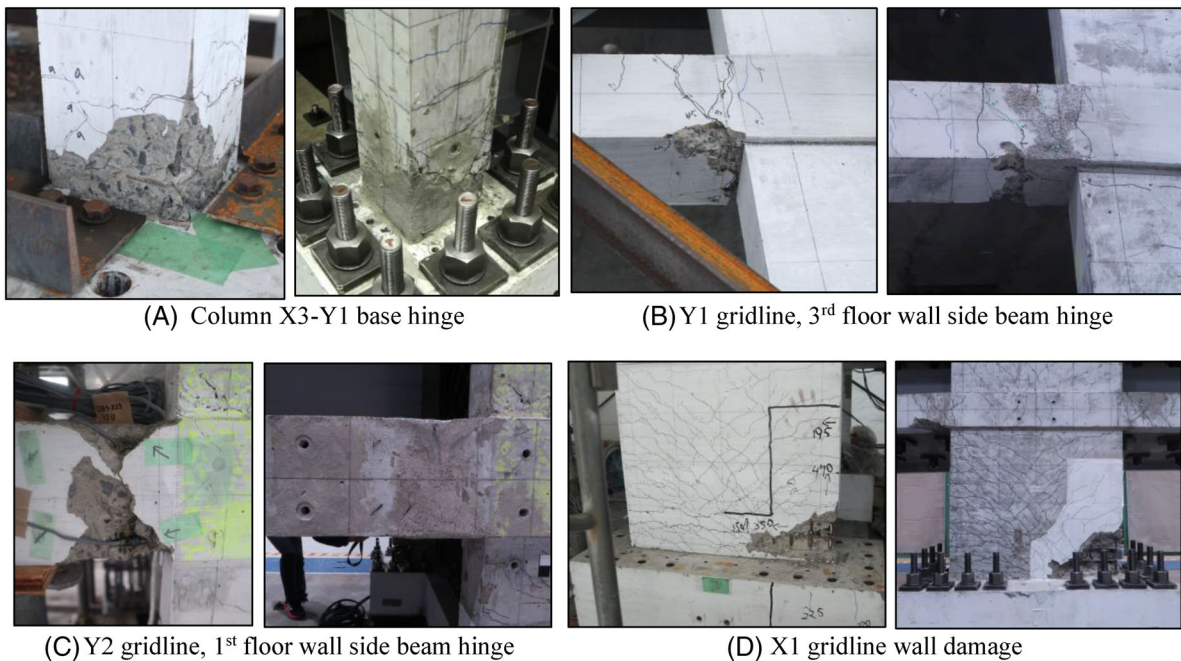
**FIGURE 8** Comparison of damage pattern to beams, columns and walls at the conclusion of the Original (left) and Repaired (right) structure tests

The peak inter-story drift ratio, Δ_{max} , peak base shear, V_{max} and salient damage characteristics following each Run are summarized in Table 5. A photo comparison of the most severely damaged members for the Original structure (after correction of residual drift and prior to initiating repair) and Repaired structure is shown in Figure 8. Base shear of the structure was determined from the sum of the accelerations of each story multiplied by respective floor masses, while inter-story drift ratios were calculated from laser measurements at each floor.

Damage observed up to Run 4 was generally consistent between the Original and Repaired structures. A reduced structural stiffness resulted in slightly lower strengths observed in the Repaired structure for each run until Run 4 compared to the Original structure. At Run 4, the Repaired structure’s strength exceeded that of the Original structure. Following this run a crack running along the full base length of the cast-iron wall was identified, signifying that the cast-iron wall became essentially pinned at the base. No structural strength reduction was observed as a result of the crack formation, confirming the assumption that the out-of-plane strength of the cast-iron wall was insignificant to the X-direction response. Spalling in epoxy mortar repaired plastic hinges was minimal, and generally occurred at later drifts for the Repaired structure compared to the Original structure. Examples of the reduced level of spalling in the Repaired structure compared to the Original structure can be seen in Figure 8A–C for columns and beams. Limited spalling that did occur in the repaired hinges tended to concentrate in the original material directly adjacent to the repaired zone as can be seen in Figure 8A and B. Similar spalling performance has been observed in epoxy mortar repaired members in previous research.¹⁷ It is thought that the lower stiffness of the epoxy mortar (~19% that of the original concrete; Table 3) in combination with its high strength allowed large compression strains to be induced in the repaired regions without extensive spalling. On the other hand, repaired zones where standard concrete was utilized (i.e., CW1 walls), spalling damage was similar for both the Original and Repaired structures (Figure 8D). Spalling in the CW1 walls did not extend beyond the assumed plastic hinge length, suggesting that the welded splice longitudinal reinforcement repair technique was effective.

1. Damage characteristics: The degree of visually observed damage in the Repaired structure was generally less severe (i.e., less spalling) compared to that in the Original structure. This difference is largely attributed to the low stiffness and high strength of the epoxy mortar used in the repair of previously spalled areas.
