Geo-Disaster Report

# Levee damage and bridge scour by 2019 typhoon Hagibis in Kanto Region, Japan

**Keywords:** Typhoon Hagibis; Levee breach; Overtopping; Inland flooding; Bridge scour

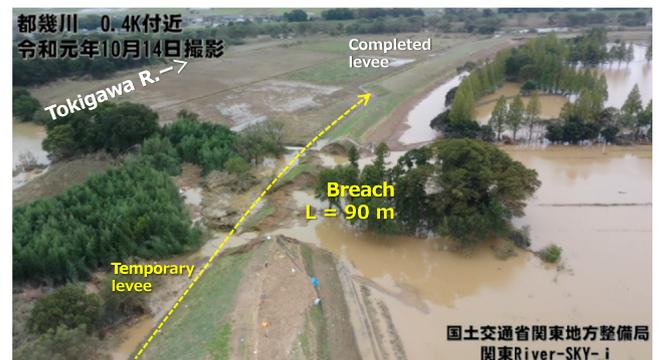
Fig. 7. Breach at 0.4 k on right levee of Tokigawa River. The drone image was obtained from the database maintained by the Ministry of Land, Infrastructure, Transport and Tourism, Japan (<https://www.ktr.mlit.go.jp/bousai/index00000051.html>).

levee being made of a silt-based clay soil and the foundation ground being made of an alluvial soft clay soil. The cause of the failure was considered to be the erosion of the levee due to overtopping.

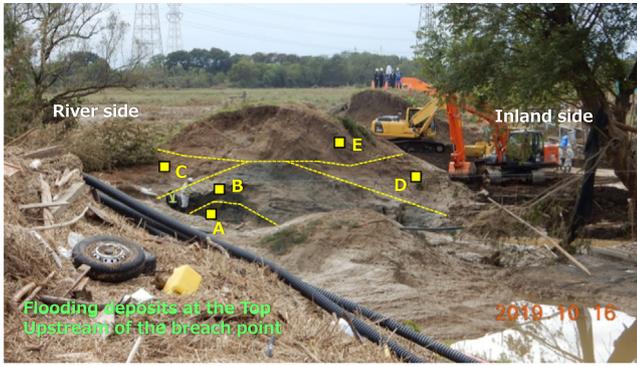
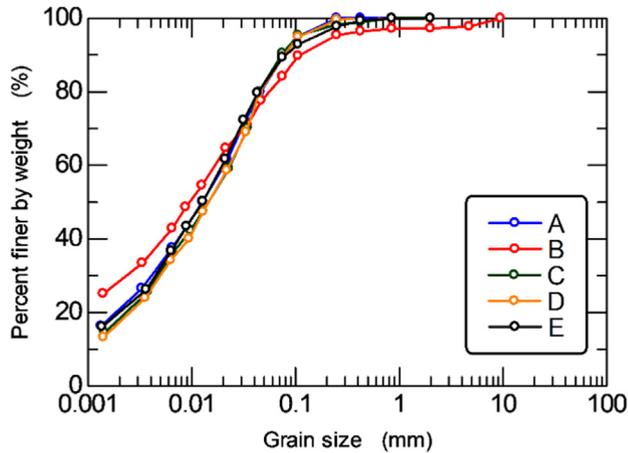
Fig. 8. Cross-section of breached levee at R0.4 k and grain size distribution curves for soils taken from points shown in picture. The data were obtained from the report by the Investigation Committee for the Levee Breach by the 2019 Typhoon Hagibis in the Kanto Region (2020).

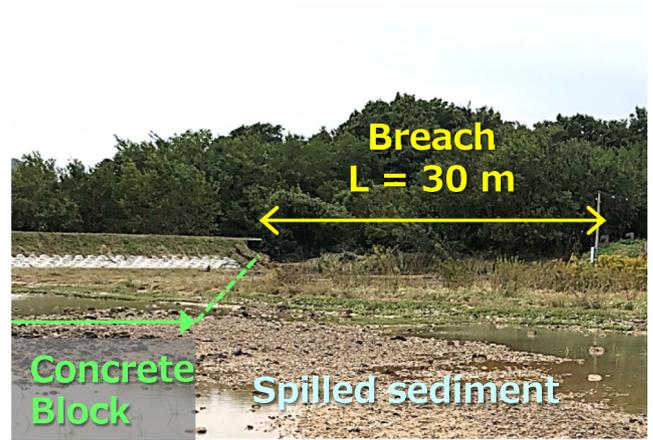
Fig. 10. Breach at 5.6 k on left levee of Tokigawa River.

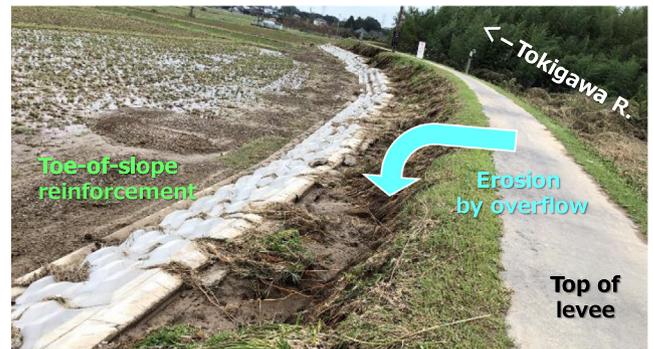
Fig. 11. Levee that survived erosion by overflow.

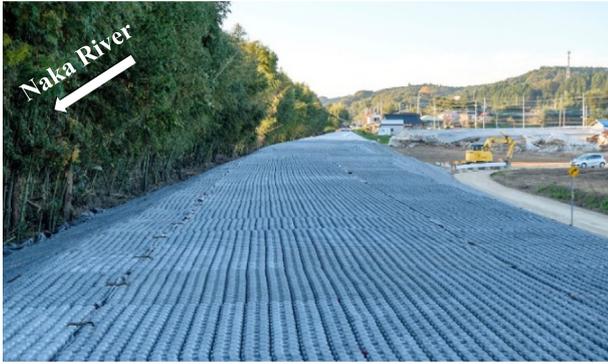
At Noguchi in Hitachi-ohmiya City, Ibaraki Prefecture, the left levee at 40.0 k was breached for about 200 m. Temporary restoration works for the breached levee were started immediately after the event, as shown in Fig. 18. The original levee section was about 3.0 m in height with a 1:2.0 slope. The crest was covered with asphalt pavement, about 3.0 m in width, as part of the temporary restoration works. The Investigation Committee for the Levee Breach by the 2019 Typhoon Hagibis in the Kanto Region (2020) surveyed the cause of the breach and concluded that over-

Fig. 18. Temporary restoration works of left levee at 40.0 k of Naka River.

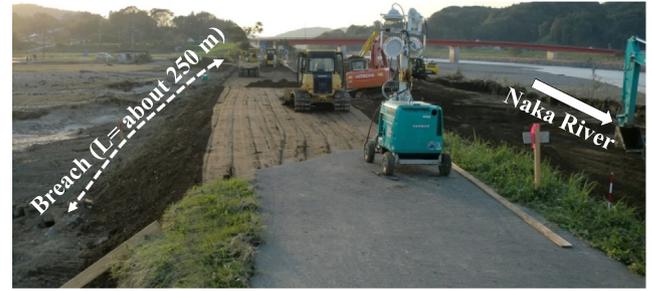
At Shimoisehata in Hitachi-ohmiya City, Ibaraki Prefecture, the failure of the right levee at 41.2 k occurred. The scene of the temporary restoration works is shown in Fig. 20. The collapsed section was about 250 m in length, 4.9 m in slope length, and 3.7 m in crest width. Fig. 21 shows the river-side and land-side slopes adjacent to the collapsed section. The river-side slope had no damage, while marked traces of erosion were found on the land-side slope despite the fact that it has been protected by revetment blocks before the typhoon. According to the construction blueprint by the MLIT, the whole area around the breached section had crest pavements and revetment blocks for the river-side slope, while the land-side slope may have been covered with revetment blocks,

Fig. 20. Temporary restoration works of right levee at 41.2 k of Naka River.

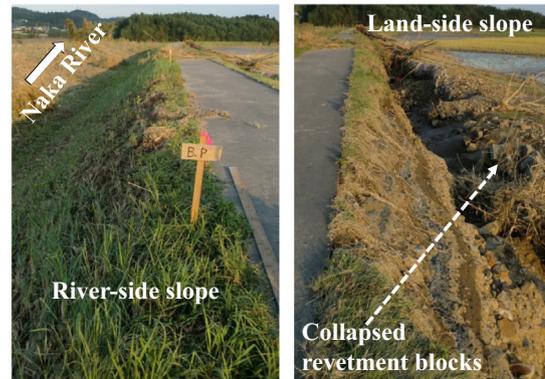
about 30 m in length, at the downstream side of the collapsed section which was about 250 m in length. On the other hand, no signs of sand boils or piping were found during the field survey conducted five days after the event. Considering these results, the breach may have been caused by the erosion of the land-side slope, without revetment blocks, brought about by overtopping. In particular, the failure of the section with revetment blocks, with a land-side slope 30 m in length, may have occurred subsequently due to the flow-out of fill materials after the collapse of the section without revetment blocks (i.e., a progressive failure). The breach at this location suggests that the effects of crest pavements and revetment blocks on reducing the overtopping-induced damage to both side slopes are still unclear. Further studies will need to be conducted to clarify these effects in the future.

Fig. 21. River-side and land-side slopes adjacent to collapsed section at 41.2 k of Naka River.

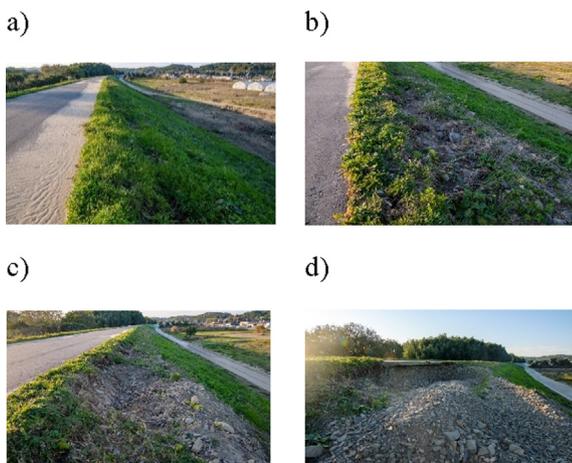
- Step 1: The beginning of vegetation erosion due to overtopping was seen at the shoulder of the levee (Fig. 19a)).
- Step 2: Small grain size soil began to flow out due to the overtopped water (Fig. 19b)).
- Step 3: Then, larger grain size soil was washed away (Fig. 19c)).
- Step 4: The failure of the levee by erosion took place at its shoulder (Fig. 19d)).

Fig. 19. Process of erosion of land-side slope by overtopping: (a) Step 1, (b) Step 2, (c) Step 3, and (d) Step 4.

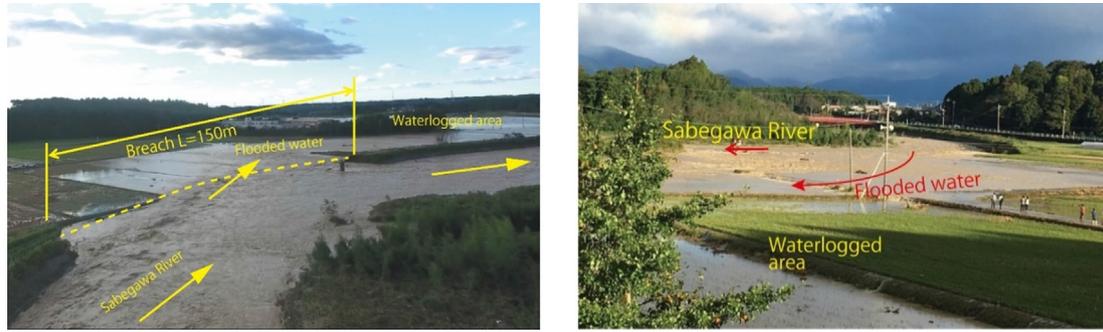
Fig. 22. Breached point on Sabigawa River (in Naka River system) in Kita-owagu area, Otawara City, Tochigi Prefecture. Left photo: View from upstream side, Right photo: View from left levee (Photos provided by Tochigi Prefectural Office with English translation).

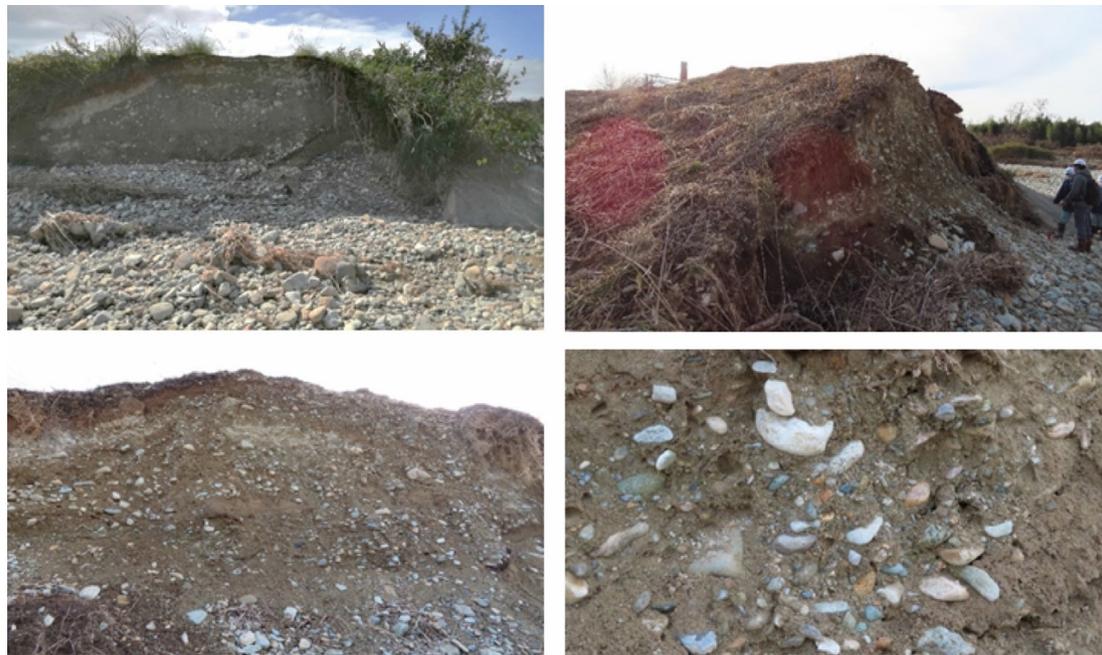
ment material is sandy soil, containing a large amount of cobbles the size of a fist. Fig. 25 shows the damaged levee at the breached point. Along with sandy soil, the embankment also contains many boulders. The cross-section of the damaged levee shows that the embankment was made of sandy soil and there was no core made of low-permeability material. Based on the conditions of the breached levee, soil of the embankment, surrounding topography, and river, the flood-induced wetting of the levee presumably made the levee unstable and resulted in its collapse due to external forces, such as increased water pressure. Most of the levees in the surrounding area are also old. As the material of the levees in this area comprise sandy soil with cobbles/boulders, they are prone to collapse depending on the topography and rainfall conditions. The emergency response to this breach was completed in about 10 days and consisted of constructing a temporary water barrier using large sandbags. Repairs to the levee, including the damaged sections, are planned for the future.

Fig. 25. Damage to levee at breach point. The embankment contains many boulders along with the soil. The embankment was presumably constructed from the surrounding sediment (Photos taken by Unno on December 2, 2019).

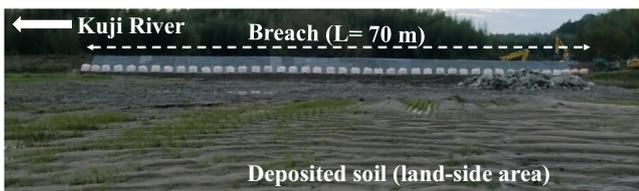
At Onuki in Hitachi-ohmiya City, Ibaraki Prefecture, the failure of the left levee at 34.0 k occurred at a length of about 60 m. The slope length of the collapsed section was about 5 m. As shown in Fig. 27, large sandbags were placed on the levee toe in the temporary restoration works. Considering the facts that (1) no traces of sand boils or piping were found in the field investigations conducted about two weeks after the event and (2) soils were deposited behind the collapsed section, as shown in Fig. 27, the

Fig. 27. Temporary restoration works of left levee at 34.0 k of Kuji River and deposited soils in land-side area.

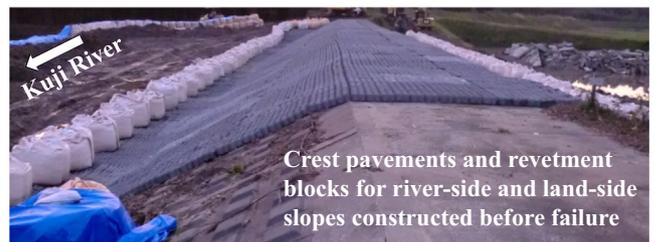
breach might have been caused by the erosion of the land-side slope due to overtopping. As seen in Fig. 28, both side surfaces of the undamaged levee that was adjacent to the breached section has been covered with crest pavements and revetment blocks. According to the aerial photograph, most of the breached section had also been covered with the pavements and blocks prior to the typhoon. As mentioned earlier (i.e., the right levee of 41.2 k on the Naka River), the effects of the crest pavements and revetment blocks for both side slopes on reducing overtopping-induced damage are still unclear.

Fig. 28. Crest pavements and revetment blocks for river-side and land-side slopes constructed before failure at 34.0 k of the Kuji River.

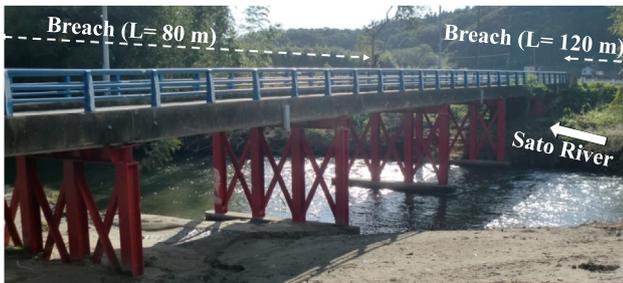
occurred across the Akasu Bridge, as shown in Fig. 30. These two damaged sections were about 80 and 120 m in length, respectively, 2–3 m in slope length, and 4–4.5 m in crest width. As seen in Fig. 31, the Akasu Bridge has six spans in spite of its short length. According to photos taken by a neighbourhood resident, the bridge girder and piers caught driftwood generated by this flood, suggesting that the rise in the river was accelerated locally by the trapped driftwood and might have led to the breach attributed to the erosion of the land-side slope caused by overtopping.

Fig. 31. Akasu Bridge constructed across Sato River.

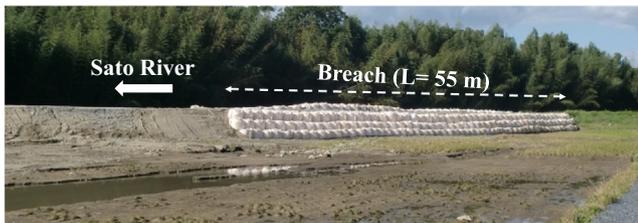
On the upstream side, about 400 m from Point C (i.e., at Point D in Fig. 29), the failure of the left levee occurred at a length of about 55 m (Fig. 32). The slope length and crest width of the collapsed section were about 4.5 and 3 m, respectively. Large sandbags were used to temporarily fill in the breached section as part of the restoration works.

Fig. 32. Temporary restoration works of left levee of Sato River at Point D in Fig. 29.

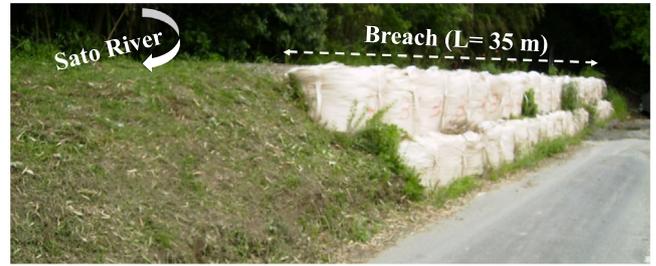
At Point B, indicated in Fig. 29, which corresponds to the downstream side from Point C, the failure of the left levee took place at a length of about 35 m, as shown in Fig. 33. The slope length and crest width of the collapsed section were about 2.5 and 3.5 m, respectively. The main cause of the breach at Point B might have been the erosion of the land-side slope caused by the overtopping attributed to the sharp curve of the river channel (see Fig. 29). As demonstrated by this case, a sharp curve in a river channel can be one of the most important factors causing overtopping-induced damage to a levee.

Fig. 33. Temporary restoration works of left levee of Sato River at Point B in Fig. 29.

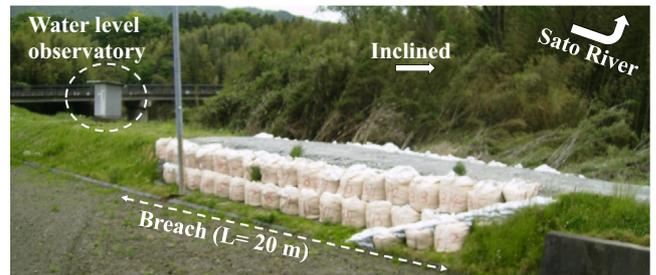
At the downstream side, about 500 m from Point B (i.e., at Point A in Fig. 29), the failure of the right levee, about 20 m in length, 4 m in slope length, and 3.5 m in crest width, occurred as shown in Fig. 34. The foundation of the water level observatory, constructed on the river-side shoulder and located on the downstream side about 16 m from the breached area, shown in Fig. 34, was severely damaged by scour. On the downstream side of the observatory, traces of the erosion of the river-side shoulder were found at a length of 22 m, as shown in Fig. 35. Moreover, as seen in Figs. 34 and 35, bamboo bushes on the river-side shoulder were inclined toward the river-side. When considering these factors, the possible process of the breach could be explained as follows.

- (1) The overtopping occurred possibly due to the sharp curve of the river channel (Fig. 29).
- (2) The river water flowed back to the river channel after overtopping.
- (3) The backwater, whose water level on the protected side was higher than that in the river channel, caused the erosion of the river-side slope. The cross-section of the levee was gradually reduced, and finally, the breach occurred.

Fig. 34. Temporary restoration works of right levee of Sato River at Point A in Fig. 29.

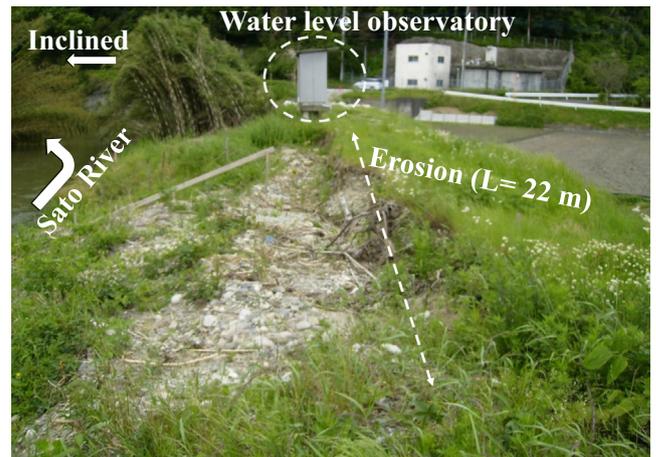
Fig. 35. Traces of erosion of river-side shoulder observed at downstream side from Point A in Fig. 29.

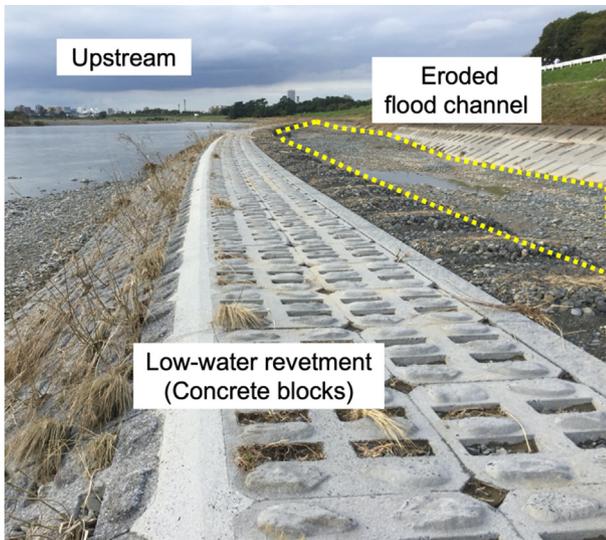
Fig. 38. Levee damage on left levee at 23.4 k on Tamagawa River.

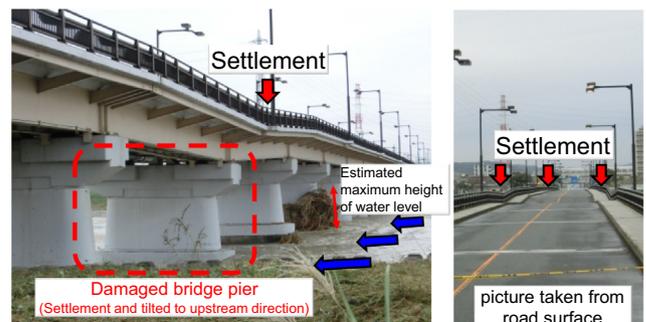
Fig. 41 shows the damaged Hino Bridge (see Fig. 2 for the location). The Hino Bridge was constructed in 1926 as a bridge that crosses the Tamagawa River. The foundation type was an open caisson made of reinforced concrete with a width of about 3.3 m and a depth of about 5.4 m. This bridge used to be along an important road that was employed as National Route 20 until March 2007. As shown in Fig. 41, the pier settled and tilted in the upstream

Fig. 41. Damaged river bridge pier caused by scour.

direction due to scour, and it took about seven months to repair it. To carry out the restoration work of the damaged pier, it was necessary to secure a construction approach road and construction yard around the damaged pier, so

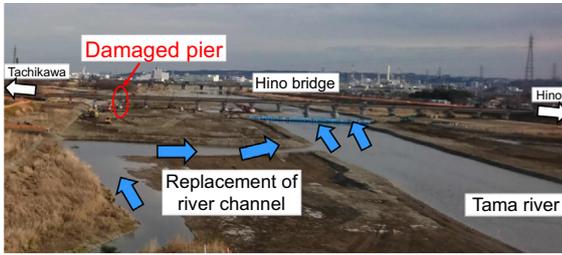
Fig. 42. River channel replacement for restoration work of Hino Bridge.

that a large-scale river channel replacement could be carried out (Fig. 42). It can be learned from this case that, once a scouring disaster occurs, the recovery work often takes a long time. Thus, it is important to take measures to prevent such disasters, as much as possible, by establishing a practical method for distinguishing the piers at high risk for scouring. As a characteristic of the recent scour damage to river bridges, bridge piers located in high water beds, which are supposed to have a low risk of scouring damage, are often damaged. The aforementioned Hino Bridge followed this exact disaster pattern, and details on it are provided in the next subsection.

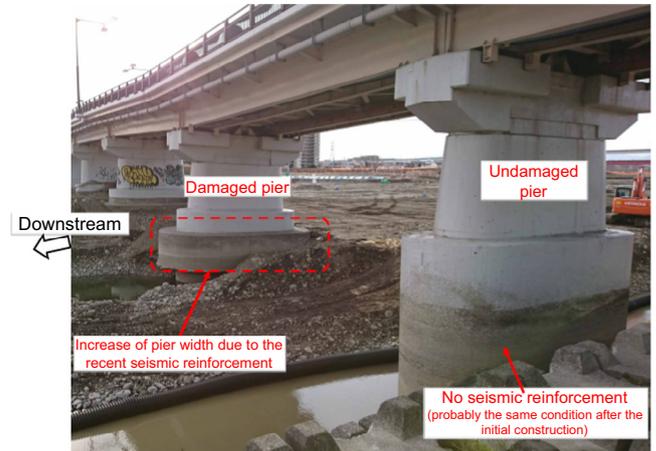
Fig. 44. Damaged pier during the restoration work (from downstream).
