Title	Performance recovery of a repaired 4-storey reinforced concrete structure subjected to shake-table testing
Authors	Alex Shegay, Kota Miura, Akira Mikawa, Masaki Maeda, Matsutaro Seki
Citation	Earthquake Engineering & Structural Dynamics, Volume 52, Issue 5, pp. 1339-1359
Pub. date	2023, 1
DOI	https://doi.org/10.1002/eqe.3818
Creative Commons	Information is in the article.

Performance recovery of a repaired 4-storey reinforced concrete structure subjected to shake-table testing

Understanding the effects of repair on reinforced concrete (RC) structures is critical to evaluating their performance in future earthquakes. In this research, a system-level approach is taken by repairing a previously damaged ¼ scale 4-storey RC structure and subjecting it to a series of dynamic excitations via shake table testing. The repair was undertaken using common construction materials with the primary motivation of restoring original performance. The performance of the repaired structure was compared to that of the original structure prior to repairs. It was found that overall initial stiffness of the structure was recovered to 66% of the original initial stiffness and was generally higher in

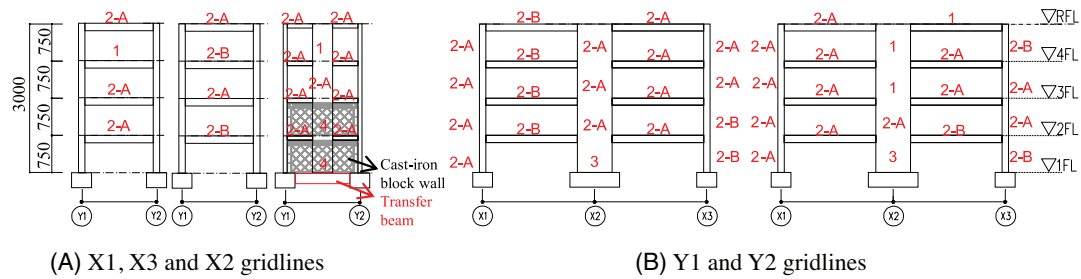
Prior to undertaking the repair work, the structure's residual deformation was corrected in both directions. This was achieved by statically applying external lateral forces to the 2nd and 4th stories of the structure until the residual inter-story drift reduced to below 0.2% (based on an average of five measurement locations per floor) once the external loads were released. It is acknowledged that correction of residual deformation is generally impractical in real-life application; however, to meet the study's objective of evaluating the effects of basic repair techniques, a fair comparison to the Original structure was given priority. Therefore, it was decided to reduce other major influencing factors (i.e., p-delta effects) that would hinder this comparison. Following correction of residual deformation, the structure was moved off the shake-table test to conduct the repairs (full vertical and foundation lateral bracing was provided to the structure to prevent further damage during relocation). The repair work in the X-direction did not include any changes in cross-section dimensions, steel reinforcement ratios, or any repair techniques that could otherwise be considered to enhance performance relative to the Original structure. The repair works undertaken were divided into five classes, and the class adopted for each structural member was decided based on the member damage level. Damage level definitions were adopted from the JBDPA Guidelines,^{7,26} and are summarized in Appendix B. The repair class definitions and the corresponding repair materials used are described in Table 2. The repair methodology within each class was based on a combination of guidance provided in the JBDPA Guidelines,⁷ the Japan Building Conservation Center's Building Repair Works Guidelines,²⁷ and discussions of “best-practice” with the contractor employed to carry out the repair. The repair class assigned to each member throughout the structure is shown in Figure 5.

FIGURE 5 Repair classification of each member of the structure

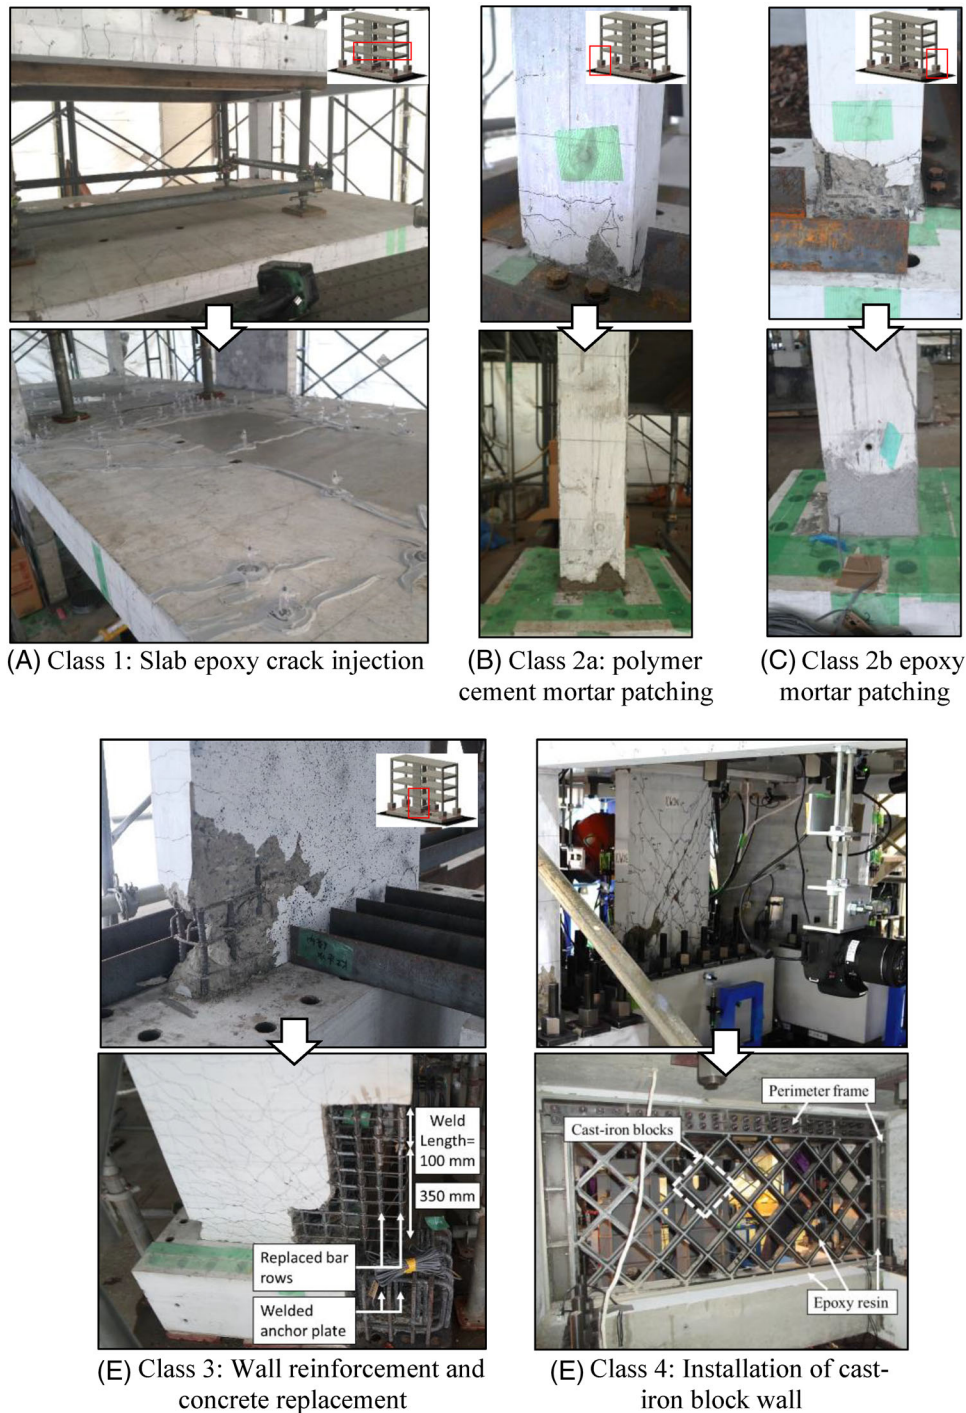
Typical before and after photos for each repair class are shown in Figure 6. For Repair Class 1, all cracks exceeding an in-situ width measurement of 0.05 mm found in beams, columns and walls were epoxy injected by a hand-operated applicator gun. The 0.05 mm width limit was targeted to account for the structure's reduced scale, given the typical injection limit capability in practice is around 0.2 mm. This lower limit was advised possible by the contractor based on the low viscosity properties of the chosen epoxy resin. For cracks in the floor slabs, it was deemed impractical and unrealistic to inject all the cracks due to the large surface area; instead, only the cracks in the slab that propagated to the beams, columns, or walls were injected (i.e., cracks originating *and* terminating internally in the slab were not injected). Slab

FIGURE 6 Typical examples for each repair class listed in Table 2

cracks that did not meet these criteria were deemed to not be from flexural damage, but the result of stresses developing from the anchoring of the additional floor masses. For Repair Class 2a, polymer cement mortar was used where spalling was not severe enough to expose any reinforcement. In areas of spalling where longitudinal reinforcement was exposed (Figure 6C), epoxy mortar was used for patching (Repair Class 2b) because better adhesion could be achieved to the original material compared to using polymer cement. This approach is also in accordance with guidance in.²⁷ For Repair Class 3, concrete was removed such that buckled longitudinal reinforcement could be extracted and replacement reinforcement could be lap-splice welded outside the plastic hinge zone (assumed as half the wall length). The length of the weld was ten times the bar diameter on both sides of the splice as recommended in.⁷ Welds in the first and second row of reinforcement were staggered by half the weld length as shown in Figure 6D. The bottom of the reinforcement was anchored into the foundation by welding a steel plate to the bottom end of the bar. The repaired area was recast using a concrete mix with similar strength characteristics to the original material. Repair Class 4 was only applied to the area where the CW2 wall had undergone a shear failure in the Y-direction, as shown in Figure 6E. The damaged CW2 wall was completely removed from the 1st and 2nd floors, and a proprietary cast-iron block wall²⁸ was installed in its place (Figure 6E). The cast-iron blocks (122 × 122 × 40(depth) × 8(thick) mm hollow square sections) were stacked diagonally and adhered to each other with epoxy resin. The cast-iron blocks were installed within a perimeter steel frame, which required a continuous concrete support along the base. The bottom support was provided by replacing the original foundation underneath the CW2 with a transfer beam spanning between the foundations of the CW1 walls. The perimeter steel frame was fixed to the surrounding concrete by a 6 mm layer of epoxy resin. Given the weak tensile adhesion of the base of the cast-iron block wall to the transfer beam below it (2.5 MPa over an 80 mm width), the wall was not expected to have significant strength in its out-of-plane response and therefore a negligible contribution to the X-direction response. Under this assumption (confirmed in a later section), the Repair structure X-direction response could be studied in isolation of the strengthening effects of the Y-direction. It is also noted that the net increase in story mass from the installation of the cast-iron block wall was around 1% compared to the Original structure, which was considered to be negligible. The performance of the structure in the Y-direction is outside the scope of this paper, instead, the reader is referred to another publication.²⁵

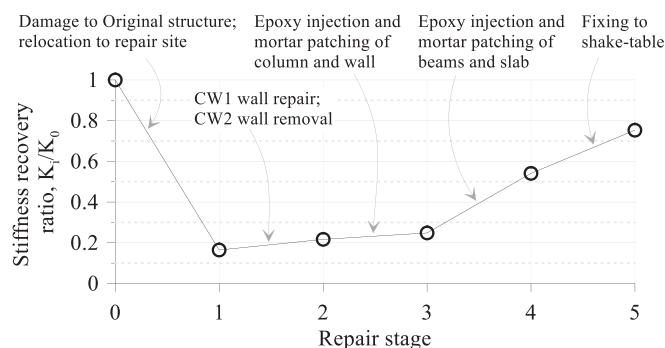
where K_0 is the stiffness of the Original undamaged structure and K_i is the stiffness of the Repaired structure following the i th repair stage. The results of Equation (3) for each repair stage are plotted in Figure 7. From Figure 7 it can be observed that repairs to the wall (stage 2) and columns (stage 3) resulted in incremental increases in structural stiffness of 32% and 17% (relative to stage 1), respectively. Repair of the beams and slabs, (stage 4; corresponding to the largest volume of crack epoxy injection), resulted in the largest increase of stiffness relative to stage 1 of 151%. After re-attaching the structure to the shake-table (stage 5), the final Repaired structure's natural period was measured to have recovered to 87% of the Original structure's natural period (i.e., relative to stage 0), suggesting an overall stiffness recovery of 75%. This is considerably higher than the 70% recovery of natural period (50% stiffness recovery) achieved in a full-scale, 7-storey, repaired structure in a previous study.¹⁷ It is thought that the comprehensive epoxy injection repair policy adopted in the

FIGURE 7 Estimated stiffness recovery factor from natural period measurements at each repair stage

present study (compared to¹⁷ where only “major cracks” were injected) is the main reason for the higher stiffness recovery achieved.

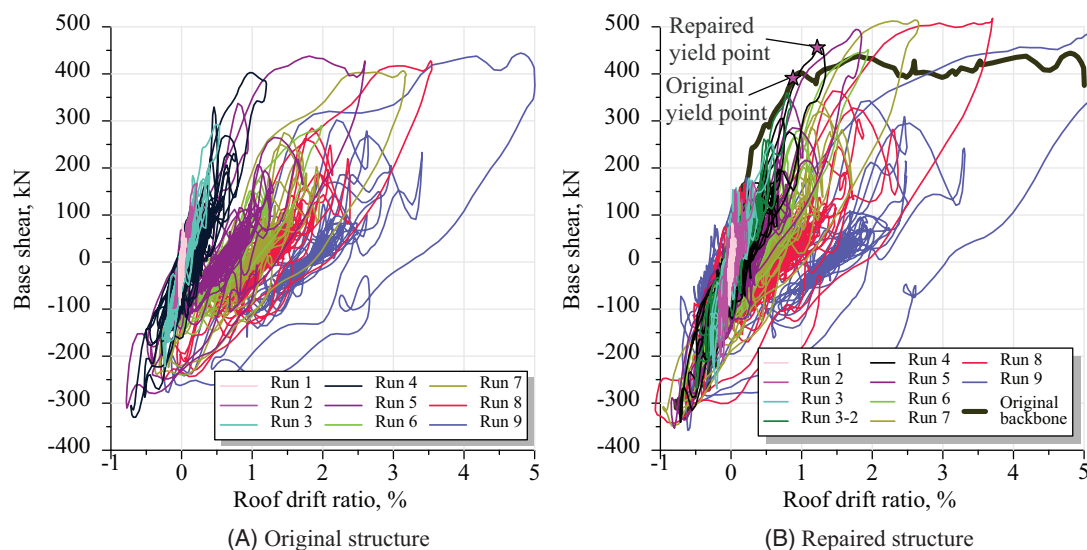
FIGURE 9 Base shear-roof drift ratio response of the (A) Original structure and (B) Repaired structure

The base shear-roof drift ratio relationship for the Original and Repaired structures are shown in Figure 9A and B, respectively. The envelope of the Original structure is traced as a grey line in Figure 9B for ease of comparison. Roof drift ratio was calculated as the cumulative sum of the inter-story drifts from each floor divided by the total height of the structure. The “yield points” of the Original and Repaired structures are also plotted in Figure 9B. The “yield point” corresponds to the formation of a full beam-sway mechanism in the structure. The full beam-sway mechanism was judged to have formed when strain in longitudinal reinforcement in all measured flexural hinges (beams, columns, and walls) exceeded the yield strain. From the comparison of Figure 9A and B the following observations can be readily made: (1) the stiffness of the Repaired structure leading up to the yield point is lower than that of the Original structure, (2) the apparent yield point of the Repaired structure has shifted to the right of the Original structure’s yield point, (3) the hysteresis loops in the Repaired structure do not exhibit any obvious increase in pinching characteristics compared to the Original structure (i.e., no significant reinforcement bond degradation, or shear sliding along cracks), and (4) the strength of the Repaired structure is considerably higher than that of the Original structure. These aspects will be discussed in detail in the next section.

From Figure 9B, the yield point has shifted from 0.97% in the Original structure to 1.3% in the Repaired structure. This shift is not thought to be due to a reduction in post-cracking stiffness (e.g., due to Bauschinger effect) because the Run 4 hysteretic curve of the Repaired structure passes directly through the Original structure's yield point, as can be seen in Figure 9B. Rather, this shift is thought to be due to member sections developing higher yield curvatures due to higher section yield strengths.²⁹ This observation suggests that the overall structural strength increase seen in Figure 9 is due to inherent strength increase of individual members rather than a change in modal vibration characteristics. Based on the yield point definition in Figure 9B, the “overall” yield secant stiffness of the Repaired structure recovered to 87% of the Original structure.

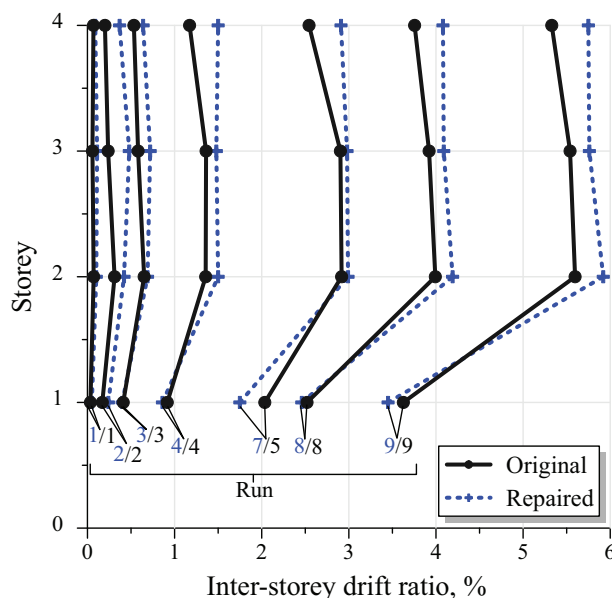
Maximum inter-story drift ratio distributions of the Original and Repaired structures are compared in Figure 10. Runs included in the comparison are those that achieve similar maximum roof drift ratios in both experimental programs (hereinafter “comparable Runs”). The purpose of this comparison is to make qualitative judgment on the shape of the drift ratio distribution rather than compare absolute magnitude. The maximum inter-story drift ratio distribution shape is very similar between the Original and Repaired structures suggesting no significant changes in the mode of vibration. Some minor difference is observed in the Repaired structure where the top inter-story drift ratio is slightly higher relative to the lower floors, when compared to the Original structure. This difference suggests that in the Repaired structure, upper stories are softer relative to the lower stories compared to the Original structure. Higher stiffness recovery in the lower floors is expected because of the higher intensity repair implemented (replacement of reinforcement and concrete) compared to the upper floors (epoxy injection only). Additionally, concrete cracks in the upper stories were generally narrower compared to that of the lower stories (particularly for columns and walls), resulting in likely reduced epoxy resin penetration depth.

FIGURE 10 Maximum inter-story drift ratio distribution for runs resulting in similar peak roof drift ratio

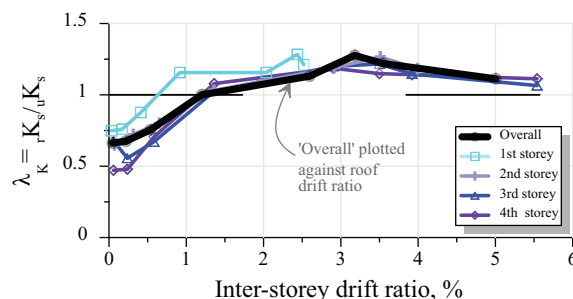
FIGURE 11 Recovery of secant stiffness, λ_K , for overall structure and for each storey

drifts, and again suggests that the repair was more effective in the lower stories. Following Run 4, the Repaired structure exceeded the strength of the Original structure, resulting in secant stiffness higher than unity thereafter.

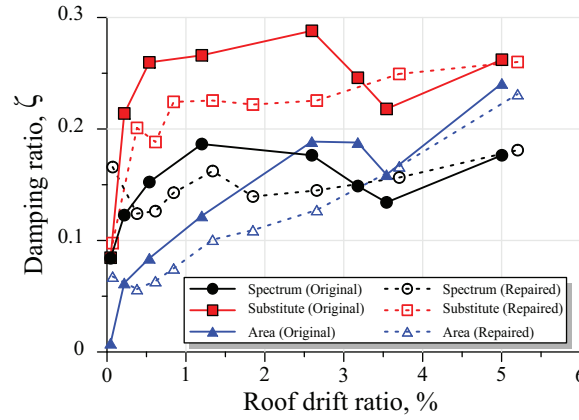
FIGURE 12 Equivalent viscous damping ratio of the Original and Repaired structures evaluated using three methods

From Figure 12 it can be seen that the absolute value of the equivalent viscous damping ratio varies significantly between each calculation method. The level of variability tends to decrease with increasing roof drift ratio of the structure. The “substitute” method results in the highest damping ratios (above 20% for both Original and Repaired structures). The “spectrum” method produces higher damping ratios than the “area” method up until roof drifts of around 3%, after which the trend is reversed, such that the “area” method produces higher damping ratios. The large variability in the damping ratio between methods is not unexpected given the fundamentally different theoretical and empirical assumptions in the calculations. These differences have been previously shown to have a dependence on the structural period, ductility and hysteresis shape.³³ In this study, the focus is given on the level of recovery of damping ratio rather than the absolute magnitudes. To calculate the damping capacity recovery factor, λ_d , the damping ratios for the Repaired structure were normalized by that of the Original structure for comparable Runs. The results are shown in Figure 13 (Run 1 and 2 data are excluded as large scatter was obtained when executing the quotient operation in the elastic region of the response). The comparison shows that despite large differences in the absolute damping ratio values seen in Figure 12, the magnitude of the damping recovery factor is generally in agreement between all three calculation methods for the Runs shown. The damping capacity recovery factor is approximately $\lambda_d \approx 80\%$ up to 2.7% roof drift (i.e., Run 7/5 in Figure 13). This suggests that the damping capacity is only partially recovered at low-moderate seismic demands. The loss of damping capacity is attributed to imperfect restoration of the concrete performance (e.g., deficiencies in epoxy injection technique to reseal all cracks). On the other hand, at higher drifts (Run 8/8 and Run 9/9) corresponding to higher levels of damage, the damping capacity recovery factor is close to or slightly exceeding 1.0. At these high drift demands, concrete is generally fully cracked and so energy dissipation capacity is largely governed by the plastic deformation of reinforcement; thus, reduction in damping capacity is not expected provided there is no degradation in performance of reinforcement. Given these results, in simplified models of repaired structures that utilize some form of equivalent linearization of the beam-sway structural system, using a lower bound damping capacity recovery factor of 80% may be appropriate.

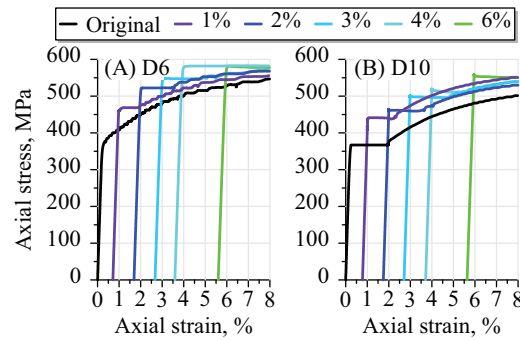
FIGURE 15 Stress-strain relationship of D6 and D10 reinforcement before and after strain aging

Therefore, a combination of reinforcement strain hardening and strain aging are thought to be the principal causes for the observed strength increase. The presence of strain aging also helps explain the absence of Bauschinger effect in Figure 9, as previous studies have demonstrated that the Bauschinger effect is “reset” by strain aging.³⁵ Previous studies on strain aged reinforcement have indicated that a strength increase of 10%–20% of the original yield stress can be expected, and that this value is somewhat independent of the maximum previously exerted strain.^{34–37} To confirm whether strain aging was a cause of the observed strength increase in the present study, longitudinal reinforcement used in the beams (D6 bars), columns and walls (D10 bars) were tested. The test procedure involved subjecting the reinforcement to an initial tensile strain ranging from 1%–6% (strain ranges recorded in members of the Original structure); unloading and allowing the bars to age; and finally reloading the bars until tensile fracture. The aging process was accelerated by heat treating the bars at 100°C for 4 h, to simulated 1-year of strain aging³⁸ (the period between testing of the Original and Repaired structures). The stress-strain curves for the “original” non-aged reinforcement and strain-aged reinforcement are shown in Figure 15. It can be seen that after the strain aging process the yield stress of both the D6 and D10 reinforcement exceeded the envelope of the “original” reinforcement. The strain aged reinforcement curves also exhibit reemergence of the yield-plateau, which would otherwise not be present had reloading occurred immediately after unloading from the initial strain. This provides evidence for the disappearance of the Bauschinger effect and an explanation of why the backbone of the Repaired structure in Figure 9B passes through the yield point of the Original structure. The increase in stress directly attributed to strain aging (i.e., excluding the effect of strain hardening) for each bar diameter is shown in Figure 16. It can be seen that while the magnitude of the stress increase is different for the D6 and D10 reinforcement, it is essentially independent of the initially applied peak strain level, provided yielding has occurred. On average, the increase in stress is 57 MPa for D6 reinforcement and 81 MPa for D10 reinforcement. Expressed as a percentage relative to the expected stress at the corresponding strain level for a non-aged bar, this becomes 12% and 19% for D6 and D10 reinforcement, respectively.

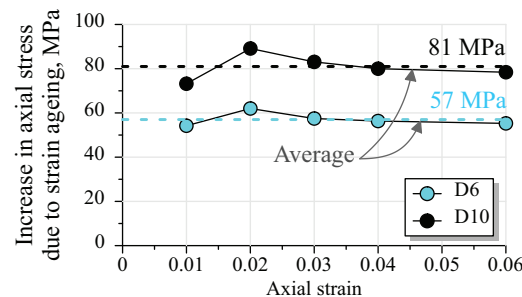
FIGURE 16 Increase in strength attributed to strain aging for D6 and D10 reinforcement
