# Performance recovery of a repaired 4-storey reinforced concrete structure subjected to shake-table testing

Understanding the effects of repair on reinforced concrete (RC) structures is critical to evaluating their performance in future earthquakes. In this research, a system-level approach is taken by repairing a previously damaged ¼ scale 4-storey RC structure and subjecting it to a series of dynamic excitations via shake table testing. The repair was undertaken using common construction materials with the primary motivation of restoring original performance. The performance of the repaired structure was compared to that of the original structure prior to repairs. It was found that overall initial stiffness of the structure was recovered to 66% of the original initial stiffness and was generally higher in floors where more intensive repair works were undertaken. Damping capacity was quantified via equivalent viscous damping ratio using three different methods. Regardless of the calculation method, the damping capacity recovery was around 80% for low-moderate drifts and 100% for high drifts. While collapse was not induced in the structure, drift ratio demands of over 5% could be

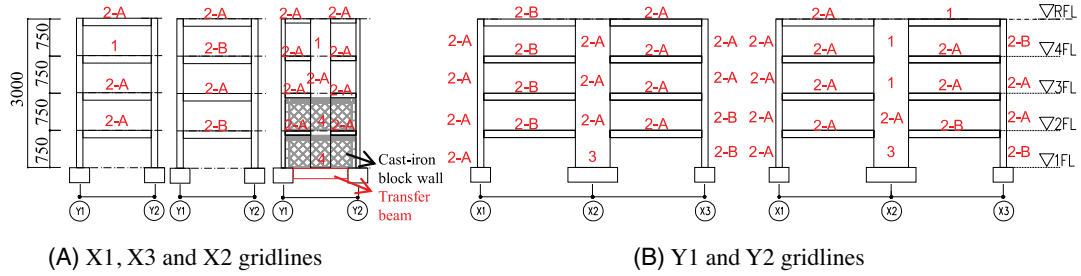
FIGURE 5 Repair classification of each member of the structure

Prior to undertaking the repair work, the structure's residual deformation was corrected in both directions. This was achieved by statically applying external lateral forces to the 2<sup>nd</sup> and 4<sup>th</sup> stories of the structure until the residual inter-story drift reduced to below 0.2% (based on an average of five measurement locations per floor) once the external loads were released. It is acknowledged that correction of residual deformation is generally impractical in real-life application; however, to meet the study's objective of evaluating the effects of basic repair techniques, a fair comparison to the Original structure was given priority. Therefore, it was decided to reduce other major influencing factors (i.e., p-delta effects) that would hinder this comparison. Following correction of residual deformation, the structure was moved off the shake-table test to conduct the repairs (full vertical and foundation lateral bracing was provided to the structure to prevent further damage during relocation). The repair work in the X-direction did not include any changes in cross-section dimensions, steel reinforcement ratios, or any repair techniques that could otherwise be considered to enhance performance relative to the Original structure. The repair works undertaken were divided into five classes, and the class adopted for each structural member was decided based on the member damage level. Damage level definitions were adopted from the JBDPA Guidelines,<sup>7,26</sup> and are summarized in Appendix B. The repair class definitions and the corresponding repair materials used are described in Table 2. The repair methodology within each class was based on a combination of guidance provided in the JBDPA Guidelines,<sup>7</sup> the Japan Building Conservation Center's Building Repair Works Guidelines,<sup>27</sup> and discussions of "best-practice" with the contractor employed to carry out the repair. The repair class assigned to each member throughout the structure is shown in Figure 5.

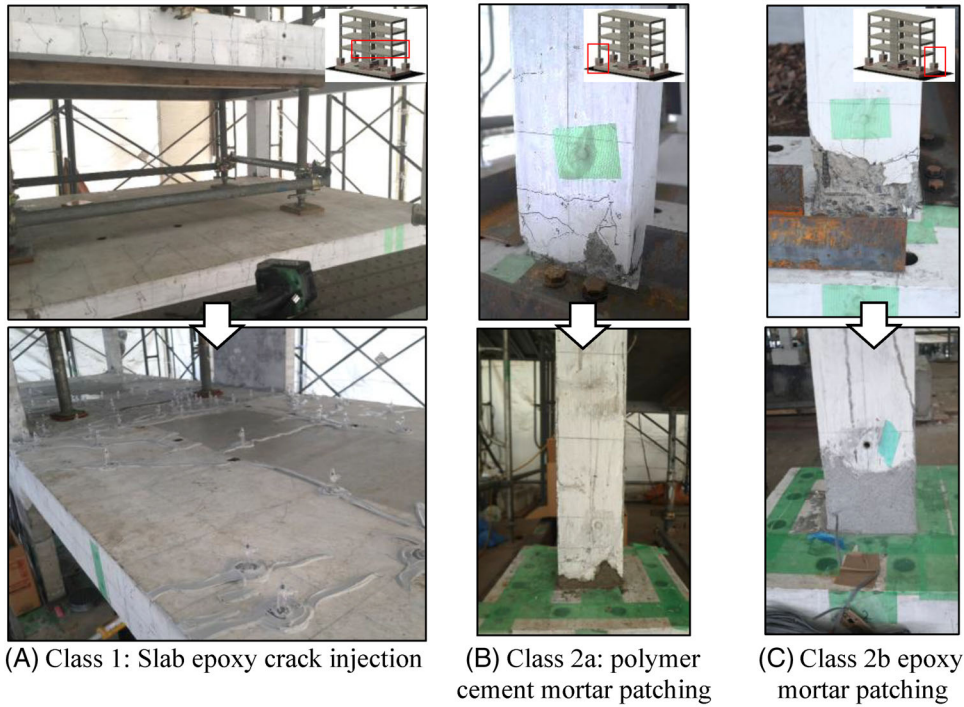
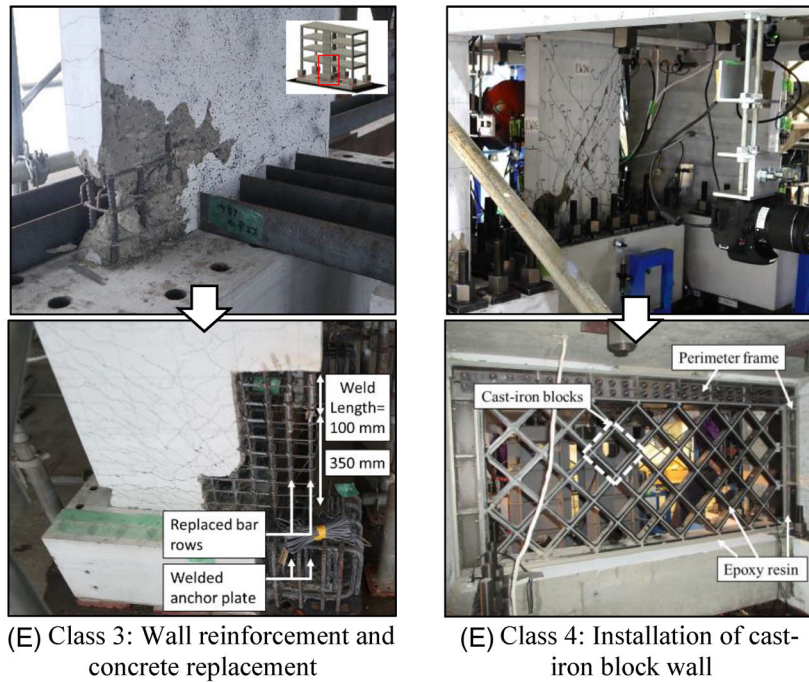
FIGURE 6 Typical examples for each repair class listed in Table 2

(A) Class 1: Slab epoxy crack injection (B) Class 2a: polymer cement mortar patching (C) Class 2b: epoxy mortar patching

(E) Class 3: Wall reinforcement and concrete replacement (E) Class 4: Installation of cast-iron block wall

Typical before and after photos for each repair class are shown in Figure 6. For Repair Class 1, all cracks exceeding an in-situ width measurement of 0.05 mm found in beams, columns and walls were epoxy injected by a hand-operated applicator gun. The 0.05 mm width limit was targeted to account for the structure's reduced scale, given the typical injection limit capability in practice is around 0.2 mm. This lower limit was advised possible by the contractor based on the low viscosity properties of the chosen epoxy resin. For cracks in the floor slabs, it was deemed impractical and unrealistic to inject all the cracks due to the large surface area; instead, only the cracks in the slab that propagated to the beams, columns, or walls were injected (i.e., cracks originating *and* terminating internally in the slab were not injected). Slab

cracks that did not meet these criteria were deemed to not be from flexural damage, but the result of stresses developing from the anchoring of the additional floor masses. For Repair Class 2a, polymer cement mortar was used where spalling was not severe enough to expose any reinforcement. In areas of spalling where longitudinal reinforcement was exposed (Figure 6C), epoxy mortar was used for patching (Repair Class 2b) because better adhesion could be achieved to the original material compared to using polymer cement. This approach is also in accordance with guidance in.<sup>27</sup> For Repair Class 3, concrete was removed such that buckled longitudinal reinforcement could be extracted and replacement reinforcement could be lap-splice welded outside the plastic hinge zone (assumed as half the wall length). The length of the weld was ten times the bar diameter on both sides of the splice as recommended in.<sup>7</sup> Welds in the first and second row of reinforcement were staggered by half the weld length as shown in Figure 6D. The bottom of the reinforcement was anchored into the foundation by welding a steel plate to the bottom end of the bar. The repaired area was recast using a concrete mix with similar strength characteristics to the original material. Repair Class 4 was only applied to the area where the CW2 wall had undergone a shear failure in the Y-direction, as shown in Figure 6E. The damaged CW2 wall was completely removed from the 1<sup>st</sup> and 2<sup>nd</sup> floors, and a proprietary cast-iron block wall<sup>28</sup> was installed in its place (Figure 6E). The cast-iron blocks (122 × 122 × 40(depth) × 8(thick) mm hollow square sections) were stacked diagonally and adhered to each other with epoxy resin. The cast-iron blocks were installed within a perimeter steel frame, which required a continuous concrete support along the base. The bottom support was provided by replacing the original foundation underneath the CW2 with a transfer beam spanning between the foundations of the CW1 walls. The perimeter steel frame was fixed to the surrounding concrete by a 6 mm layer of epoxy resin. Given the weak tensile adhesion of the base of the cast-iron block wall to the transfer beam below it (2.5 MPa over an 80 mm width), the wall was not expected to have significant strength in its out-of-plane response and therefore a negligible contribution to the X-direction response. Under this assumption (confirmed in a later section), the Repair structure X-direction response could be studied in isolation of the strengthening effects of the Y-direction. It is also noted that the net increase in story mass from the installation of the cast-iron block wall was around 1% compared to the Original structure, which was considered to be negligible. The performance of the structure in the Y-direction is outside the scope of this paper, instead, the reader is referred to another publication.<sup>25</sup>

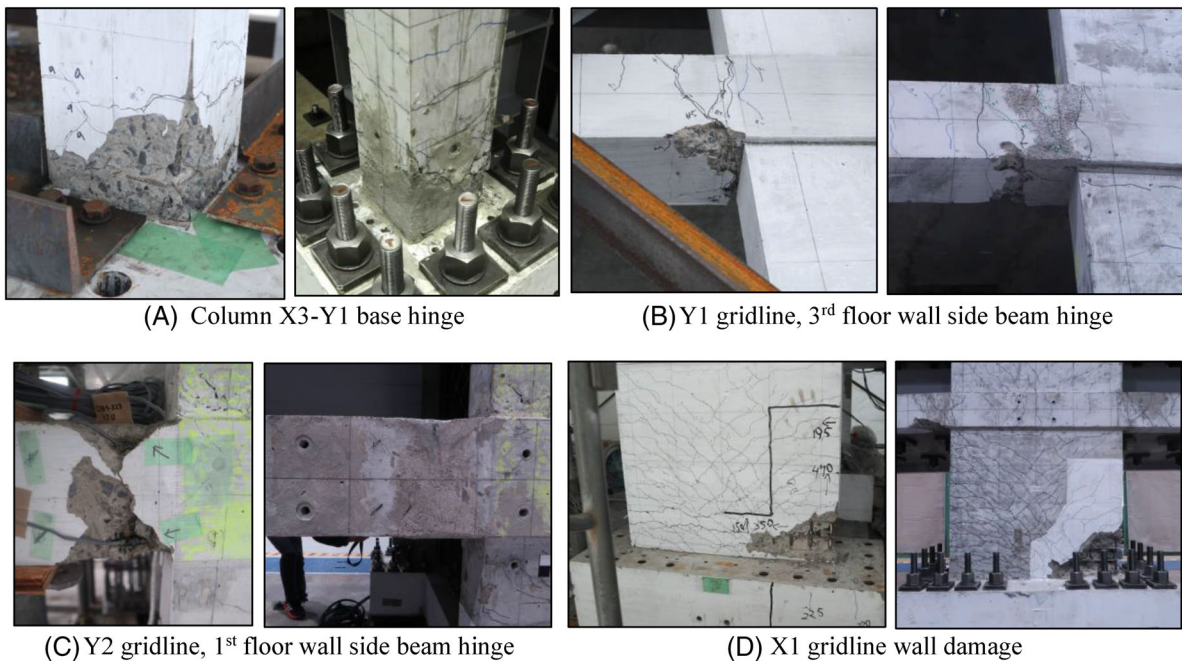
The peak inter-story drift ratio,  $\Delta_{max}$ , peak base shear,  $V_{max}$  and salient damage characteristics following each Run are summarized in Table 5. A photo comparison of the most severely damaged members for the Original structure (after correction of residual drift and prior to initiating repair) and Repaired structure is shown in Figure 8. Base shear of the structure was determined from the sum of the accelerations of each story multiplied by respective floor masses, while inter-story drift ratios were calculated from laser measurements at each floor.

Damage observed up to Run 4 was generally consistent between the Original and Repaired structures. A reduced structural stiffness resulted in slightly lower strengths observed in the Repaired structure for each run until Run 4 compared to the Original structure. At Run 4, the Repaired structure’s strength exceeded that of the Original structure. Following this run a crack running along the full base length of the cast-iron wall was identified, signifying that the cast-iron wall became essentially pinned at the base. No structural strength reduction was observed as a result of the crack formation, confirming the assumption that the out-of-plane strength of the cast-iron wall was insignificant to the X-direction response. Spalling in epoxy mortar repaired plastic hinges was minimal, and generally occurred at later drifts for the Repaired structure compared to the Original structure. Examples of the reduced level of spalling in the Repaired structure compared to the Original structure can be seen in Figure 8A–C for columns and beams. Limited spalling that did occur in the repaired hinges tended to concentrate in the original material directly adjacent to the repaired zone as can be seen in Figure 8A and B. Similar spalling performance has been observed in epoxy mortar repaired members in previous research.<sup>17</sup> It is thought that the lower stiffness of the epoxy mortar (~19% that of the original concrete; Table 3) in combination with its high strength allowed large compression strains to be induced in the repaired regions without extensive spalling. On the other hand, repaired zones where standard concrete was utilized (i.e., CW1 walls), spalling damage was similar for both the Original and Repaired structures (Figure 8D). Spalling in the CW1 walls did not extend beyond the assumed plastic hinge length, suggesting that the welded splice longitudinal reinforcement repair technique was effective.

**FIGURE 8** Comparison of damage pattern to beams, columns and walls at the conclusion of the Original (left) and Repaired (right) structure tests
