Title	Levee Damage and Bridge Scour by 2019 Typhoon Hagibis in Kanto Region, Japan
Authors	Tadao Enomoto, Kazuki Horikoshi, Keisuke Ishikawa, Hirotoshi Mori, Akihiro Takahashi, Toshiyasu Unno, Kenji Watanabe
Citation	Soils and Foundations, Vol. 61, Issue 2, pp. 566-585
Pub. date	2021, 4

Geo-Disaster Report

Levee damage and bridge scour by 2019 typhoon Hagibis in Kanto Region, Japan

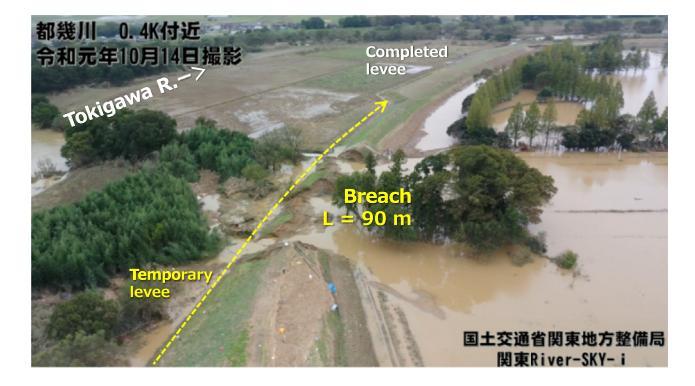
Fig. 7. Breach at 0.4 k on right levee of Tokigawa River. The drone image was obtained from the database maintained by the Ministry of Land, Infrastructure, Transport and Tourism, Japan (https://www.ktr.mlit.go.jp/bousai/index00000051.html).

levee being made of a silt-based clay soil and the foundation ground being made of an alluvial soft clay soil. The cause of the failure was considered to be the erosion of the levee due to overtopping.

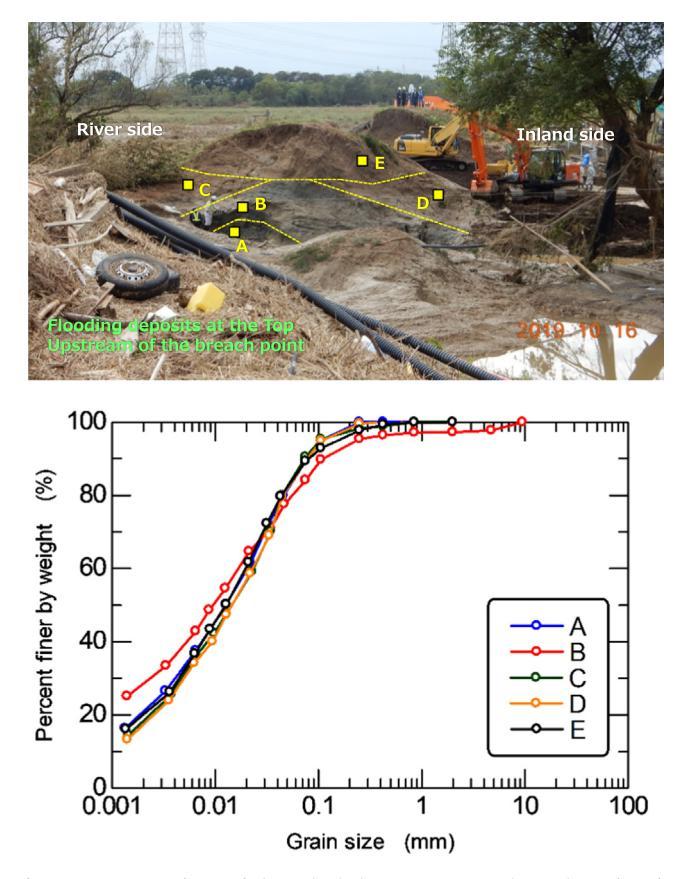
Fig. 8. Cross-section of breached levee at R0.4 k and grain size distribution curves for soils taken from points shown in picture. The data were obtained from the report by the Investigation Committee for the Levee Breach by the 2019 Typhoon Hagibis in the Kanto Region (2020).

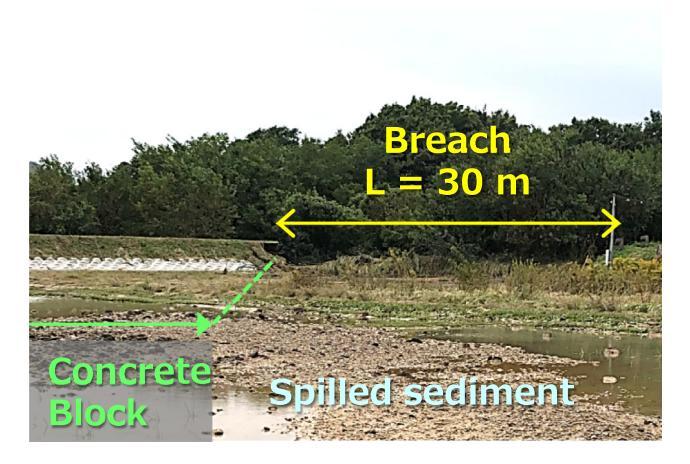
Fig. 10. Breach at 5.6 k on left levee of Tokigawa River.

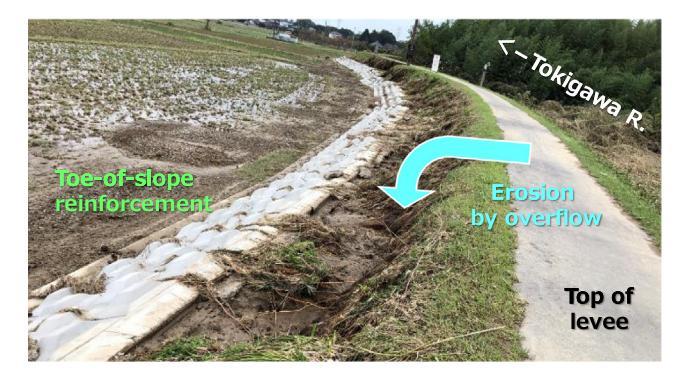
Fig. 11. Levee that survived erosion by overflow.

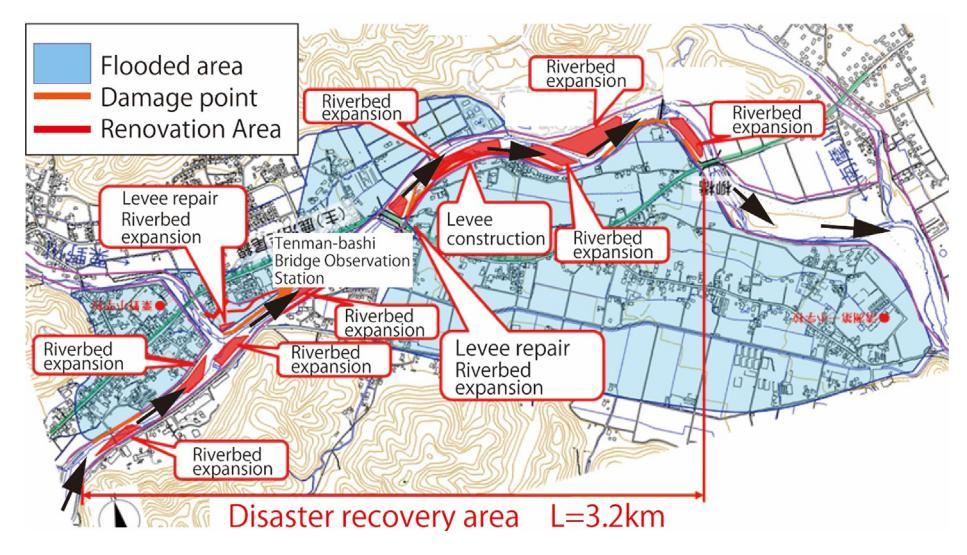
Fig. 16. Overview of plan for restoration and repair services for damaged areas on Omoigawa River (Map provided by Tochigi Prefectural Office with English translation).

Fig. 16 shows the repair works laid out by the Tochigi Prefectural Government for the surrounding areas. There is a plan to widen the beds upstream and downstream of the river, in the vicinity of the flooded area, to secure the flow of water and to repair the levees.

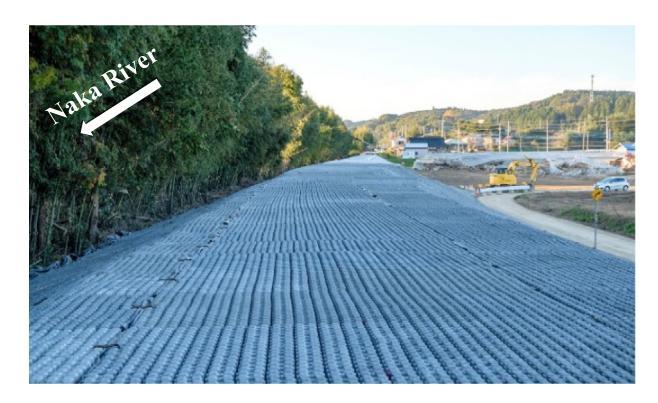
At Noguchi in Hitachi-ohmiya City, Ibaraki Prefecture, the left levee at 40.0 k was breached for about 200 m. Temporary restoration works for the breached levee were started immediately after the event, as shown in Fig. 18. The original levee section was about 3.0 m in height with a 1:2.0 slope. The crest was covered with asphalt pavement, about 3.0 m in width, as part of the temporary restoration works. The Investigation Committee for the Levee Breach by the 2019 Typhoon Hagibis in the Kanto Region (2020) surveyed the cause of the breach and concluded that over-

topping was a major cause, but that seepage and erosion also had the potential to be complex causes.

The depth of the overtopping was more than 0.60 m at the section of the levee that breached and became less than 0.60 m at the downstream section of the levee that did not breach. A trace of overtopping could be observed at the downstream section of the levee. From the field survey, the process of erosion by overtopping was classified into the following four steps:

Fig. 18. Temporary restoration works of left levee at 40.0 k of Naka River.

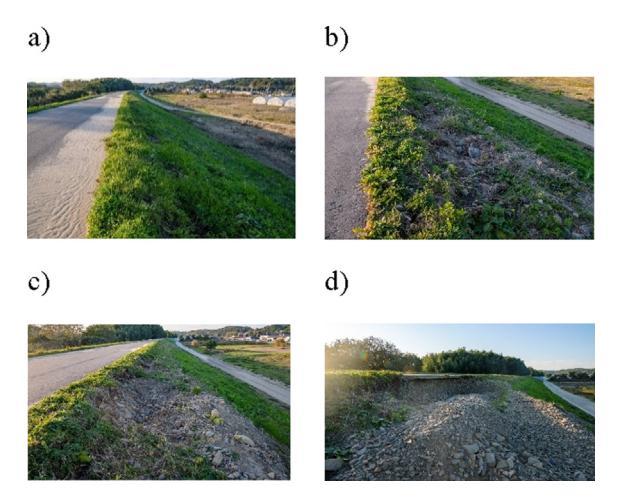
- Step 1: The beginning of vegetation erosion due to overtopping was seen at the shoulder of the levee (Fig. 19a)).
- Step 2: Small grain size soil began to flow out due to the overtopped water (Fig. 19b)).
- Step 3: Then, larger grain size soil was washed away (Fig. 19c)).
- Step 4: The failure of the levee by erosion took place at its shoulder (Fig. 19d)).

Fig. 19. Process of erosion of land-side slope by overtopping: (a) Step 1, (b) Step 2, (c) Step 3, and (d) Step 4.

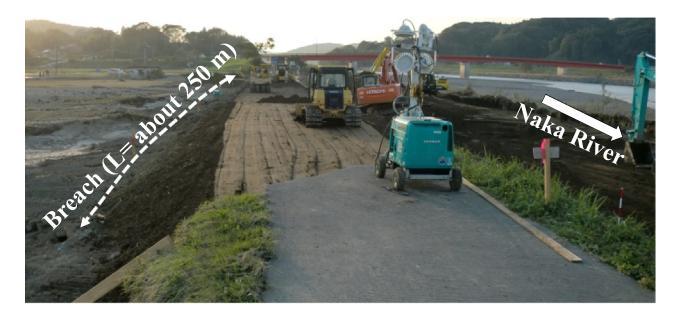
At Shimoisehata in Hitachi-ohmiya City, Ibaraki Prefecture, the failure of the right levee at 41.2 k occurred. The scene of the temporary restoration works is shown in Fig. 20. The collapsed section was about 250 m in length, 4.9 m in slope length, and 3.7 m in crest width. Fig. 21 shows the river-side and land-side slopes adjacent to the collapsed section. The river-side slope had no damage, while marked traces of erosion were found on the landside slope despite the fact that it has been protected by revetment blocks before the typhoon. According to the construction blueprint by the MLIT, the whole area around the breached section had crest pavements and revetment blocks for the river-side slope, while the landside slope may have been covered with revetment blocks,

Fig. 20. Temporary restoration works of right levee at 41.2 k of Naka River.

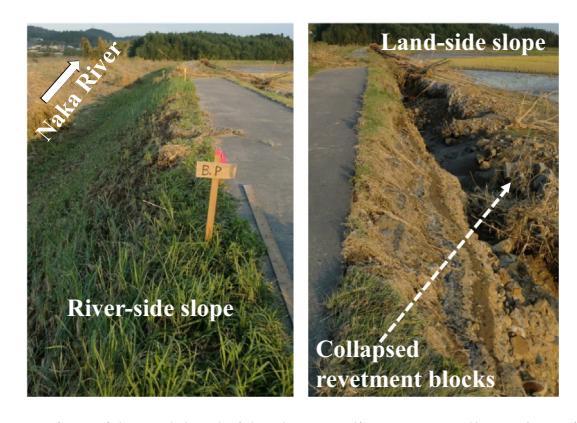
about 30 m in length, at the downstream side of the collapsed section which was about 250 m in length. On the other hand, no signs of sand boils or piping were found during the field survey conducted five days after the event. Considering these results, the breach may have been caused by the erosion of the land-side slope, without revetment blocks, brought about by overtopping. In particular, the failure of the section with revetment blocks, with a landside slope 30 m in length, may have occurred subsequently due to the flow-out of fill materials after the collapse of the section without revetment blocks (i.e., a progressive failure). The breach at this location suggests that the effects of crest pavements and revetment blocks on reducing the overtopping-induced damage to both side slopes are still unclear. Further studies will need to be conducted to clarify these effects in the future.

Fig. 21. River-side and land-side slopes adjacent to collapsed section at 41.2 k of Naka River.

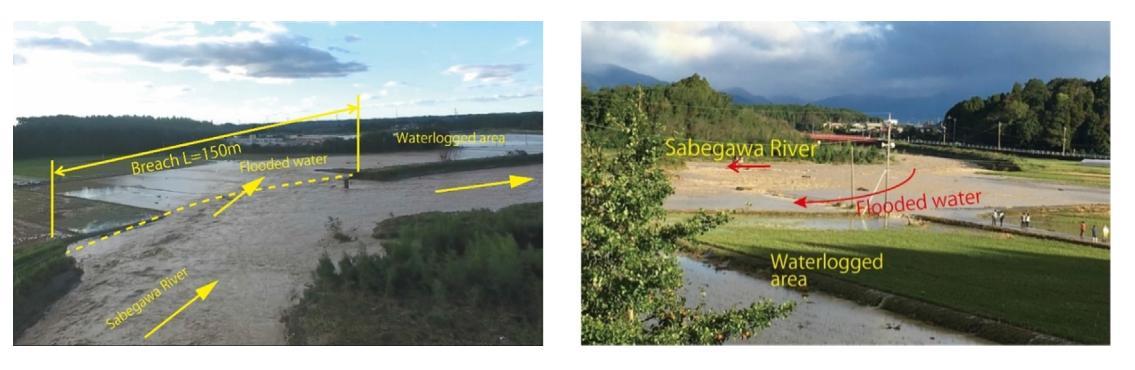
Fig. 22. Breached point on Sabigawa River (in Naka River system) in Kita-owagu area, Otawara City, Tochigi Prefecture. Left photo: View from upstream side, Right photo: View from left levee (Photos provided by Tochigi Prefectural Office with English translation).

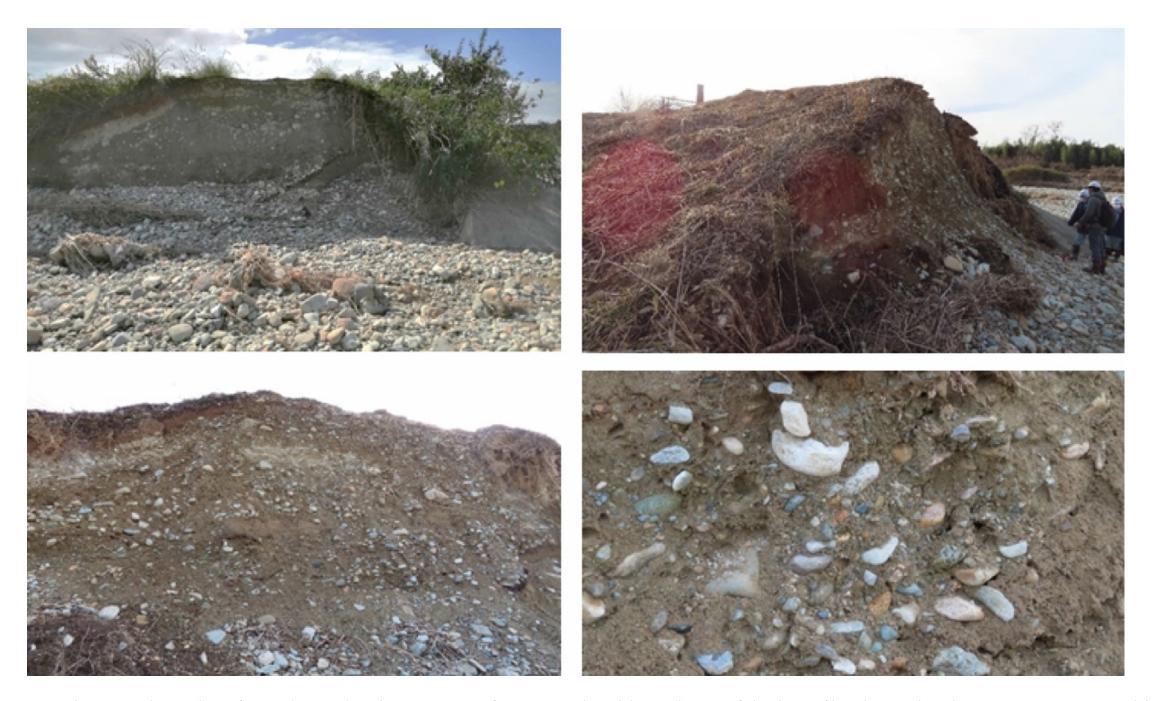
ment material is sandy soil, containing a large amount of cobbles the size of a fist. Fig. 25 shows the damaged levee at the breached point. Along with sandy soil, the embankment also contains many boulders. The cross-section of the damaged levee shows that the embankment was made of sandy soil and there was no core made of lowpermeability material. Based on the conditions of the breached levee, soil of the embankment, surrounding topography, and river, the flood-induced wetting of the levee presumably made the levee unstable and resulted in its collapse due to external forces, such as increased water pressure. Most of the levees in the surrounding area are also old. As the material of the levees in this area comprise sandy soil with cobbles/boulders, they are prone to collapse depending on the topography and rainfall conditions. The emergency response to this breach was completed in about 10 days and consisted of constructing a temporary water barrier using large sandbags. Repairs to the levee, including the damaged sections, are planned for the future.

Fig. 25. Damage to levee at breach point. The embankment contains many boulders along with the soil. The embankment was presumably constructed from the surrounding sediment (Photos taken by Unno on December 2, 2019).

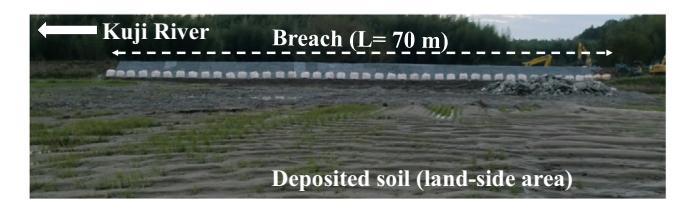
At Onuki in Hitachi-ohmiya City, Ibaraki Prefecture, the failure of the left levee at 34.0 k occurred at a length of about 60 m. The slope length of the collapsed section was about 5 m. As shown in Fig. 27, large sandbags were placed on the levee toe in the temporary restoration works. Considering the facts that (1) no traces of sand boils or piping were found in the field investigations conducted about two weeks after the event and (2) soils were deposited behind the collapsed section, as shown in Fig. 27, the

breach might have been caused by the erosion of the landside slope due to overtopping. As seen in Fig. 28, both side surfaces of the undamaged levee that was adjacent to the breached section has been covered with crest pavements and revetment blocks. According to the aerial photograph, most of the breached section had also been covered with the pavements and blocks prior to the typhoon. As mentioned earlier (i.e., the right levee of 41.2 k on the Naka River), the effects of the crest pavements and revetment blocks for both side slopes on reducing overtoppinginduced damage are still unclear.

Fig. 27. Temporary restoration works of left levee at 34.0 k of Kuji River and deposited soils in land-side area.

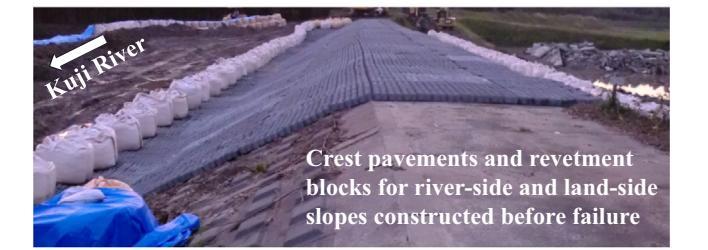
Fig. 28. Crest pavements and revetment blocks for river-side and landside slopes constructed before failure at 34.0 k of the Kuji River.

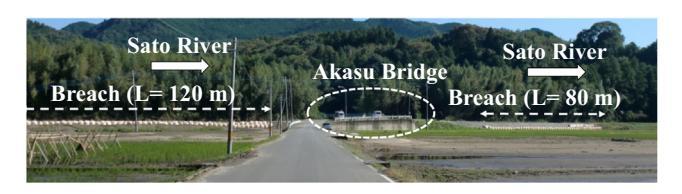
occurred across the Akasu Bridge, as shown in Fig. 30. These two damaged sections were about 80 and 120 m in length, respectively, 2–3 m in slope length, and 4–4.5 m in crest width. As seen in Fig. 31, the Akasu Bridge has six spans in spite of its short length. According to photos taken by a neighbourhood resident, the bridge girder and piers caught driftwood generated by this flood, suggesting that the rise in the river was accelerated locally by the trapped driftwood and might have led to the breach attributed to the erosion of the land-side slope caused by overtopping.

Fig. 30. Temporary restoration works of right levee of Sato River at Point C in Fig. 29 (near Akasu Bridge).

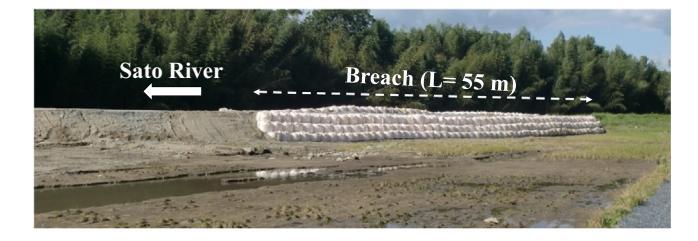
On the upstream side, about 400 m from Point C (i.e., at Point D in Fig. 29), the failure of the left levee occurred at a length of about 55 m (Fig. 32). The slope length and crest width of the collapsed section were about 4.5 and 3 m, respectively. Large sandbags were used to temporarily fill in the breached section as part of the restoration works.

Fig. 32. Temporary restoration works of left levee of Sato River at Point D in Fig. 29.

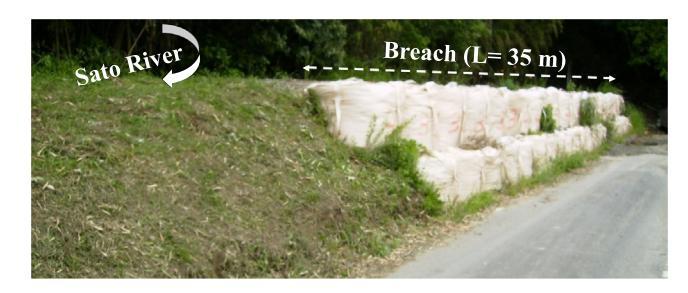
At Point B, indicated in Fig. 29, which corresponds to the downstream side from Point C, the failure of the left levee took place at a length of about 35 m, as shown in Fig. 33. The slope length and crest width of the collapsed section were about 2.5 and 3.5 m, respectively. The main cause of the breach at Point B might have been the erosion of the land-side slope caused by the overtopping attributed to the sharp curve of the river channel (see Fig. 29). As demonstrated by this case, a sharp curve in a river channel can be one of the most important factors causing overtopping-induced damage to a levee.

Fig. 33. Temporary restoration works of left levee of Sato River at Point B in Fig. 29.

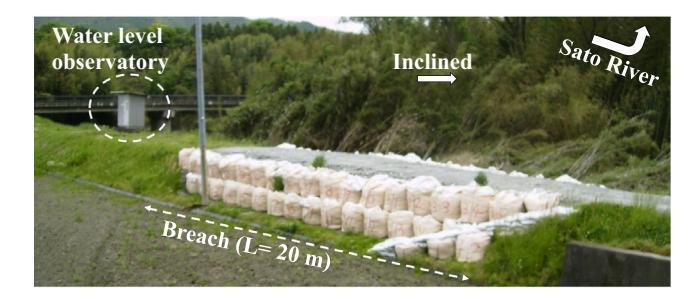
At the downstream side, about 500 m from Point B (i.e., at Point A in Fig. 29), the failure of the right levee, about 20 m in length, 4 m in slope length, and 3.5 m in crest width, occurred as shown in Fig. 34. The foundation of the water level observatory, constructed on the river-side shoulder and located on the downstream side about 16 m from the breached area, shown in Fig. 34, was severely damaged by scour. On the downstream side of the observatory, traces of the erosion of the river-side shoulder were found at a length of 22 m, as shown in Fig. 35. Moreover, as seen in Figs. 34 and 35, bamboo bushes on the river-side shoulder were inclined toward the river-side. When considering these factors, the possible process of the breach could be explained as follows.

- (1) The overtopping occurred possibly due to the sharp curve of the river channel (Fig. 29).
- (2) The river water flowed back to the river channel after overtopping.
- (3) The backwater, whose water level on the protected side was higher than that in the river channel, caused the erosion of the river-side slope. The cross-section of the levee was gradually reduced, and finally, the breach occurred.

Fig. 34. Temporary restoration works of right levee of Sato River at Point A in Fig. 29.

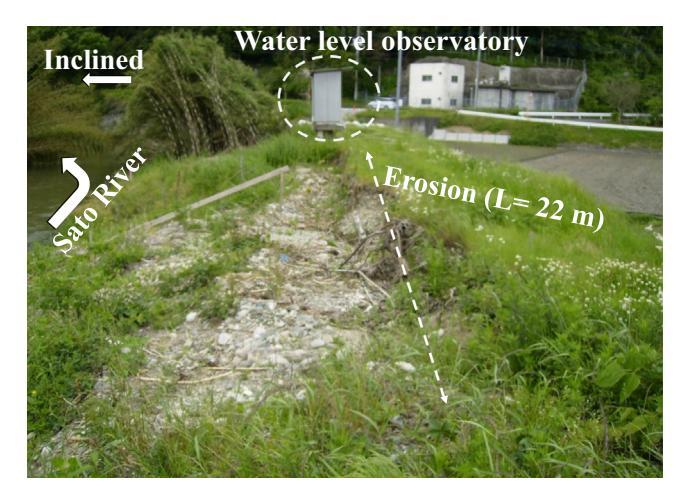
Fig. 35. Traces of erosion of river-side shoulder observed at downstream side from Point A in Fig. 29.

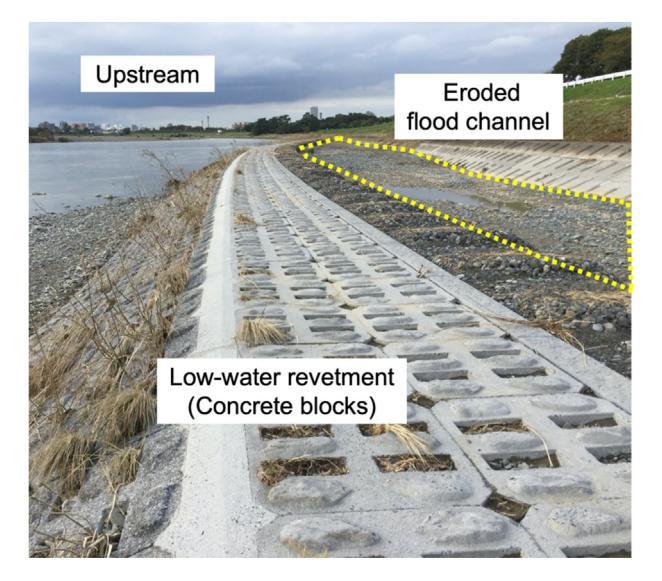
Fig. 38. Levee damage on left levee at 23.4 k on Tamagawa River.

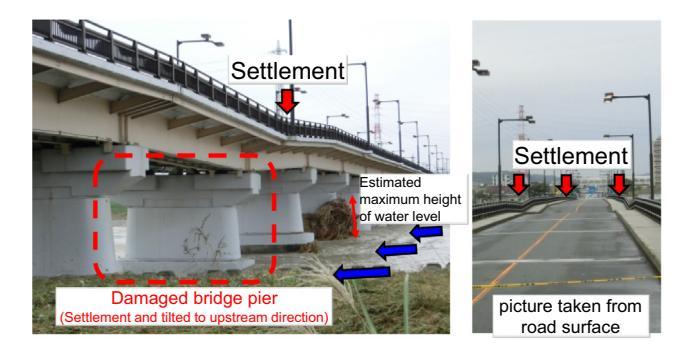
Fig. 41 shows the damaged Hino Bridge (see Fig. 2 for the location). The Hino Bridge was constructed in 1926 as a bridge that crosses the Tamagawa River. The foundation type was an open caisson made of reinforced concrete with a width of about 3.3 m and a depth of about 5.4 m. This bridge used to be along an important road that was employed as National Route 20 until March 2007. As shown in Fig. 41, the pier settled and tilted in the upstream

Fig. 41. Damaged river bridge pier caused by scour.

direction due to scour, and it took about seven months to repair it. To carry out the restoration work of the damaged pier, it was necessary to secure a construction approach road and construction yard around the damaged pier, so

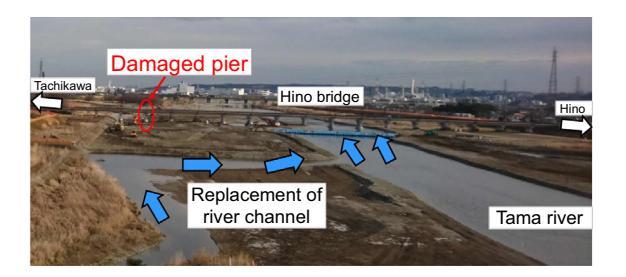
Fig. 42. River channel replacement for restoration work of Hino Bridge.

that a large-scale river channel replacement could be carried out (Fig. 42). It can be learned from this case that, once a scouring disaster occurs, the recovery work often takes a long time. Thus, it is important to take measures to prevent such disasters, as much as possible, by establishing a practical method for distinguishing the piers at high risk for scouring. As a characteristic of the recent scour damage to river bridges, bridge piers located in high water beds, which are supposed to have a low risk of scouring damage, are often damaged. The aforementioned Hino Bridge followed this exact disaster pattern, and details on it are provided in the next subsection.

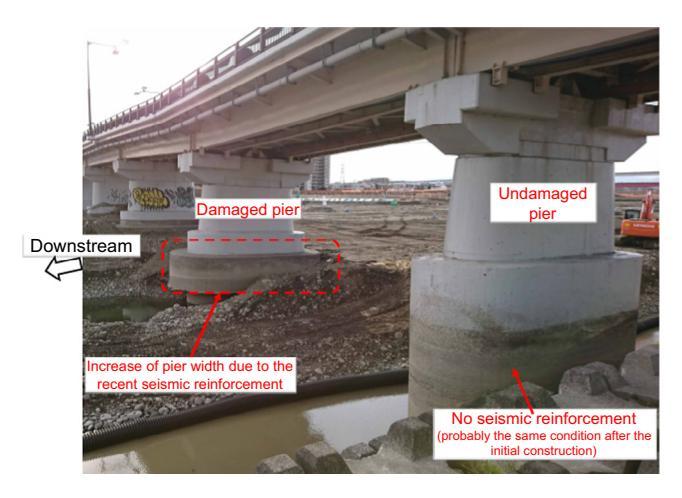
Fig. 44. Damaged pier during the restoration work (from downstream).
