Title	Performance recovery of a repaired 4-storey reinforced concrete structure subjected to shake-table testing
Authors	Alex Shegay, Kota Miura, Akira Mikawa, Masaki Maeda, Matsutaro Seki
Citation	Earthquake Engineering & Structural Dynamics, Volume 52, Issue 5, pp. 1339-1359
Pub. date	2023, 1
DOI	https://doi.org/10.1002/eqe.3818
Creative Commons	Information is in the article.

Performance recovery of a repaired 4-storey reinforced concrete structure subjected to shake-table testing

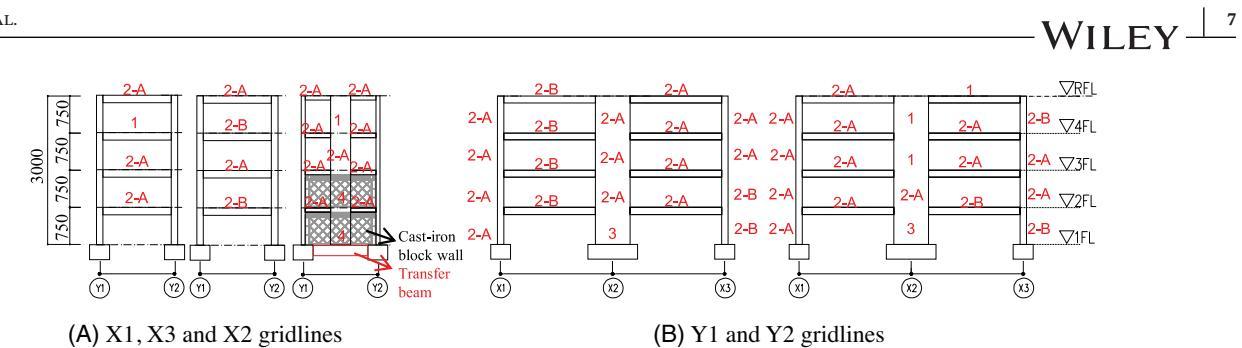
FIGURE 5 Repair classification of each member of the structure

Prior to undertaking the repair work, the structure's residual deformation was corrected in both directions. This was achieved by statically applying external lateral forces to the 2nd and 4th stories of the structure until the residual interstory drift reduced to below 0.2% (based on an average of five measurement locations per floor) once the external loads were released. It is acknowledged that correction of residual deformation is generally impractical in real-life application; however, to meet the study's objective of evaluating the effects of basic repair techniques, a fair comparison to the Original structure was given priority. Therefore, it was decided to reduce other major influencing factors (i.e., p-delta effects) that would hinder this comparison. Following correction of residual deformation, the structure was moved off the shake-table test to conduct the repairs (full vertical and foundation lateral bracing was provided to the structure to prevent further damage during relocation). The repair work in the X-direction did not include any changes in cross-section dimensions, steel reinforcement ratios, or any repair techniques that could otherwise be considered to enhance performance relative to the Original structure. The repair works undertaken were divided into five classes, and the class adopted for each structural member was decided based on the member damage level. Damage level definitions were adopted from the JBDPA Guidelines,^{7,26} and are summarized in Appendix B. The repair class definitions and the corresponding repair materials used are described in Table 2. The repair methodology within each class was based on a combination of guidance provided in the JBDPA Guidelines,⁷ the Japan Building Conservation Center's Building Repair Works Guidelines,²⁷ and discussions of "best-practice" with the contractor employed to carry out the repair. The repair class assigned to each member throughout the structure is shown in Figure 5.

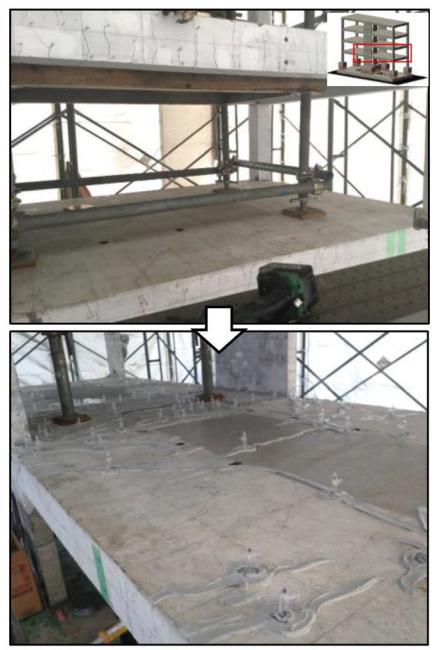
(A) Class 1: Slab epoxy crack injection

Typical before and after photos for each repair class are shown in Figure 6. For Repair Class 1, all cracks exceeding an in-situ width measurement of 0.05 mm found in beams, columns and walls were epoxy injected by a hand-operated applicator gun. The 0.05 mm width limit was targeted to account for the structure's reduced scale, given the typical injection limit capability in practice is around 0.2 mm. This lower limit was advised possible by the contractor based on the low viscosity properties of the chosen epoxy resin. For cracks in the floor slabs, it was deemed impractical and unrealistic to inject all the cracks due to the large surface area; instead, only the cracks in the slab that propagated to the beams, columns, or walls were injected (i.e., cracks originating *and* terminating internally in the slab were not injected). Slab

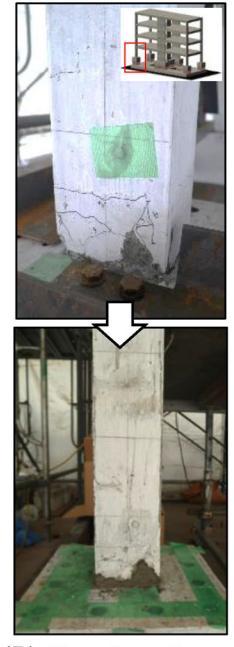
(B) Class 2a: polymer cement mortar patching

cracks that did not meet these criteria were deemed to not be from flexural damage, but the result of stresses developing from the anchoring of the additional floor masses. For Repair Class 2a, polymer cement mortar was used where spalling was not severe enough to expose any reinforcement. In areas of spalling where longitudinal reinforcement was exposed (Figure 6C), epoxy mortar was used for patching (Repair Class 2b) because better adhesion could be achieved to the original material compared to using polymer cement. This approach is also in accordance with guidance in.²⁷ For Repair Class 3, concrete was removed such that buckled longitudinal reinforcement could be extracted and replacement reinforcement could be lap-splice welded outside the plastic hinge zone (assumed as half the wall length). The length of the weld was ten times the bar diameter on both sides of the splice as recommended in.⁷ Welds in the first and second row of reinforcement were staggered by half the weld length as shown in Figure 6D. The bottom of the reinforcement was anchored into the foundation by welding a steel plate to the bottom end of the bar. The repaired area was recast using a concrete mix with similar strength characteristics to the original material. Repair Class 4 was only applied to the area where the CW2 wall had undergone a shear failure in the Y-direction, as shown in Figure 6E. The damaged CW2 wall was completely removed from the 1st and 2nd floors, and a proprietary cast-iron block wall²⁸ was installed in its place (Figure 6E). The cast-iron blocks ($122 \times 122 \times 40$ (depth) $\times 8$ (thick) mm hollow square sections) were stacked diagonally and adhered to each other with epoxy resin. The cast-iron blocks were installed within a perimeter steel frame, which required a continuous concrete support along the base. The bottom support was provided by replacing the original foundation underneath the CW2 with a transfer beam spanning between the foundations of the CW1 walls. The perimeter steel frame was fixed to the surrounding concrete by a 6 mm layer of epoxy resin. Given the weak tensile adhesion of the base of the cast-iron block wall to the transfer beam below it (2.5 MPa over an 80 mm width), the wall was not expected to have significant strength in its out-of-plane response and therefore a negligible contribution to the X-direction response. Under this assumption (confirmed in a later section), the Repair structure X-direction response could be studied in isolation of the strengthening effects of the Y-direction. It is also noted that the net increase in story mass from the installation of the cast-iron block wall was around 1% compared to the Original structure, which was considered to be negligible. The performance of the structure in the Y-direction is outside the scope of this paper, instead, the reader is referred to another publication.²⁵

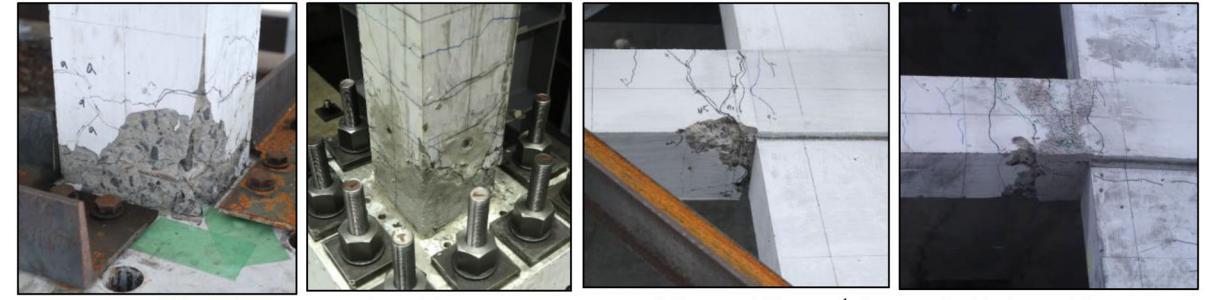
(A) Column X3-Y1 base hinge

Damage observed up to Run 4 was generally consistent between the Original and Repaired structures. A reduced structural stiffness resulted in slightly lower strengths observed in the Repaired structure for each run until Run 4 compared to the Original structure. At Run 4, the Repaired structure's strength exceeded that of the Original structure. Following this run a crack running along the full base length of the cast-iron wall was identified, signifying that the cast-iron wall became essentially pinned at the base. No structural strength reduction was observed as a result of the crack formation, confirming the assumption that the out-of-plane strength of the cast-iron wall was insignificant to the X-direction response. Spalling in epoxy mortar repaired plastic hinges was minimal, and generally occurred at later drifts for the Repaired structure compared to the Original structure. Examples of the reduced level of spalling in the Repaired structure compared to the Original structure can be seen in Figure 8A-C for columns and beams. Limited spalling that did occur in the repaired hinges tended to concentrate in the original material directly adjacent to the repaired zone as can be seen in Figure 8A and B. Similar spalling performance has been observed in epoxy mortar repaired members in previous research.¹⁷ It is thought that the lower stiffness of the epoxy mortar (\sim 19% that of the original concrete; Table 3) in combination with its high strength allowed large compression strains to be induced in the repaired regions without extensive spalling. On the other hand, repaired zones where standard concrete was utilized (i.e., CW1 walls), spalling damage was similar for both the Original and Repaired structures (Figure 8D). Spalling in the CW1 walls did not extend beyond the assumed plastic hinge length, suggesting that the welded splice longitudinal reinforcement repair technique was effective.

FIGURE 8 Comparison of damage pattern to beams, columns and walls at the conclusion of the Original (left) and Repaired (right) structure tests
