| Title | Stability of soft clay slopes along Mekong river |

## Stability of Soft Clay Slope along Mekong River

Slope failure, Slope rehabilitation, Cambodia

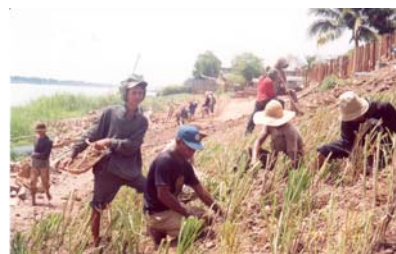
Fig.1a Gabion retaining wall

The past study was conducted in May 1997 over a project of 78m-slope rehabilitation along Tonle Sap River [1], Prek Pnov district, Phnom Penh. Gabion wall was first introduced to protect erosion as well as to retain the earth pressure. The amount gabions were placed in the woven containers, and every year those baskets settled. The more gabion adjusted, the more settle and slip to ground. Finally, this concept failed because of less technical design support. In May 2002 a new concept was proposed. Partial of gabion wall was removed and artificial slope was made by embankment with the inclination of  $28^\circ$  and protected soil from erosion due to river flow and runoff by revegetating the site with perennial “gramineae” plants. Neither precise method nor sufficient data of soil investigation were proposed to design for supporting this project. (Fig.1a and Fig.1b)

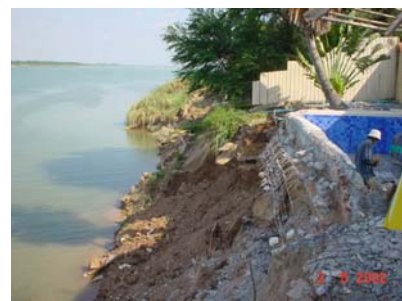
Fig.1b Embankment slope

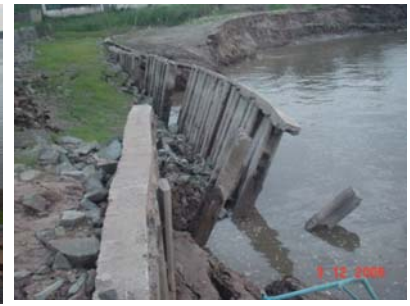
Fig.4b Collapse of wall (view from river)

Excess pore pressure in the landfill embankment including the partial erosion of passive side led to a serious damage of the slope as well as the retaining material. This project was completely restored in July 2006 (Fig.4a to 4f). However, the consequences of this concept are not yet observed [3].

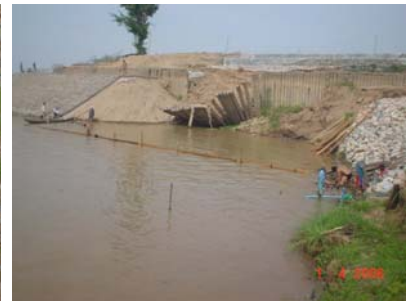
Fig.4d Slope rehabilitation works

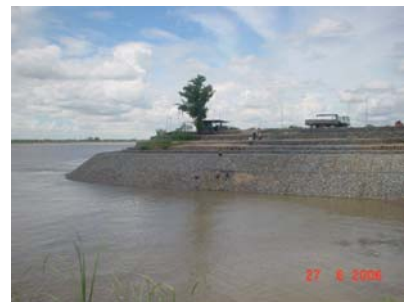
Fig.4f Man-made slope rehabilitation
