| Title | Stability of soft clay slopes along Mekong river |

## Stability of Soft Clay Slope along Mekong River

Slope failure, Slope rehabilitation, Cambodia

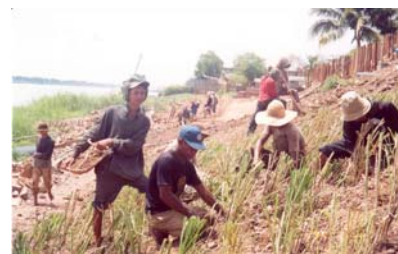
The past study was conducted in May 1997 over a project of 78m-slope rehabilitation along Tonle Sap River [1], Prek Pnov district, Phnom Penh. Gabion wall was first introduced to protect erosion as well as to retain the earth pressure. The amount gabions were placed in the woven containers, and every year those baskets settled. The more gabion adjusted, the more settle and slip to ground. Finally, this concept failed because of less technical design support. In May 2002 a new concept was proposed. Partial of gabion wall was removed and artificial slope was made by embankment with the inclination of  $28^\circ$  and protected soil from erosion due to river flow and runoff by revegetating the site with perennial “gramineae” plants. Neither precise method nor sufficient data of soil investigation were proposed to design for supporting this project. (Fig.1a and Fig.1b)

Fig.1b Embankment slope

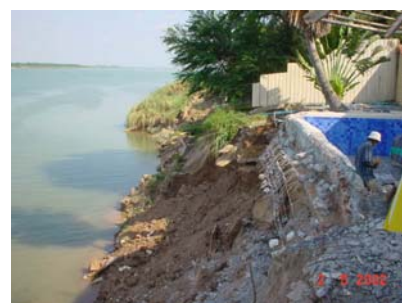
Another case observation in May 2002, a few days after raining, it occurred a failure of natural slope at a private house located along the Mekong River, Phnom Penh. A swimming pool behind the house, close to the riverside was demolished in order to reduce the surcharge pressure. This phenomenon was simply observed when the river water falls to the lowest level since April, collecting the discharge of underground water together with raining water which penetrated quickly to the ground during the onset of the monsoon rains in late May. (Fig.2)

Fig.2 Collapsed natural slope

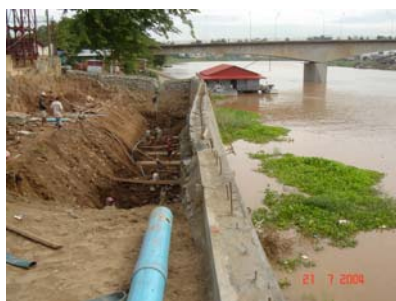
In July 2004, an improper method of soil reclamation implemented by the land owner to the Basaac River, Phnom Penh, caused the failure of the landfill [2]. Both wall and filling materials collapsed to the river when the passive pressure of water decreased with river falls. (Fig.3a and Fig.3b)

Fig.3a Retaining structure

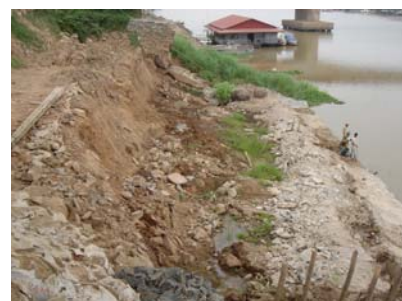
Fig.3b Collapse of retaining wall

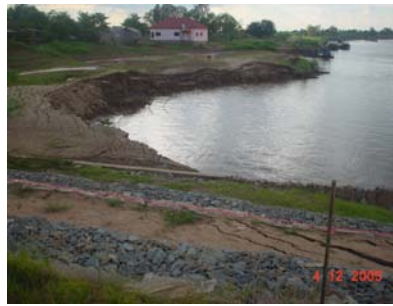
A very recent project of slope rehabilitation was conducted in March 2006 at a Children Center located at National Road No.1, Phum Kdey Takoy, Khum Veal Sbov, Srok Hien Svay, Kahdal Province, Cambodia. Since 2004, when sediment movement transported by river flow concentrated naturally, along the Mokong riverside, at this place created the important deposited slopes. Some measures were used by the landowner to protect this deposited slope. Soldier piles were driven to a certain depth of the ground to retain the active saturated soil deposited. At the passive side laid the baskets of gabion wall placing as a series of steps to protect the erosion and collapse of the artificial slope at the footing. The flood in September 2005 made the deposited slope and embankment on the top very much saturated and weakened the effective stress of the soil.

Fig.4a Slope erosion

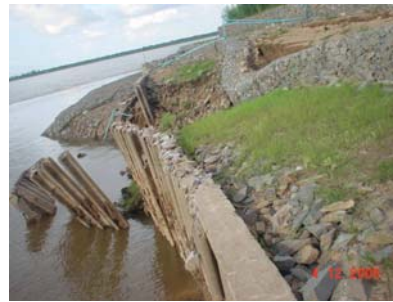
Excess pore pressure in the landfill embankment including the partial erosion of passive side led to a serious damage of the slope as well as the retaining material. This project was completely restored in July 2006 (Fig.4a to 4f). However, the consequences of this concept are not yet observed [3].

Fig.4c Collapse of wall (view from side)

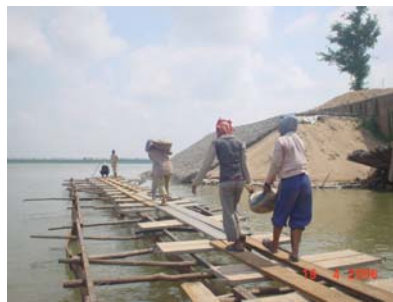
Fig.4e Slope footing enforcement
