| Title(English) | Analytical Evaluation on Structural Seismic Performance of Corroded RC Columns Subjected to Higher Axial Compression |
| Citation(English) | EASEC-13, , , G-1-3 |

# ANALYTICAL EVALUATION ON STRUCTURAL SEISMIC PERFORMANCE OF CORRODED RC COLUMNS SUBJECTED TO HIGHER AXIAL COMPRESSION

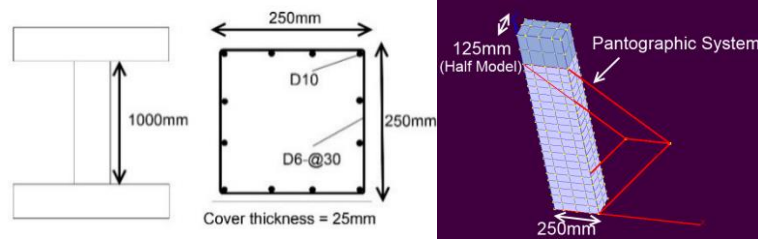
**Figure 1: Design of the column.**

In the analysis, an FE mesh (**Figure 1**) was used. The mesh size was decided such that it fulfilled the model's requirement, in specific the applicability of average stress-strain relationships, and sufficient fineness for accurate calculation. In order to keep the bottom and the top surfaces horizontal, a pantographic system was added using line elements which transfer only vertical force.

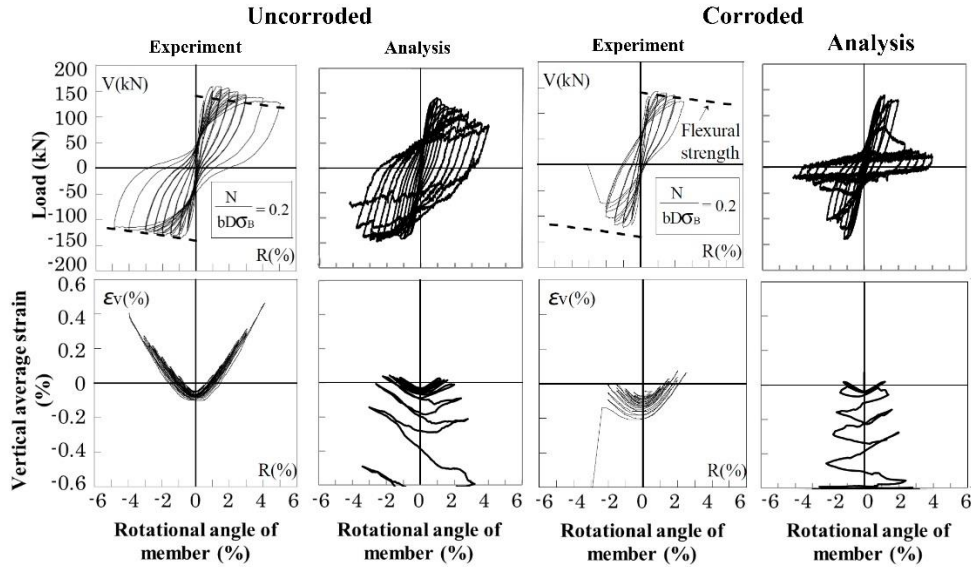
**Figure 2: Comparison of results of loading on experiment and analysis.**

**Figure 2** shows a comparison of the result of loading tests both experiment and analysis for uncorroded and corroded specimens. The authors cited the experimental result in the figure (Arasato *et al.* 2003). For the uncorroded specimens, experiment and analysis correspond in almost all aspects. The horizontal axis represents rotational angle of the column, and the vertical represents the reaction force in the horizontal direction. There is a slight difference in the vertical mean strain. This may be explained by a concentration of compressive stress on the bottom of the column due to rigid restraints. The rigid restraint doesn't allow the bottom element to sink any further, and instead of sinking, the element is subjected to a concentrated compressive stress and shrinks.

For the corroded specimens, there is some agreement and disagreement between experiment and analysis. The most notable disagreement is in the corrosion distribution along reinforcing bars. The distribution of corrosion was not uniform in the experiment; there were some cross-sections with over 20% mass loss of reinforcing bars, while the average mass loss in reinforcing bars is 5%. There was also uneven distribution in the horizontal direction.

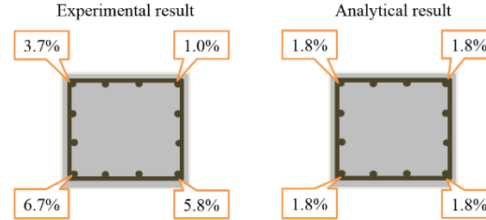
**Figure 3: Comparison of average mass loss of reinforcing bars at each point.**

**Figure 3** shows a comparison of analytical and experimental results of the average mass loss ratio in reinforcing bars at each location. The authors concluded that environmental input must be major reason of this disagreement. At real coasts, complex wind, the washing out effect of rain, and the direction of sunlight most likely create an un-uniform environment. Due to the lack of data, analysis could not consider such un-uniform environmental input, which is the probable cause. Although these differences exist, the R-V relationship and R- $\epsilon_v$  relationship coincide for the most part. In **Figure 2**, reduction in maximum load, reduction in stiffness and change of failure mode from bending to bending-shear fracture due to corrosion can be observed. Also, extra shrinkage is observed compared to the uncorroded specimen in both the experiment and the analysis.

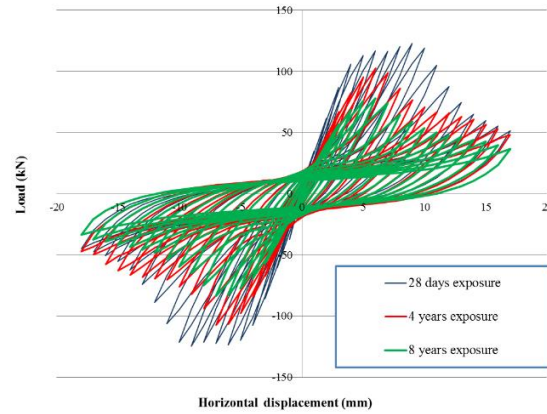
**Figure 5: Changing structural performance due to corrosion.**

The analytical results are shown in **Figure 5**. While the column at a progressed stage of corrosion failed in shear before bending, the column at an early stage of corrosion failed in shear after bending. **Figure 6** shows shear and bending capacity correspond to corrosion rate. The markers represent the analytical result; specifically, the square markers are those that failed in bending and the triangular markers are those that failed in shear. The green line represents shear capacity calculated with the JSCE formula considering only the mass loss of the reinforcement as a cause of reduction in shear capacity. From the Figure, the reduction of shear capacity in FE analysis is much larger than that calculated in the formula. The analysis traces not only the loss of reinforcement but also cracking as a cause of structural deterioration by corrosion, while the calculation using the formula only considers the loss of reinforcing bars. The large reduction in shear capacity in the analysis likely comes from cracking rather than loss of reinforcement.

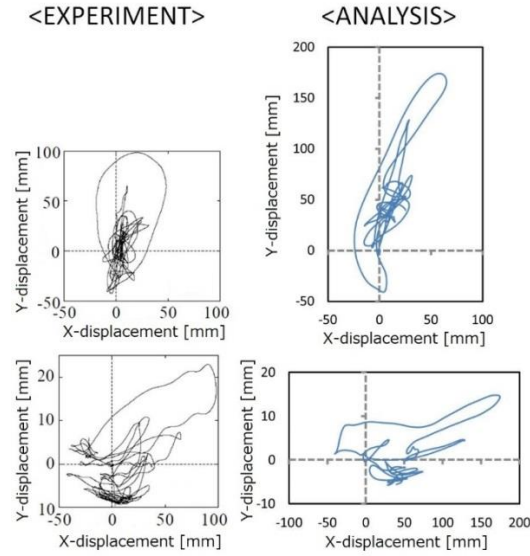
**Figure 8: Comparison of experimental and analytical result.**

**Figure 8** shows the comparison of experiment and analysis. The authors cited the experimental result in the figure (Matumori *et al.* 2008). The upper figure shows the 2nd floor's displacement (see **Figure 7**) in the horizontal (X-Y) direction. The bottom figures show the Y-Z displacement. Although imperfect, motion of the building could be essentially reproduced.

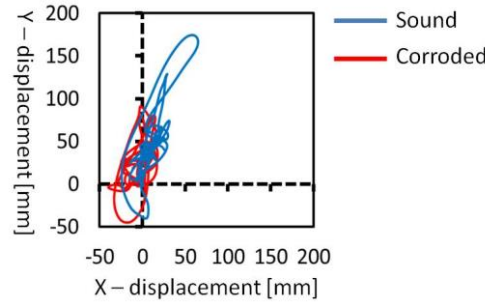
**Figure 9: analytical result with corrosion.**

In the analysis, the authors introduced corrosion in the columns and walls on the outside of each floor to simulate the severe effects of the surrounding environment. The mass loss due to corrosion was set to 30%. In this case, it was assumed that the building had been in service for decades in a very harsh environment causing progressive corrosion. **Figure 9** is the result of this analysis. The authors inputted 4 sets of seismic data, representing 10%, 25%, 50%, and 100%-amplitude of the seismic data recorded during the Kobe earthquake. During the shaking simulation, plastic damage accumulated in the structure. **Figure 9** shows the result of 100% acceleration. Under smaller accelerations, the building with steel corrosion swayed much larger extent than the un-corroded one. However, with 100% acceleration, the difference between response of sound structure and the corroded one became small.

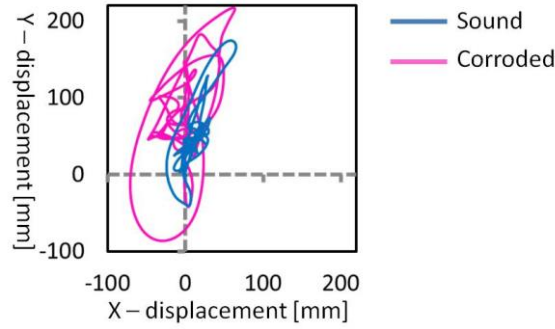
**Figure 10: analytical result with 1<sup>st</sup> floor corroded.**

Additional analysis of the building was conducted in which only the 1st floor's columns' steel was corroded. The result is shown in **Figure 10**. The 2nd floor's displacement with steel corrosion was found to be smaller than the un-corroded case. **Figure 11** shows the peak Y-displacement. Most deformation took place in the 1st floor (83%). This value is 53% in the un-corroded case and 30% in the case where all floors are corroded. The damage was concentrated in the 1st floor because the upper floors were un-corroded and so stiff that they wouldn't comply with the deformation of the overall structure.
