Journal of Advanced Concrete Technology, volume 13 (2015), pp. 438-448

Rapid Degradation of Concrete Anchorage Performance by Liquid Water

Nobuhiro Chijiwa^{1*}, Hong Thi Mai², Mitsuyasu Iwanami³, Tomohisa Saito⁴, Atsushi Yamaya⁵, Hiroyuki Motegi⁶ and Hiroo Shinozaki⁷

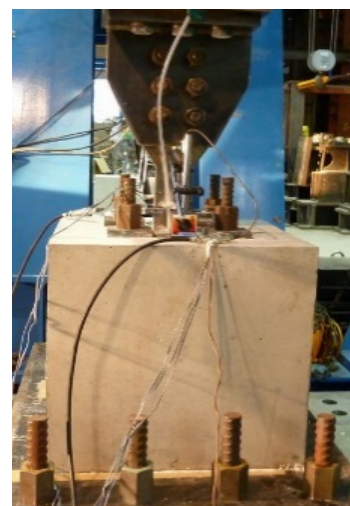
Loading was done with the anchor steel plate and actuator connected with a special jig as shown in Fig. 4. Fur-

ther, the specimen was fixed to a frame with four PC steel rods. Each PC steel rod was prestressed to about 150 kN.

Gauges for measuring the strain in the anchor steel plate (corresponding to the anchor ring part in a real tower) were attached at four locations on the vertical plane to match the loading direction, and an additional two strain gauges were attached to the underside of the base plate. Displacement transducers were installed on the upper surface of the concrete in order to measure vertical displacement at the measurement points set on the side of anchor steel plate approximately 10 cm from the upper surface of the concrete.

Fig. 4 Installation condition of specimens.

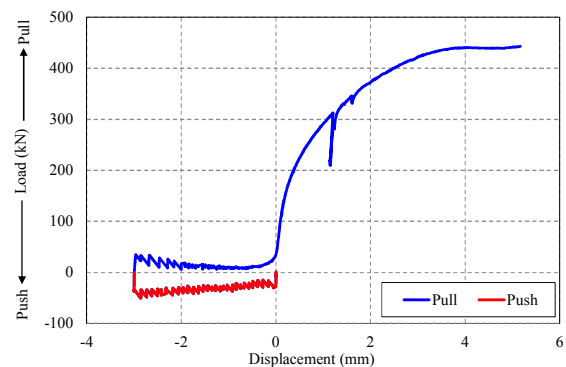
The results of a monotonic test conducted using Specimen No. 1 with W/C of 62.4% are shown in Fig. 5. In this test, the specimen was pushed down 5 mm, equivalent to the thickness of the expanded polystyrene, and the pull-out test was then performed. Based on the results of this test, the chemical bond between the steel and concrete broke under load action in the range of 20 kN to 30 kN for both pushing and pulling. When the pull displacement reached 5.1 mm, cracks appeared and load started decreasing. The pull peak load was 443 kN. The load equivalent to the bearing strength ratio of 0.43 used in the cyclic loading test for the material strength of the specimen is estimated at 31 kN, but this is a load equivalent to just about 6% of the obtained pull peak load.

Fig. 5 Static push and pull test results.

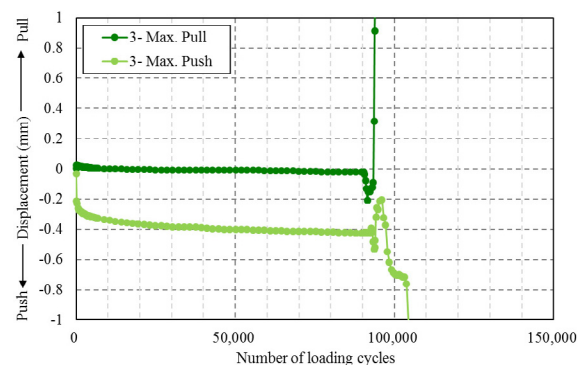
entered the tube at 35,000 cycles, in Case 3, this occurred at 95,000 repetitions (Fig. 8). It should be noted that distinctive motion was observed, with only the pull displacement of the base plate temporarily becoming smaller around the time of water ingress, and following overall sinking action, pull displacement gradually increasing (Fig. 9).

Fig. 9 Characteristic displacement before pull acceleration (Case 3 example).

Further, in the present experiment, there is a certain interval of time from the ingress of water until sludge ejection, and prior to the rapid increase of pull displacement and sludge ejection, the entire base plate was observed to temporarily sink inside in all cases (Fig. 9).

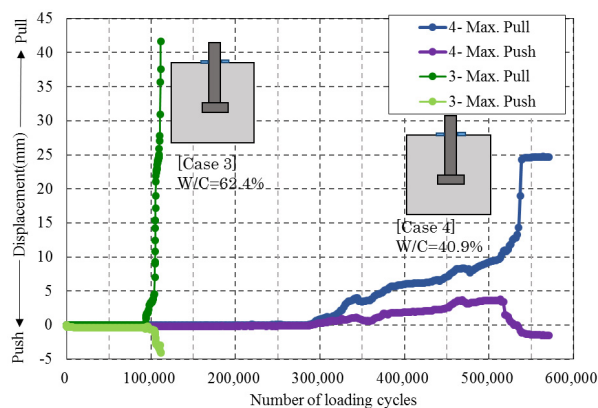
and negative loads of 35 kN for Case 3 and positive and negative loads of 51 kN for Case 4, with water supplied in both cases. **Fig. 10** shows the maximum and minimum displacements per cycle plotted against the number of repetitions.

In Case 3 using a high W/C, water was observed to enter the tube in the vicinity of 95,000 repetitions. Immediately after that, both pull displacement and push displacement increased sharply. At about 105,000 repetitions, pull displacement reached about 10 mm, and push displacement 1.2 mm. Sludge was ejected on the upper surface, where it gradually accumulated. On the other hand, in Case 4 with a low W/C, water movement inside the tube was detected when the number of repetitions reached 220,000. However, even after water entered the tube, displacement did not increase, and it began changing gradually from 280,000 repetitions. The change, rather than sharp, was a gentle increase and after about 360,000 repetitions, pull displacement reached 5 mm. Sludge was deposited on the upper surface of the specimen (**Fig. 11**). Until the number of repetitions reached about 500,000, the mean position of

Fig. 10 Relationship between pore structure and reduction of anchorage performance by liquid water.

base plate was shifted to tension side. This is because the concrete strength was high, the path to discharge the sludge to outside was hard to form and the sludge was deposited under the base plate.

Based on these results, the rate of progress of breakdown by liquid water was different when using concrete with a low W/C, which had long fatigue life than concrete with a high W/C.

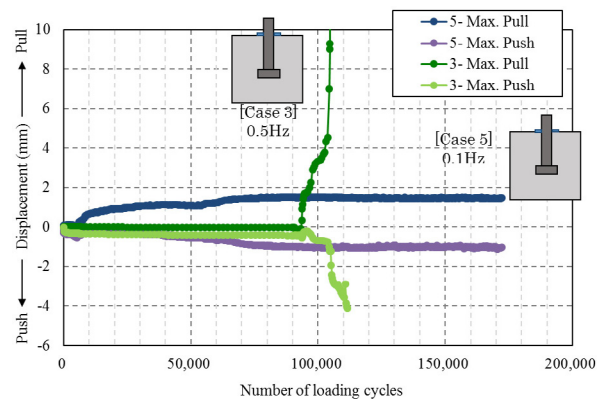
To analyze the influence of the viscous behavior of liquid water on the progress of breakdown, loading was performed at the rate of 0.1 Hz in Case 5 and the results were compared with Case 3, which used the loading rate of 0.5 Hz. **Fig. 12** shows the maximum and minimum displacements per cycle plotted against the number of repetitions. It should be noted that to unify the bearing strength ratio with other experiments, loading in Case 5 was performed using positive and negative loads of 30 kN.

Fig. 12 Relationship between loading rate and reduction of anchorage performance by liquid water.

In Case 3, which uses a higher loading rate, displacement grew more sharply following water ingress in the vicinity of 95,000 repetitions, leading to earlier breakdown. On the other hand, in Case 5 with a lower loading rate, water entered the tube at 8,000 repetitions, and then displacement gradually increased, but at 80,000 repetitions, pull displacement was just on the order of 1.5 mm and push displacement about 1.0 mm, and thereafter displacement remained unchanged and breakdown did not occur even after 170,000 cycles.

Observation of the movement of the water head inside the tube after water entered the tube showed that in Case 5 with loading rate of 0.1 Hz, the next operation started after the position of the water head stabilized at a given push-pull location, whereas in Case 3 with loading rate of 0.5 Hz, the next operation started without the position of the water head first becoming stable. Whereas in Case 5, there was sufficient time for water pressure to be statically balanced with the surrounding environment, in Case 3, the water head was observed to keep moving under pressure without reaching statically balanced state with the surrounding environment, which is considered to have had a major influence on the pro-

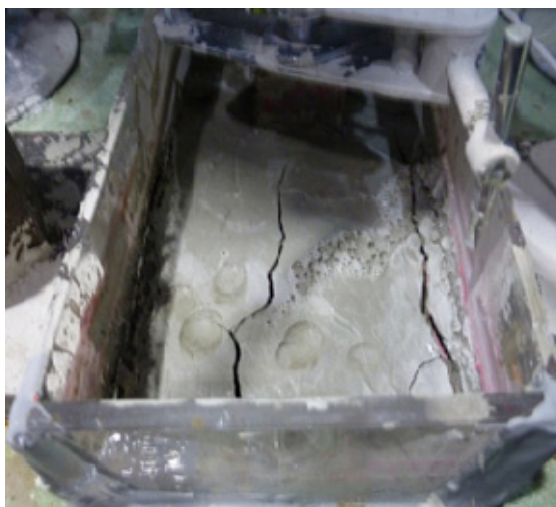
Specimen 3, upper surface

Fig. 11 Sludge deposition state after test.

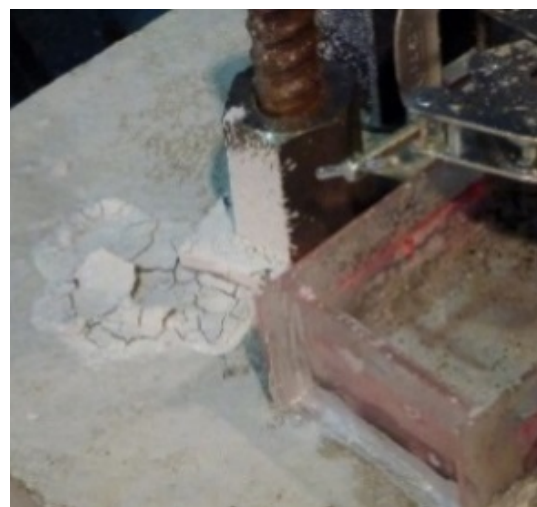
Specimen 4, upper surface

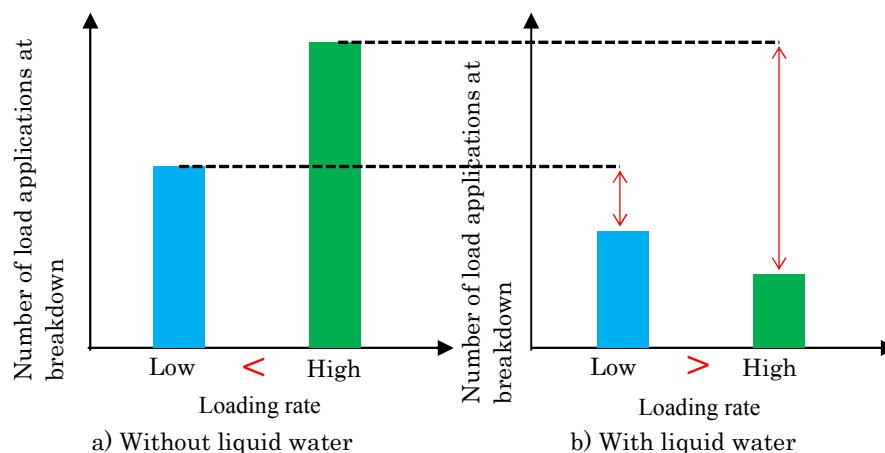
As shown in **Fig. 13**, it is known that the higher the loading rate during fatigue loading under dry conditions, the larger the number of repetitions until breakdown is (Ishibashi *et al.* 1987). However, when water has ingress the concrete, the number of repetitions until breakdown is believed to be low to the extent that the loading rate is high.

Fig. 13 Influence of loading rate in presence of liquid water.

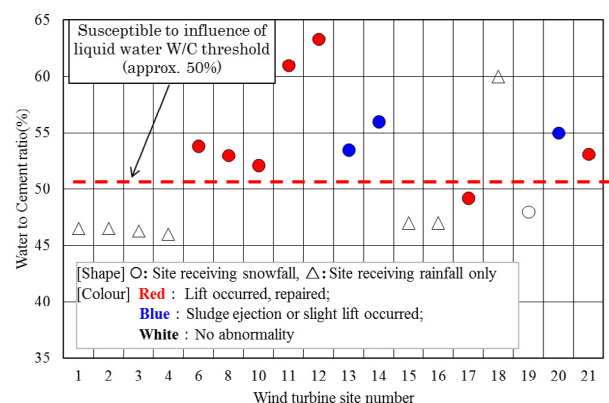
Based on the knowledge obtained from this study, the relationship between lifting of the tower and the water-cement ratio listed in the mix design and the weather conditions was analyzed for existing wind turbine foundations fixed by the anchor-ring method. The results are shown in Fig. 16. In the case of foundations with W/C of 50% or higher, sludge ejection was observed along with lifting of the tower, but these phenomena did not occur for the majority of foundations with W/C under 50%, paralleling the findings obtained from the present study. Further, the foundations where damage occurred were in snowfall areas, and foundations located in areas of rainfall only did not exhibit damage. Since the damage locations were all situated in snowfall areas, freeze-thaw action may have been a factor, but the facts that damage became evident in an extremely short time period of just a few months from entry into service, and that inspection reports make no mention of freeze-thaw issues, suggest that this is unlikely. In the case of rainfall, if there is no water accumulation, the rainwater

dissipates a few hours after the weather dries up, but in the case of snowfall, the snow remains for several days even after the weather recovers, and liquid water is continuously supplied as snowmelt, a difference in water supply that is considered to account for this difference between rainfall and snowfall areas (Kunieda *et al.* 2012). It should be noted that even in the case of rainfall, prolonged water accumulation may occur if drainage is poor, giving rise to the same problem as with snowfall.

Fig. 16 Relationship between lifting of tower, W/C, and environmental conditions.

a) Installation of drainage system

Given that the influence of liquid water is significant reduced if it does not remain at the interface between the steel and concrete or in cracks, providing drainage channels or an appropriate drainage gradient ensuring reliable drainage, or some other system to prevent ingress of liquid water, is effective. In the sense of reducing as much as possible the effect of water, it is also effective to provide some kind of cover to prevent rain and snow exposure. However, owing to the effect of condensation, water may still accumulate inside the cover, so combination with some kind of drainage system should be considered. Waterproofing through the application of sealant also has a certain life-prolonging effect, but since the long-term performance of the sealant cannot be guaranteed, such measure necessitates periodic maintenance.

b) Use of low W/C concrete

For a denser pore structure and to suppress bleeding, the W/C should preferably be kept at a low level of 50% or lower. Further, to suppress the formation of voids be-
