Title	Rapid Deterioration of the Anchor Performance of the Wind Turbine Caused by Liquid Water
Authors	N. Chijiwa, H. T. Mai, M. Iwanami
Citation	Proceedings of the 7th Regional Symposium on Infrastructure Development, Vol. 20, No. 7, pp. 80-83
Pub. date	2015, 11

Rapid Deterioration of the Anchor Performance of the Wind Turbine Caused by Liquid Water

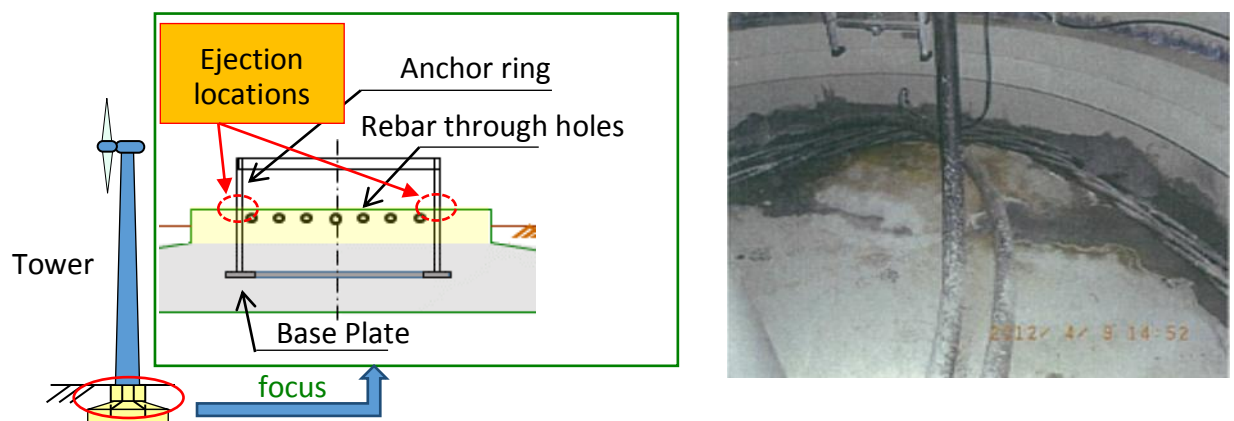
Figure 1: Anchorage zone and sludge ejection locations.

Wind power is drawing attention as a renewable source of energy and the number of wind power installations is increasing. One of the wind turbine tower fixing methods is the anchoring method, which welds a base plate to the steel tower and embeds it inside the concrete foundation (Figure 1). Sludge consisting of fine powder and water is ejected from the interface between the steel anchoring and the concrete of the foundation fixed in place by this anchoring method, causing the tower to be lifted up and in some cases necessitating repair work just a few months after commencement of service. The bearing stress applied as the result of the wind turbine operation is sufficiently low in relation to the concrete strength that such rate of degradation of concrete is unlikely in typical environments. In view of the fact that sludge, which is a mixture of water and powder, is ejected, the presence of liquid water is surmised to induce the rapid deterioration of concrete.

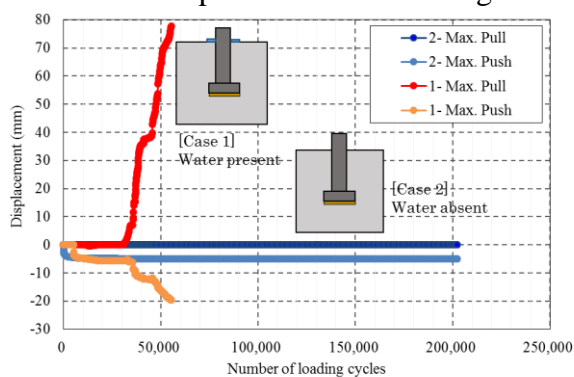
Figure 2: Effect of water presence.

Cyclic loading was performed according to the compressive strength of concrete, under the conditions of positive and negative loads of 30 kN with water supplied in Case 1, and positive and negative loads of 35 kN with no water supplied in Case 2. The maximum and minimum displacements per cycle for Case 1 and Case 2 are plotted in Figure 2.

In Case 2 without water supplied, in the interval from 10,000 repetitions to 200,000 repetitions, pull displacement was 0.12 mm, and push displacement 5.02 mm, with almost no change in displacement. Likely on account of the push displacement being equivalent to the compression of the expanded polystyrene under the plate, damage to the specimen was extremely small and did not lead to breakdown of the specimen.

On the other hand, in Case 1 where water was supplied, water was confirmed to reach the bottom flange of anchor at 35,000 cycles. Thereafter, after the entire anchor plate showed signs of sinking down toward the interior, pull displacement suddenly surged up to 7.1 mm and push displacement became 6.1 mm. At the same time, sludge began spewing forth from the steel interface to the top surface of the specimen, being gradually accumulated. This sludge ejection situation resembled very closely observed at actual wind turbines. Thereafter, pull displacement continued to increase, with the load control capability of the actuator unable to keep up, and as it became impossible to transmit the 30 kN load to the concrete, the loading rate was lowered to 0.25 Hz, 0.1 Hz, 0.075 Hz according to the displacement increases in order to ensure reliable application of the set load.
