Collapse Mechanism of Wide-area Suspended Ceiling in School Gymnasium

Tomohiro SASAKI*, Atsushi AOI^a, Koichi KAJIWARA^b, Hiroyuki TAGAWA^c, Daiki SATO^d

Abstract

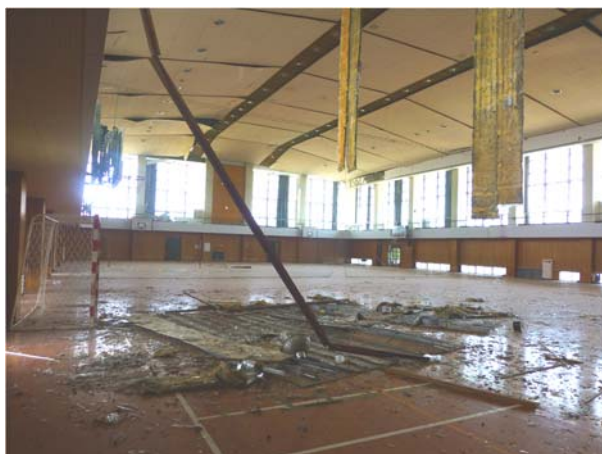
Photo 1 Collapse of Suspended Ceiling in Gymnasium during Kumamoto Earthquake

In the 2011 off the Pacific coast of Tohoku Earthquake, a lot of suspended ceilings in large-space structures such as gymnasium suffered damage and collapsed due to lack of their seismic performance [1]. In 2016 Kumamoto Earthquake, several gymnasium also suffered damage as shown in Photo 1. Because the school gymnasiums are generally expected to be used as evacuation shelters after strong earthquake, their seismic performance including nonstructural components and serviceability after earthquake is important. Thus, new seismic standards for wide-area suspended ceiling have been in effect from April 2014 in Japan. In the new standards, screw fastening to the connection of metal parts, a lot of bracings and clearance between ceilings and walls are required. However, collapse mechanism of ceiling is not yet clarified enough and effective seismic countermeasures are needed.

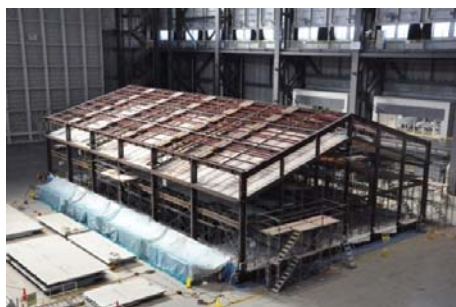
Photo 2 Full-scale Gymnasium Specimen

Photo 2, Figure 1 and Table 1 show gymnasium specimen used for full-scale shake table experiment. The gymnasium specimen is designed as a steel gymnasium in elementary or junior high schools based on current Japanese code. Its size is 18.6 m x 30 m, which is larger than E-Defense shaking table, its height is 9.09 m and it has 10:3 sloped roof.

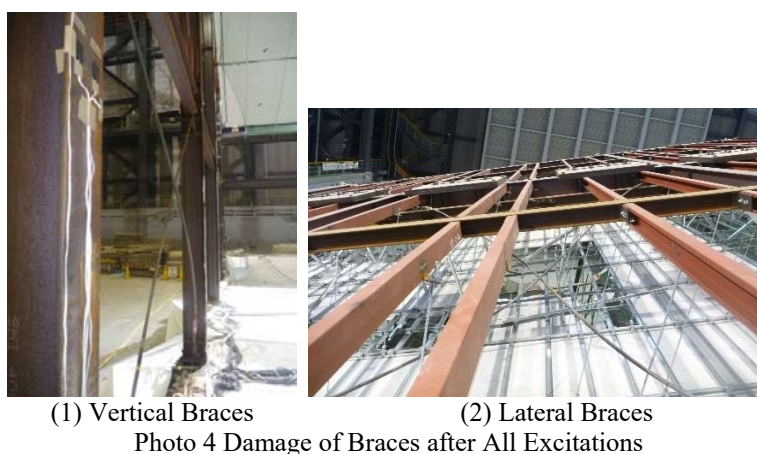
Photo 4 shows damage of braces after all excitations. All vertical and lateral braces are buckled due to expansion resulting from yielding braces. There is no specific damage to structural members except for braces, such as columns, girders and beams.

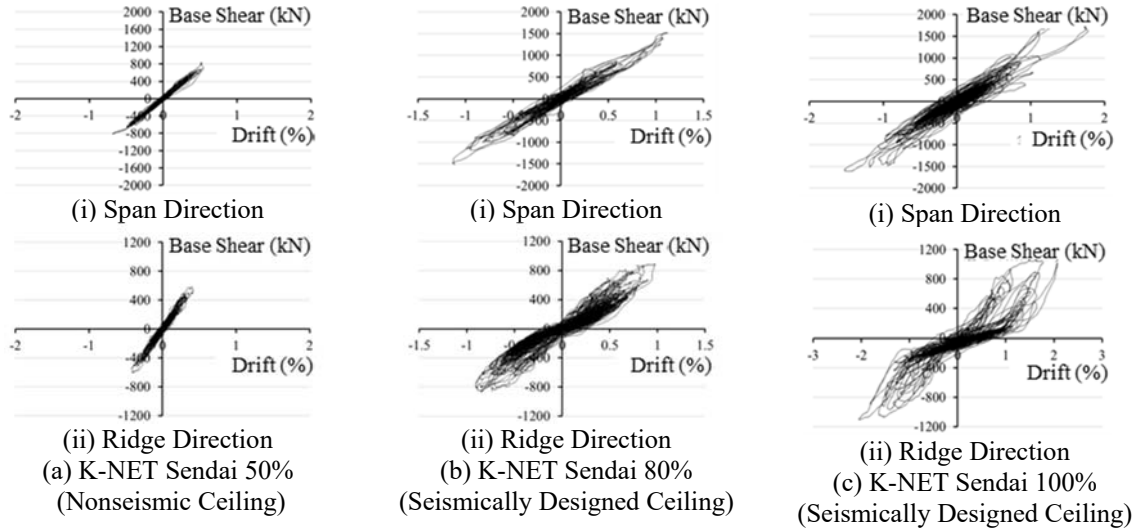
Fig. 5 Base Shear vs. Story Drift Hysteresis during K-NET Sendai Excitations

Figs. 5 and 6 show base shear vs. story drift hysteresis. Base shear is calculated from summation of shear force of column and horizontal component of axial force of braces evaluated from measured strain. As shown in Fig 5(a), the gymnasium specimen remained elastic until K-NET Sendai 50% excitation.

From K-NET Sendai 80%, Columns and vertical braces started to yield. As shown in Fig. 5, especially large measured displacement during JMA Kobe 100% and 150% excitations, bilinear hysteresis with slip response can be identified in shape of hysteresis loop.

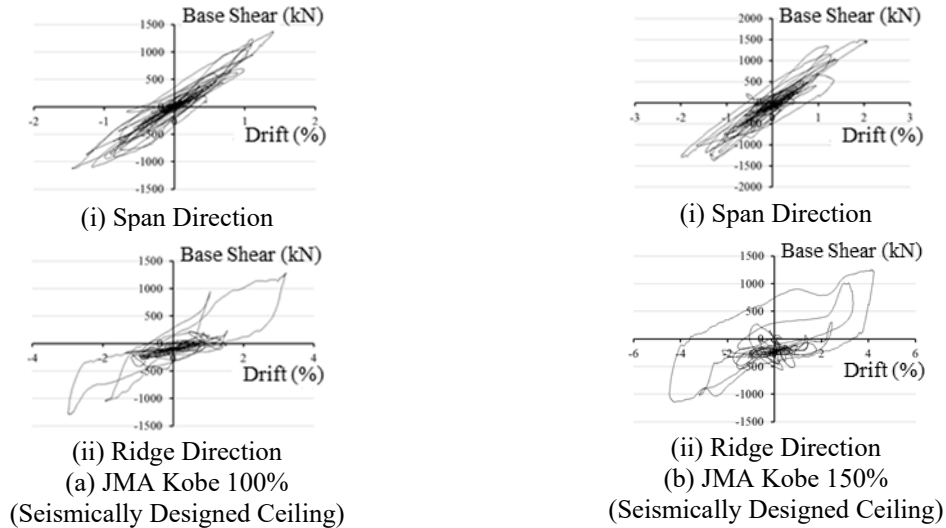
Fig. 6 Base Shear vs. Story Drift Hysteresis during JMA Kobe Excitations

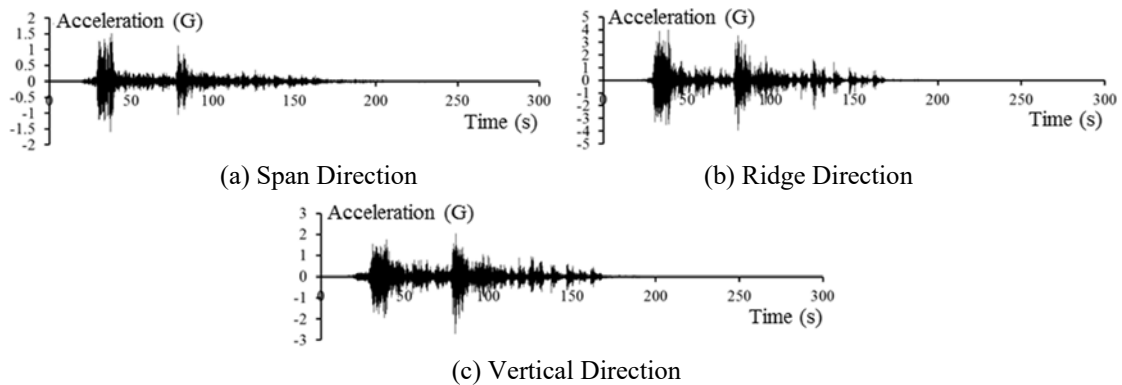
Fig. 7 Roof Acceleration (X4Y5) (Nonseismic Ceiling, 1st K-NET Sendai 50% Excitation)

Fig. 7 shows roof acceleration at X4Y5 during 1st K-NET Sendai 50% excitation in gymnasium specimen with nonseismic ceiling and Tables 5 and 6 show average of peak values of accelerations measured by 35 accelerometers. In Tables 4 and 5, table acceleration and ceiling acceleration described later are also show for comparison. As shown in Tables 4 and 5, roof acceleration in ridge direction kept constant values of 4.2-4.4G during K-NET Sendai 80% and later excitations because base shear reached its yield value due to yielding of braces.

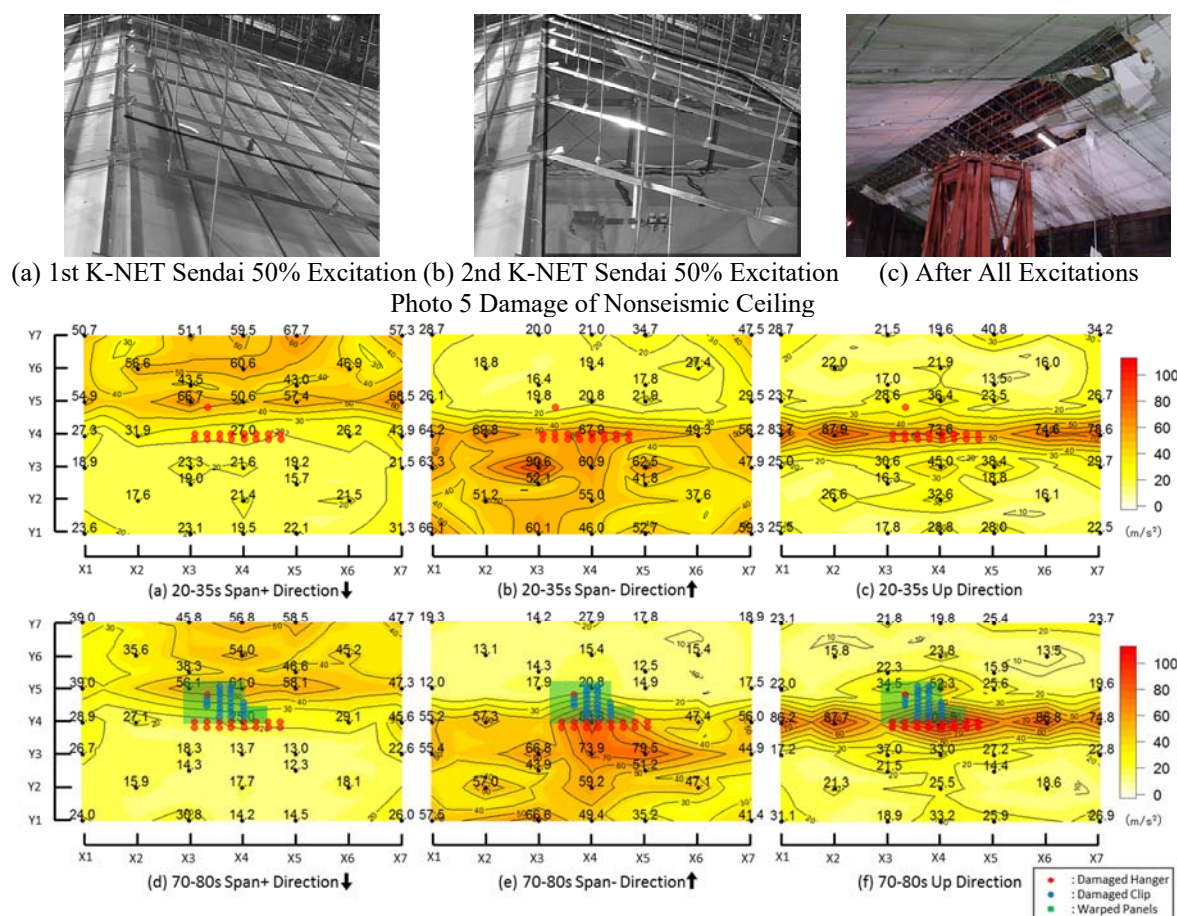
Fig. 8 Damage of Nonseismic Ceiling and Acceleration Distribution

Fig. 8 shows peak values of ceiling accelerations measured from 20 to 35 sec (a-c) and 70 to 80 sec (d-f). As shown in Figs. 8(a) and (d), acceleration in positive span direction was larger in south part of ceiling (upper part in figures) was larger than that in north part of ceiling (lower part in figure). On the other hand, as shown in Figs. 8(b) and (e), acceleration in negative span direction was larger in north part of ceiling was larger than that in south part of ceiling. Maximum acceleration in positive and negative span direction was 90.6m/s^2 at X3Y3 shown in Fig8(b). This large accelerations observed in a half part of ceiling resulted from collisions between walls and ceilings. Based on the maximum acceleration of 90.6m/s^2 , impact force in unit width, which is evaluated from multiplying of unit weight of 13.1kg/m^2 and length of ceiling of 9.71m , was 11.5kN/m . Based on the past research on strength of ceiling panels evaluated from in-plain pushover experiment of ceiling panels, it was 16.1kN/m [2], which is 1.4 times larger than impact force observed in shake table experiment. Thus, the edge of ceiling did not suffer severe damage.

As shown in Figs. 8(c) and (f), large acceleration in up direction occurred at the rooftop, where the hangers detached. Acceleration at X4Y5 in south part of ceiling, close to the location where clips broke, is more than 15m/s² larger than that at the other location. This difference resulted in the severe damage to the south part of ceiling.

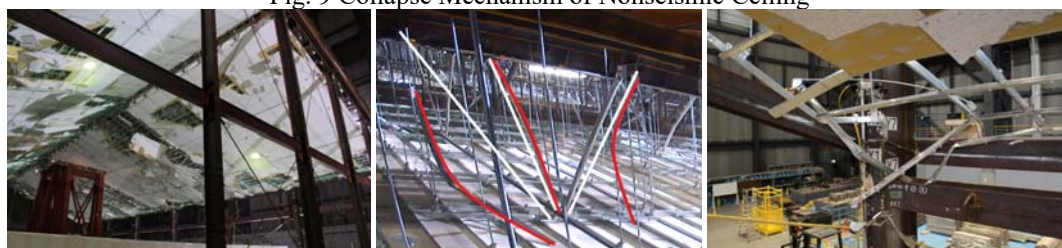
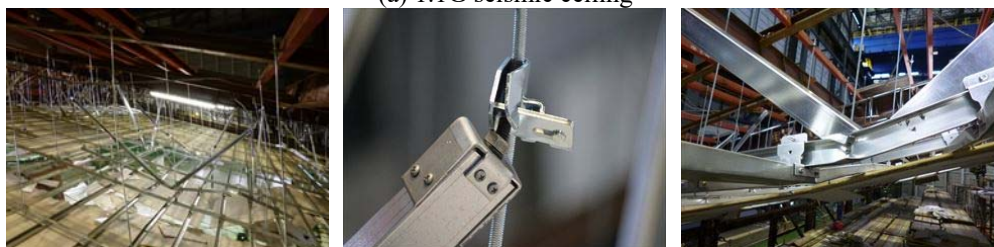
(a) 1.1G seismic ceiling

(b) 2.2G seismic ceiling

Photo 6 Damage of 1.1G and 2.2G seismic ceilings after JMA Kobe 150% excitation

Photo 6 shows damage of 1.1G and 2.2G seismic ceilings after JMA Kobe 150% excitation. In 1.1G seismic ceiling, ceiling braces buckled first during K-NET Sendai 80% excitation, horizontal ceiling displacement increased and edge of ceiling panels suffered severe damage due to collision of ceiling and columns during JMA Kobe 100% excitation. On the other hand, in 2.2G seismic ceiling, bottom and top connections of ceiling braces ruptured, ceiling joist receivers and ceiling joists deformed and ceiling panels fell down due to rupture of screws fasten the boards resulting from deformation of ceiling joists. It should be important noted that stronger buckling strength of braces than strength of bottom and top connections of ceiling braces in 2.2G seismic ceiling resulted in different damage mechanism

with 1.1G seismic ceiling. Failure mechanism of ceiling depends on relations between strength of brace connections and buckling strength of braces.

2. Failure mechanism of seismically designed ceiling with braces and clearance at edge of ceiling depends on relation between strength of brace connections and buckling strength of braces. If ceiling has stronger strength of brace connections than buckling strength of braces, ceiling pounds to walls and falls down due to increment of displacement resulting from buckling of ceiling braces. On the other hand, if ceiling has stronger buckling strength of braces than strength of brace connections, ceiling panels fall down due to deformation of ceiling joists resulting from damage of brace connections.
