**Analysis of Changing Landscape of World Heritage Site for Heritage  
Management: Case of Luang Prabang, Lao People's Democratic Republic**

Thesis submitted to  
Department of International Development Engineering,  
Graduate School of Engineering, Tokyo Institute of Technology  
in partial fulfillment of the requirement for  
Doctorate of Philosophy

June 2016

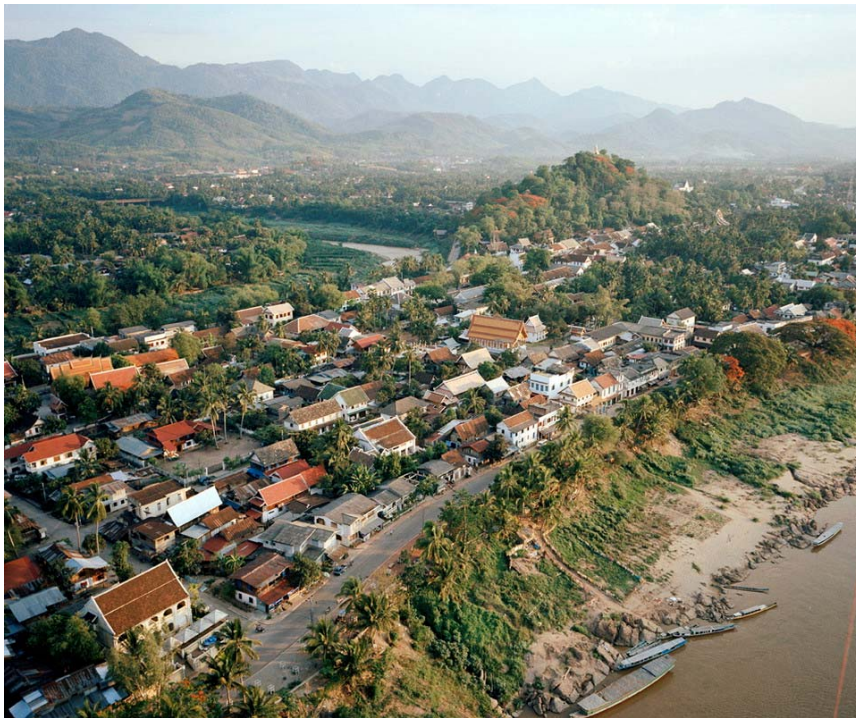
**Figure 1. Historic Urban Landscape of Luang Prabang**

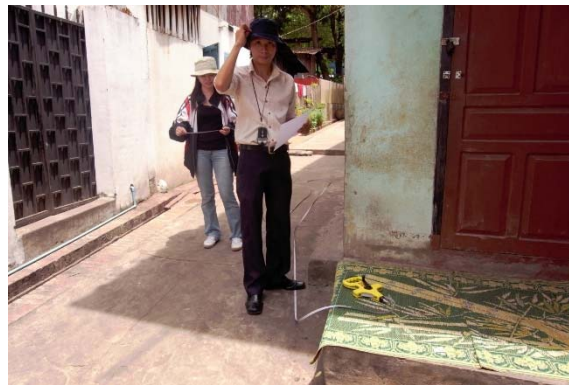
**Figure 13. Building survey conducted with the DPL's architects**

The PSMV has a wide range of building classifications. A total of 745 buildings were surveyed according to the classification (Leong et al., 2010, 2016; Takada et al., 2009). Information on seven indicators was collected and verified by DPL architects during a field survey, as shown in Figure 13. The eighth indicator, the coefficient of occupation soil, was excluded due to lack of resources. Each indicator has sub-categories. The description of each indicator and its sub-categories is summarized in Table 8. The level of preservation is essential information to distinguish inventory buildings that need to be preserved, as described in Table 9.

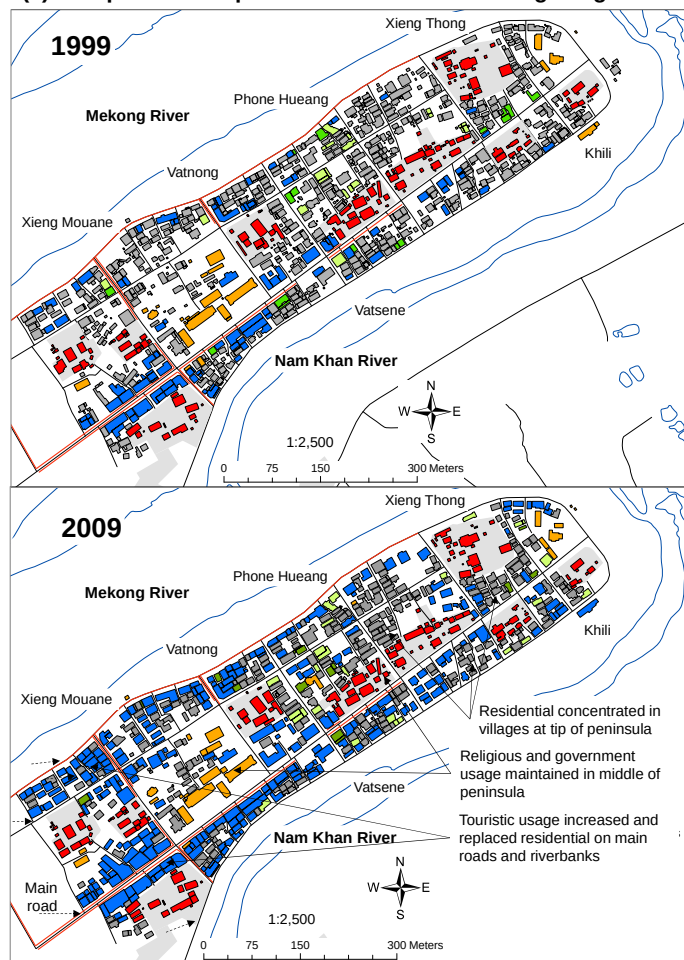
(a) Comparison of spatial distribution of building usage

(b) Change in usage of existing buildings (N=657)

(c) Usage of new buildings (N=88) and demolished buildings (N=44)

**Figure 19. Spatial distribution of changed usage and new buildings usage**

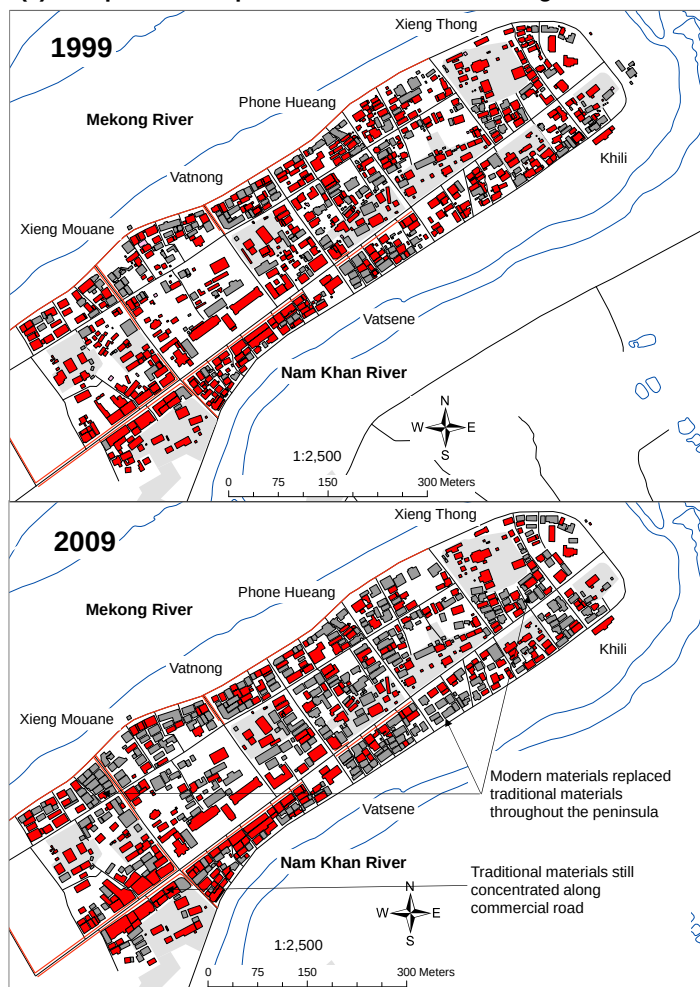
(a) Comparison of spatial distribution of building materials

(b) Change in building materials of existing buildings (N=645)

**Figure 26. Spatial distribution of changed materials and new buildings materials**

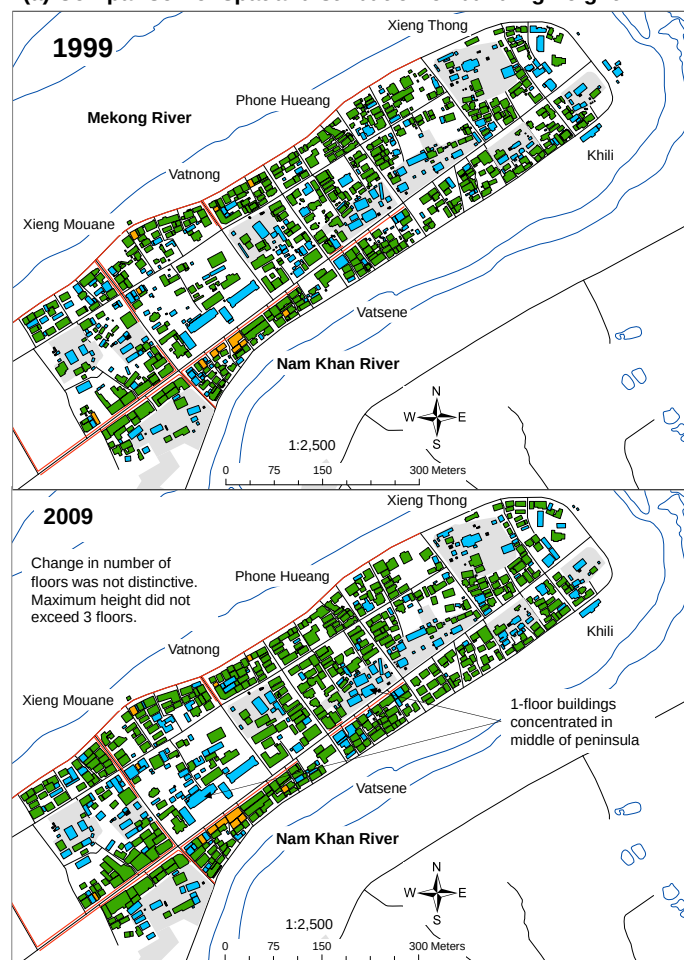
**(a) Comparison of spatial distribution of building height**

**(b) Change in building height of existing buildings (N=619)**

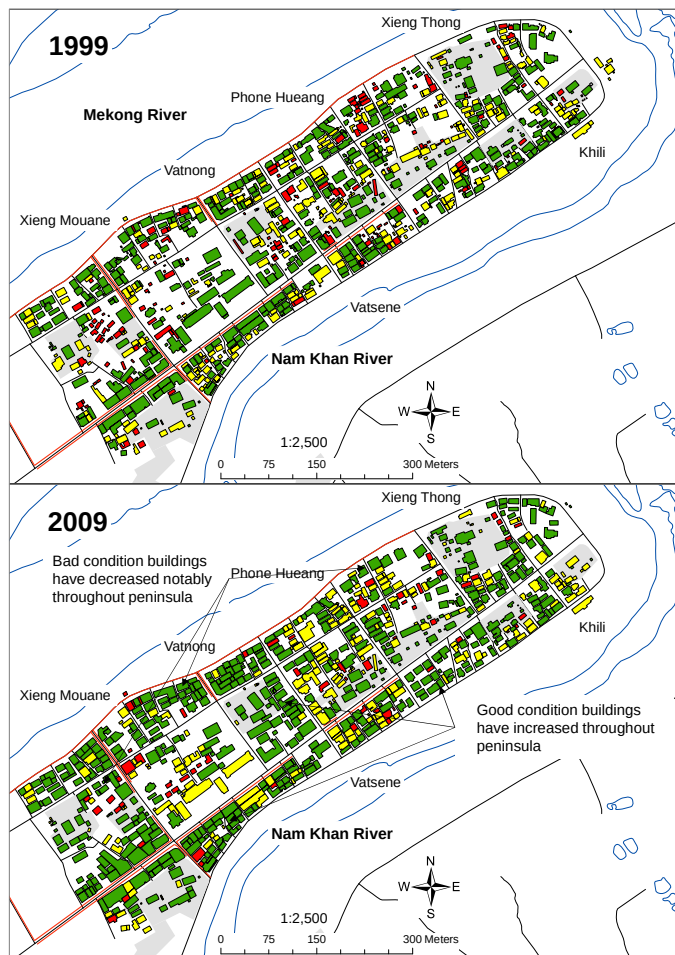
(a) Comparison of spatial distribution of building condition

(b) Change in building condition of existing buildings (N=651)

(c) Building condition of new buildings (N=88) and demolished buildings (N=44)

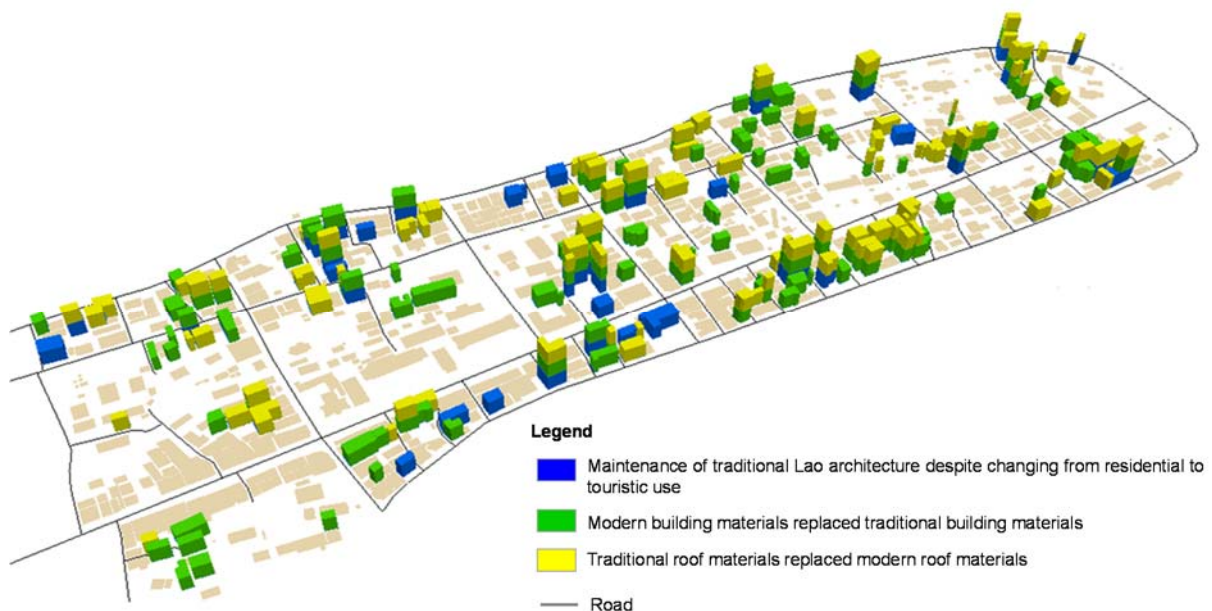
**Figure 37. Distribution of buildings that changed significantly in three aspects**

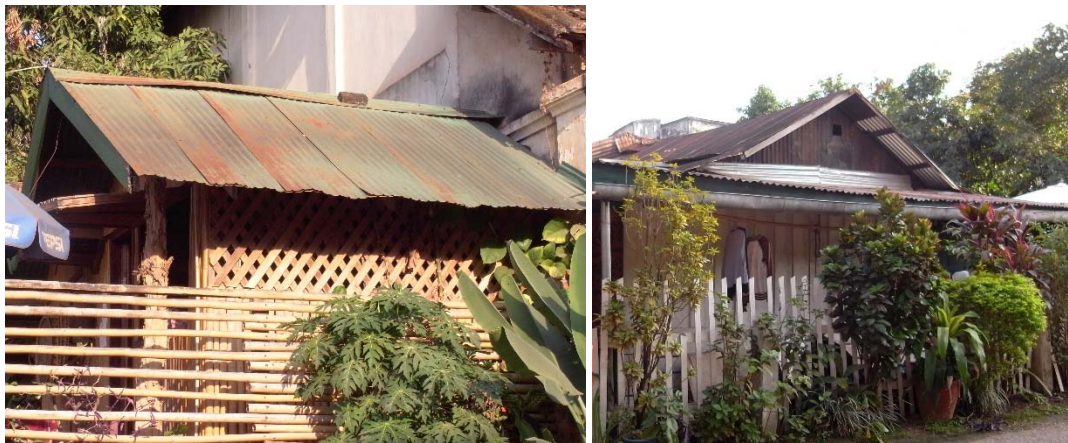
**Figure 50. Example of physical appearance of houses that have been demolished**

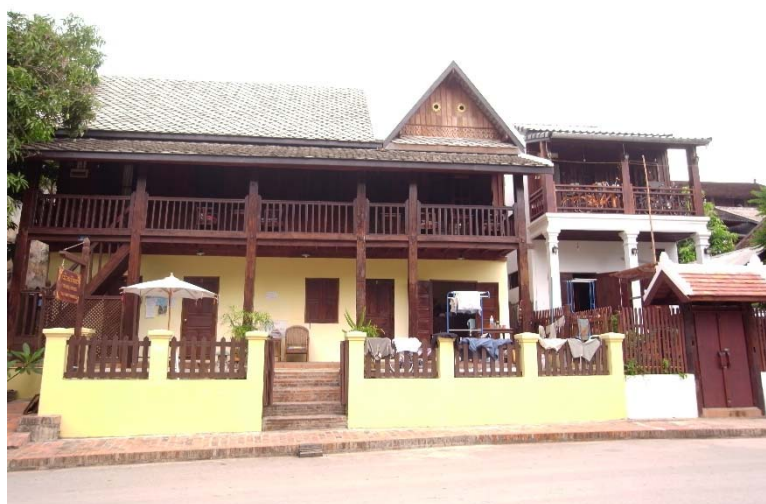
**Figure 51. Example of physical appearance of houses rebuilt as Lao architecture**
