Title	EFFECTS OF MASONRY INFILL WALLS ON THE SEISMIC BEHAVIOR OF A TYPICAL RC BUILDING IN NEPAL.
Authors	Sujan PRADHAN, Yuebing LI, Yasushi SANADA, Haruka KATAYAMA, Shinya FUKUI, Krishna Kumar BHETWAL, Ho CHOI, Yo HIBINO, Koichi KUSUNOKI
Pub. date	2020, 9
Citation	2020 17WCEE Proceedings

EFFECTS OF MASONRY INFILL WALLS ON THE SEISMIC BEHAVIOR OF A TYPICAL RC BUILDING IN NEPAL

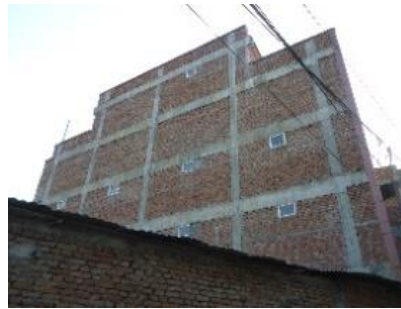
Fig. 2 - Overview of the target building

however, plaster finishing on one side of the wall (no plaster on outside of the wall, as shown in Fig. 2a) was used on the southeast side of the building.

a) Southeast view

b) Northeast view

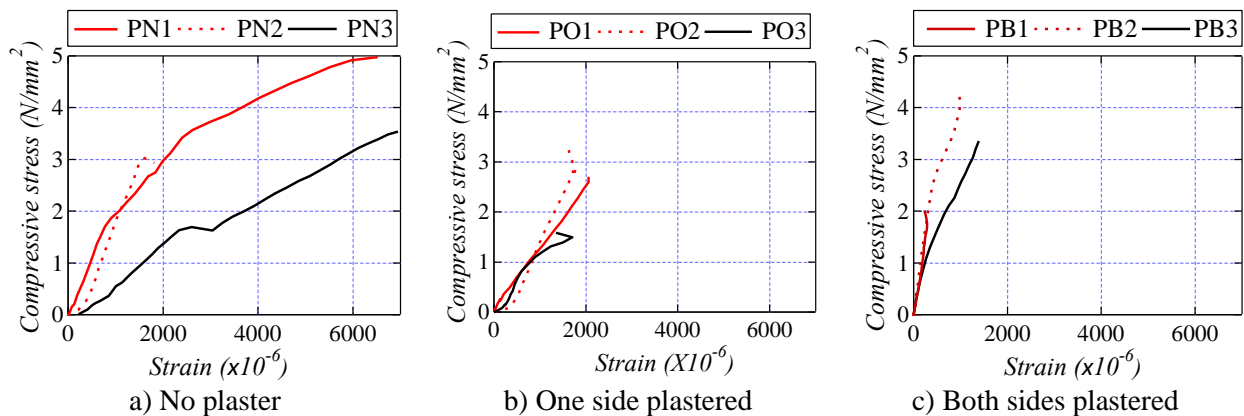
Fig. 16 - Stress-strain relationships from compression tests

The values of the elastic moduli and compressive strengths from the compression tests are summarized in Table 1. The compressive strength of the brick masonry wall was evaluated by dividing the maximum load by the gross cross-sectional area (including plaster) of the specimen. The compressive strain was obtained by dividing the output of the vertical displacement transducer by its gauge length. The compressive stress-strain relationships of all the brick masonry prism specimens are shown in Fig. 16. As shown in Fig. 16 a), the elastic modulus of PN3 was much lower than that of the other two specimens; hence, the test results of PN3 were not included to evaluate the average compressive strength and the elastic modulus of the PN series because it was considered unreliable. The elastic modulus presented in Table 1 was the initial slope with the approximate linear stiffness of the stress-strain relationships shown in Fig. 16. From the table, it is clear that the elastic moduli of the PB series with plaster finishing on both sides was significantly higher than those of the PN and PO series without plaster and with plaster on one side, respectively. However, the explicit effect of plaster finishing works on the compressive strength of brick masonry walls was not observed in this series of tests. Hence, these tests showed that the elastic modulus of the brick masonry wall was significantly affected, whereas the plaster finishing work did not have any obvious effect on the compressive strength of the wall.

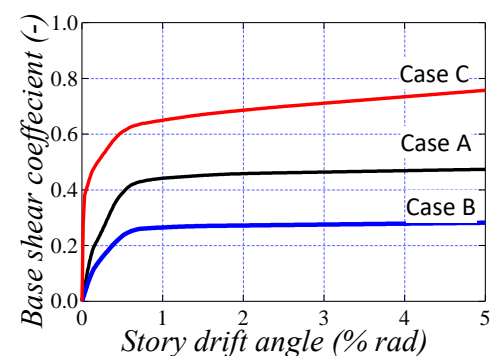
Fig. 19 - Comparison of strength

Pushover analyses were performed in the longitudinal direction, and the load was applied from the northeast to southwest direction up to the maximum story drift of 5% rad. Case C, with the struts representing masonry infill walls, had the highest yield strength among all three cases: 1.5 times higher than that of Case A and 2.5 times higher than that of Case B, as shown in Fig. 19. This result indicated that the strength of the building was significantly increased when the infill walls were considered, as in Case C. Hence, these findings clarified that the effect of the infill wall should be considered when designing a RC building, as the seismic performance of the RC building was greatly affected by different considerations of the infill wall, as shown in Table 4 and Fig. 19.
