## Stability of Soft Clay Slope along Mekong River

Slope failure, Slope rehabilitation, Cambodia

Tokyo Institute of Technology	Student	○ Sokbil Heng
Tokyo Institute of Technology	Int. Member	Thirapong Pipatpongsa
Tokyo Institute of Technology	Int. Member	Hideki Ohta

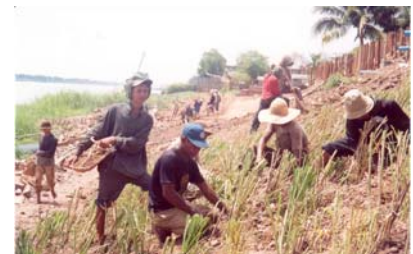
The past study was conducted in May 1997 over a project of 78m-slope rehabilitation along Tonle Sap River [1], Prek Pnov district, Phnom Penh. Gabion wall was first introduced to protect erosion as well as to retain the earth pressure. The amount gabions were placed in the woven containers, and every year those baskets settled. The more gabion adjusted, the more settle and slip to ground. Finally, this concept failed because of less technical design

Fig.1a Gabion retaining wall

Fig.1b Embankment slope

support. In May 2002 a new concept was proposed. Partial of gabion wall was removed and artificial slope was made by embankment with the inclination of  $28^\circ$  and protected soil from erosion due to river flow and runoff by revegetating the site with perennial "gramineae" plants. Neither precise method nor sufficient data of soil investigation were proposed to design for supporting this project. (Fig.1a and Fig.1b)

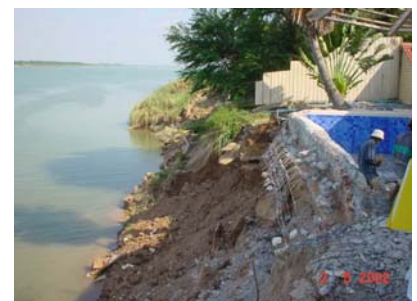
Another case observation in May 2002, a few days after raining, it occurred a failure of natural slope at a private house located along the Mekong River, Phnom Penh. A swimming pool behind the house, close to the riverside was demolished in order to reduce the surcharge pressure. This phenomenon was simply observed when the river water falls to the lowest level since April, collecting the discharge of underground water together with raining water which penetrated quickly to the ground during the onset of the monsoon rains in late May. (Fig.2)

Fig.2 Collapsed natural slope

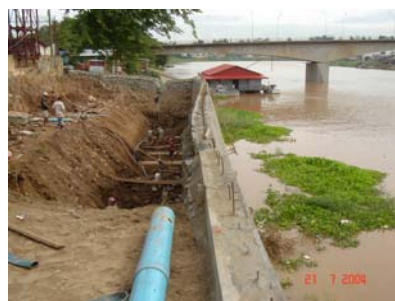
In July 2004, an improper method of soil reclamation implemented by the land owner to the Basaac River, Phnom Penh, caused the failure of the landfill [2]. Both wall and filling materials collapsed to the river when the passive pressure of water decreased with river falls. (Fig.3a and Fig.3b)

Fig.3a Retaining structure

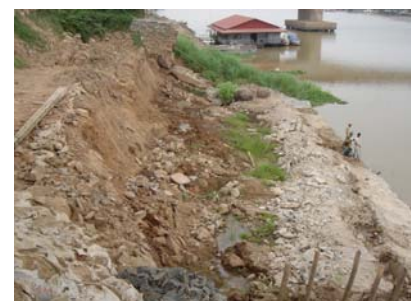
Fig.3b Collapse of retaining wall

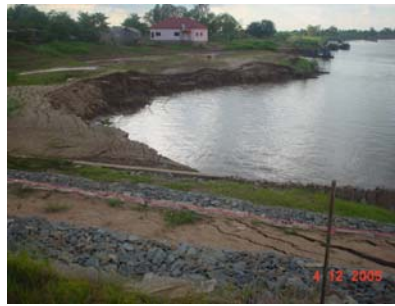
A very recent project of slope rehabilitation was conducted in March 2006 at a Children Center located at National Road No.1, Phum Kdey Takoy, Khum Veal Sbov, Srok Hien Svay, Kahdal Province, Cambodia. Since 2004, when sediment movement transported by river flow concentrated naturally, along the Mokong riverside, at this place created the important deposited slopes. Some measures were used by the landowner to protect this deposited slope. Soldier piles were driven to a certain depth of the ground to retain the active saturated soil deposited. At the passive side laid the baskets of gabion wall placing as a series of steps to protect the erosion and collapse of the artificial slope at the footing. The flood in September 2005 made the deposited slope and embankment on the top very much saturated and weakened the effective stress of the soil.

Fig.4a Slope erosion

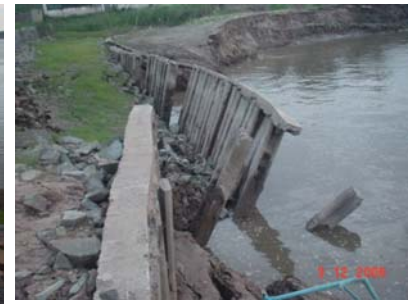
Excess pore pressure in the landfill embankment including the partial erosion of passive side led to a serious damage of the slope as well as the retaining material. This project was completely restored in July 2006 (Fig.4a to 4f). However, the consequences of this concept are not yet observed [3].

Fig.4b Collapse of wall (view from river)

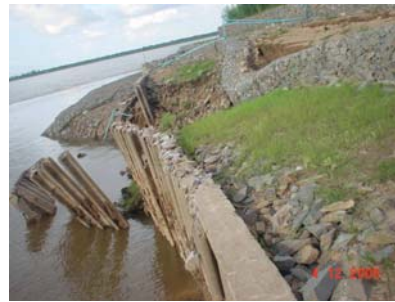
Fig.4c Collapse of wall (view from side)

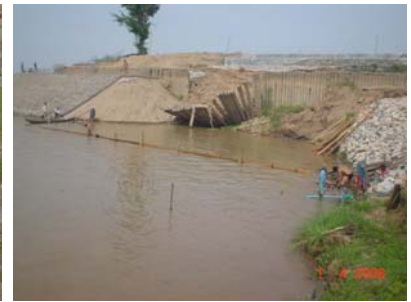
Fig.4d Slope rehabilitation works

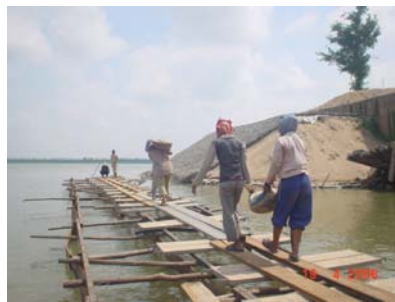
Fig.4e Slope footing enforcement

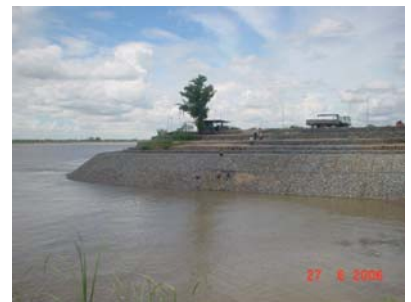
Fig.4f Man-made slope rehabilitation
