| Title | Rapid Deterioration of the Anchor Performance of the Wind Turbine Caused by Liquid Water |
| Citation | Proceedings of the 7th Regional Symposium on Infrastructure Development, Vol. 20, No. 7, pp. 80-83 |

# **Rapid Deterioration of the Anchor Performance of the Wind Turbine Caused by Liquid Water**

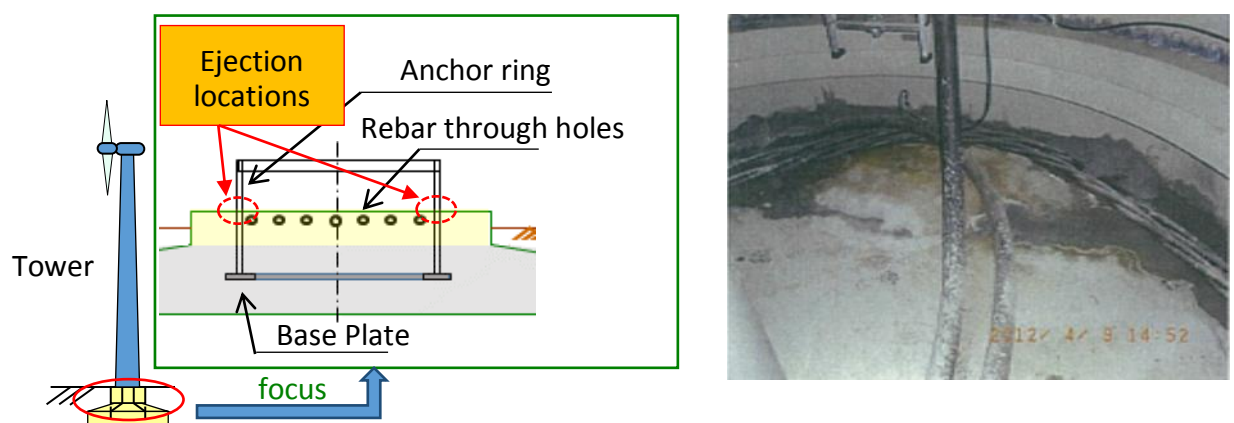
**Figure 1:** Anchorage zone and sludge ejection locations.

Wind power is drawing attention as a renewable source of energy and the number of wind power installations is increasing. One of the wind turbine tower fixing methods is the anchoring method, which welds a base plate to the steel tower and embeds it inside the concrete foundation (Figure 1). Sludge consisting of fine powder and water is ejected from the interface between the steel anchoring and the concrete of the foundation fixed in place by this anchoring method, causing the tower to be lifted up and in some cases necessitating repair work just a few months after commencement of service. The bearing stress applied as the result of the wind turbine operation is sufficiently low in relation to the concrete strength that such rate of degradation of concrete is unlikely in typical environments. In view of the fact that sludge, which is a mixture of water and powder, is ejected, the presence of liquid water is surmised to induce the rapid deterioration of concrete.

Specimens were designed to simulate the anchorage part of an anchor-ring method type wind turbine foundation. The specimen was fixed to a frame with four PC steel rods. Each PC steel rod was pre-stressed to about 150 kN. W/C ratio of the casted concrete was 62.4 %. The maximum aggregate size was 13 mm. A water tank was fabricated over the specimen so as to surround the steel, and water was poured there to simulate pooled rainwater. Further, in Case 1 and Case 2, a 5 mm thick sheet of expanded polystyrene was embedded directly under the anchor plate to foster relative slippage between the steel and concrete and cancel the interfacial bond. Case 3 does not have such an artificial defect to simulate real situation.

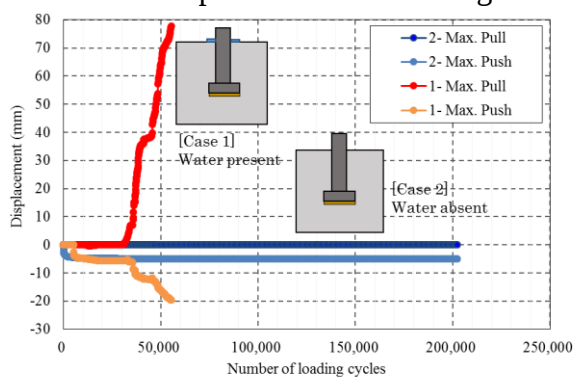
Cyclic loading was performed according to the compressive strength of concrete, under the conditions of positive and negative loads of 30 kN with water supplied in Case 1, and positive and negative loads of 35 kN with no water supplied in Case 2. The maximum and minimum displacements per cycle for Case 1 and Case 2 are plotted in Figure 2.

Figure 2: Effect of water presence.

In Case 2 without water supplied, in the interval from 10,000 repetitions to 200,000 repetitions, pull displacement was 0.12 mm, and push displacement 5.02 mm, with almost no change in displacement. Likely on account of the push displacement being equivalent to the compression of the expanded polystyrene under the plate, damage to the specimen was extremely small and did not lead to breakdown of the specimen.

On the other hand, in Case 1 where water was supplied, water was confirmed to reach the bottom flange of anchor at 35,000 cycles. Thereafter, after the entire anchor plate showed signs of sinking down toward the interior, pull displacement suddenly surged up to 7.1 mm and push displacement became 6.1 mm. At the same time, sludge began spewing forth from the steel interface to the top surface of the specimen, being gradually accumulated. This sludge ejection situation resembled very closely observed at actual wind turbines. Thereafter, pull displacement continued to increase, with the load control capability of the actuator unable to keep up, and as it became impossible to transmit the 30 kN load to the concrete, the loading rate was lowered to 0.25 Hz, 0.1 Hz, 0.075 Hz according to the displacement increases in order to ensure reliable application of the set load.

As a result, when the amplitude of 30 kN was reliably applied continuously to the concrete, total displacement reached 100 mm or more at approximately 50,000 loading cycles. Following several additional thousand loading cycles, the experiment was concluded, the specimen was sectioned and its inside was inspected, revealing that a cavity almost the width of the anchor plate and 120 mm long in the pull direction and 10 mm long in the push direction had formed inside the specimen. Observation of the sides of that cavity showed a state as if about 0.5 mm of the cement paste part had been scooped out, leaving behind the coarse aggregate. Examination by a heavy liquid analysis of the composition of the ejected sludge at the top of the specimen indicated the composition of the fines to be consistent with the original concrete mix proportion, and it was found that not only the cement paste, but even the aggregate, had been finely ground.

These results indicate that when liquid water ingresses the concrete all the way to the area around the anchor plate, progression of the damage in the interior of the concrete is accelerated and pull action occurs significantly faster than under dry conditions.

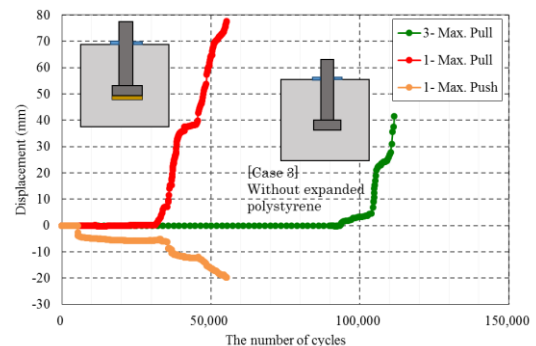
In Case 1, which as described earlier features the placement of expanded polystyrene directly under the anchor plate, allowing easy sinking of the plate, the interfacial bond between the steel and concrete is easily broken. By contrast, the anchor plate in Case 3 is in direct contact with the concrete, so that the interfacial bond is relatively difficult to break. Whereas in Case 1, water entered the tube at 35,000 cycles, in Case 3, this occurred at 95,000 repetitions (Figure 3).

Figure 3: Effect of bond soundness.

The results of this experiment are considered to show that even if concrete is compacted densely around steel, the ingress of water is difficult to avoid. When tensile force is applied to steel, gaps occur between the concrete and the surrounding concrete owing to the Poisson effect. When water pools, ingress of liquid water through gaps occurs. Next, when compressive force is exerted, the steel deforms, pushing outward the concrete around it, so that part of the liquid water that has ingressed is ejected, while part is pushed further inside, penetrating the pores of the concrete at the interface and promoting reduction of the interfacial bond through the wedge effect. The deformation of the steel increases and gaps are created around the anchor, after which the anchor starts moving up and down like a piston, causing liquid water to be drawn in from outside and then ejected, which is thought to, along with accelerating sludge discharge, exacerbate the deterioration mechanism associated with the viscosity of water, for example wedge effect, erosion and cavitation. In the actual structure, it is possible that water ingress may be further promoted by reduction of the interfacial bond between the steel and concrete by the effect of bleeding at the bottom and sides of the steel plate and also shrinkage of the concrete.
