What we learned from the Tokyo Tech 50 kg-satellite “TSUBAME”

A 50 kg-class micro satellite “TSUBAME” was launched in 2014. After a critical phase, the receiving sensitivity of the RF system on board the satellite dropped significantly and the way for command uplink was lost. A thorough investigation was conducted after the failure to determine the causes, based on the obtained telemetry and reproductive experiments in lab room. The detailed data analysis revealed many other malfunctions had occurred. In parallel with the investigation of the fault points, we also classified these malfunctions into several categories in terms of development phase, technological aspects, and management.

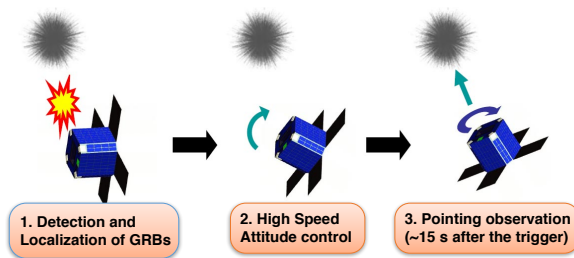
Figure 1: Schematic view of the GRB observation sequence with CMGs.

TSUBAME was designed to measure the polarization of gamma-ray bursts (GRBs), powerful gamma-ray explosions in the far distant universe. In the proximity of the central engine of a GRB, the gravitational energy is converted into the relativistic outflow via unknown physical processes. Information on gamma-ray polarimetry allow scientists to derive the magnetic field in the gamma-ray emitting region. Considering the high luminosity of a GRB, even a small detector can measure the phenomena with sufficient signal to noise ratio. However, the unpredictability of the events themselves and of their location, as well as their limited duration, typically much shorter than 100 sec, make their observations more challenging. To investigate these transient objects, a high-speed attitude control system including control moment gyroscopes (CMGs) was developed. This solution enabled a slew speed of faster than 6 deg s^{-1} . In addition, the satellite also had a Wide-field Burst Monitor (WBM) as support sensor for real time detection and localization of GRBs. The observation sequence used is schematized in Figure 1: after the detection of the GRB by the WBM, the on board computer calculates the coordinate of the target, and then the satellite quickly points the target using CMGs and starts a pointing observation with X-ray polarimeter within 15 sec after the detection[1-2].

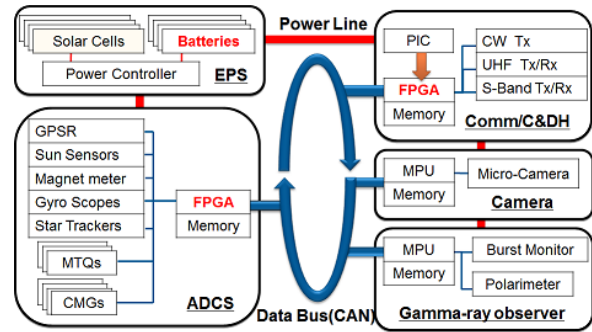
Figure 2: Block-diagram of the satellite system.

Figure 2 describes the function block diagram of TSUBAME. The satellite bus system consists of five sub-systems: Communication / Command&Data Handling sub-system (Comm/C&DH), Attitude Determination and Control sub-system (ADCS), Electric Power sub-system (EPS), gamma-ray detector sub-system (Science Payload), and optical camera sub-system (Camera). These components communicate each other via the Controller Area Network (CAN) bus. In addition, Comm/C&DH can communicate with the other sub-system via UART as a backup. This redundant data bus was included based on the experience inherited from Cute-1.7+APD II, which high speed data bus (USB) did not work in orbit and had to be controlled via backup UART line.

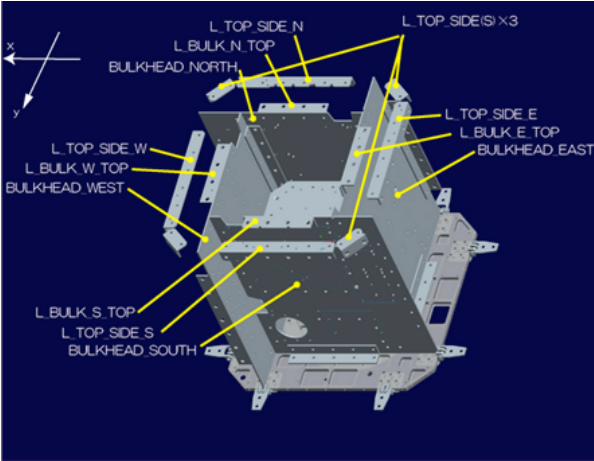
Figure 3: Inner lattice frame of TSUBAME.

The design of the Structure & Thermal sub-system (STR) started with a great focus on the vibration condition for the piggy-bag payload of the Japanese launching vehicle H-IIA, considered to be the worst condition. In order to satisfy the requirements, a rigid lattice frame nested in the outer panel was employed (Figure 3). Even though this structure actually fulfilled the required mechanical performance, few years later it was noticed that accessibility to the components, clearance for harnesses routing and radiation performance were sacrificed. The thermal design mostly failed at the beginning. In the observation with CMGs, the satellite consumed up to 90 W (50W of which for CMSs) which is one of the highest power consumption per unit surface area comparing with other satellites[3, 6]. To dissipate the heat in excess, the outer panels were covered with the OSR films instead of solar cells. A fault tolerant system was preferred for that small satellites to reduce the risk of accidental loss in the attitude control. However, since all the solar array panels (SAPs) were facing the same side of the satellite after the deployment, it was not permissible to accept any minor malfunctions in the ADCS. This situation made the ADCS to work stand-alone, which made the control software much more complicated.

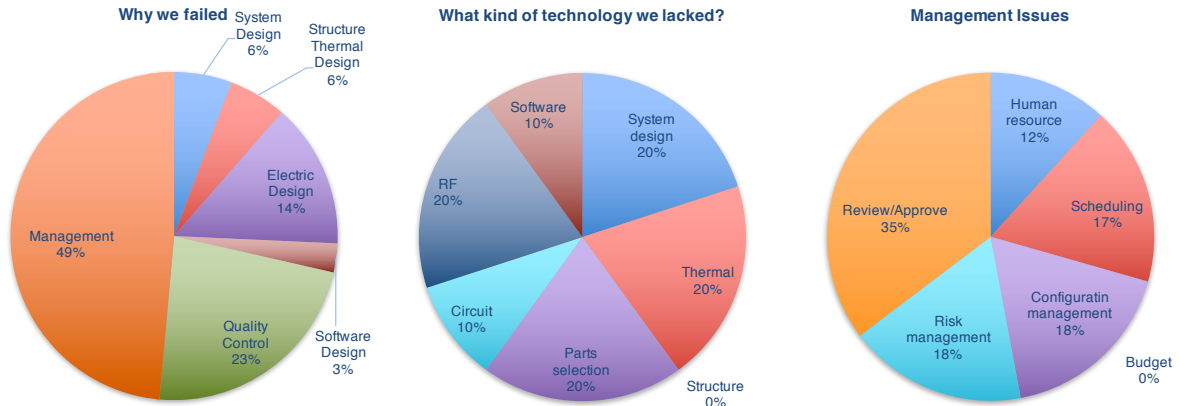
Figure 5: Breakdown of the failures by category.

failures from left to right in Table 4. Failures labeled (6), (8), and (10) Table 3 in are assumed to arise from a common reason, the burnt out of the same DC/DC converters. Figure 5 illustrates the ratio of these categories.

development phases were the most critical aspects of the project. This is not unusual, but the design errors should be identified before moving on to the next phase. As described in §3.2, the timeline of the project was accelerated by the launch schedule. This situation made the basis of the three steps development of BBM, EM and FM to collapse at the first BBM phase. This conclusion may be also confirmed by the high ratio of the management issues occupying nearly 50%, left panel of FIGURE.

The central panel of FIGURE describes the technologies lacked in the project. All the thermal issues listed here arise from the malfunction in the heat dissipation of the electronics in vacuum conditions. These problems were not encountered in the previous CubeSat projects because of their small power consumption. In addition, the thermal design of the entire satellite system was analyzed in component unit and had no concern with the inside of the components. On the other hand, most of the circuit designer were not conversant in thermal design. Actually, students do not learn similar practical techniques in the standard curriculum of Tokyo Tech.

The right panel of Figure 5 shows the management issues to be concerned. The team succeeded in financing with an enormous effort. It should be noticed that this is one of the positive sides of the early contract with DNEPR, which enabled to raise the funds. With respect to the science aspect, the X-ray polarimeter could have been a unique, unprecedented device at that time. Another positive point is the early realization of the launch. The other satellites projects that passed the launch opportunity are still on ground. If the launch had delayed for two years, our satellite would have competed against two large satellites from India and China/Swiss. On the other hand, this risky decision also made the development schedule to collapse as described in §3.2. and §5.1. This unfeasible schedule was the reason for missing bugs in the BBM phase. The key external factor is the unclear launch schedule which was postponed twice in two years, and it was not possible to wait until the completion of debugging. To avoid this fault, it is not desirable to take into account the postponement of the development period, while it is more preferable to estimate the development period much more precisely.
