Title	What we learned from the Tokyo Tech 50 kg-satellite “ TSUBAME ”
Authors	Yoichi Yatsu, Nobuyuki Kawai, Masanori Matsushita, Shota Kawajiri, Kyosuke Tawara, Kei Ohta, Masaya Koga, Saburo Matunaga, Shin'ichi Kimura
Citation	Small Satellite Conference 2017
Pub. date	2017, 6

## What we learned from the Tokyo Tech 50 kg-satellite “TSUBAME”

A 50 kg-class micro satellite “TSUBAME” was launched in 2014. After a critical phase, the receiving sensitivity of the RF system on board the satellite dropped significantly and the way for command uplink was lost. A thorough investigation was conducted after the failure to determine the causes, based on the obtained telemetry and reproductive experiments in lab room. The detailed data analysis revealed many other malfunctions had occurred. In parallel with the investigation of the fault points, we also classified these malfunctions into several categories in terms of development phase, technological aspects, and management.

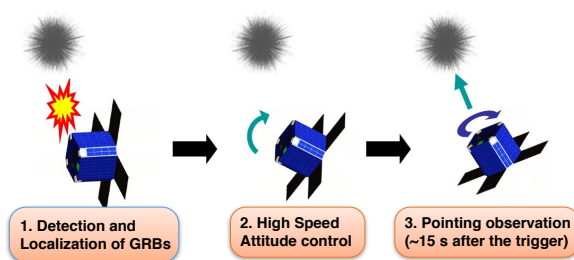
**Figure 1: Schematic view of the GRB observation sequence with CMGs.**

TSUBAME was designed to measure the polarization of gamma-ray bursts (GRBs), powerful gamma-ray explosions in the far distant universe. In the proximity of the central engine of a GRB, the gravitational energy is converted into the relativistic outflow via unknown physical processes. Information on gamma-ray polarimetry allow scientists to derive the magnetic field in the gamma-ray emitting region. Considering the high luminosity of a GRB, even a small detector can measure the phenomena with sufficient signal to noise ratio. However, the unpredictability of the events themselves and of their location, as well as their limited duration, typically much shorter than 100 sec, make their observations more challenging. To investigate these transient objects, a high-speed attitude control system including control moment gyroscopes (CMGs) was developed. This solution enabled a slew speed of faster than  $6 \text{ deg s}^{-1}$ . In addition, the satellite also had a Wide-field Burst Monitor (WBM) as support sensor for real time detection and localization of GRBs. The observation sequence used is schematized in Figure 1: after the detection of the GRB by the WBM, the on board computer calculates the coordinate of the target, and then the satellite quickly points the target using CMGs and starts a pointing observation with X-ray polarimeter within 15 sec after the detection[1-2].

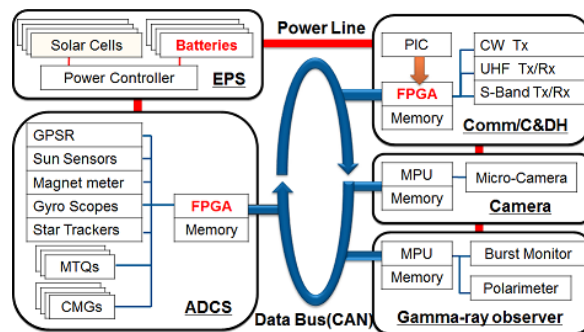
**Figure 2: Block-diagram of the satellite system.**

Figure 2 describes the function block diagram of TSUBAME. The satellite bus system consists of five sub-systems: Communication / Command&Data Handling sub-system (Comm/C&DH), Attitude Determination and Control sub-system (ADCS), Electric Power sub-system (EPS), gamma-ray detector sub-system (Science Payload), and optical camera sub-system (Camera). These components communicate each other via the Controller Area Network (CAN) bus. In addition, Comm/C&DH can communicate with the other sub-system via UART as a backup. This redundant data bus was included based on the experience inherited from Cute-1.7+APD II, which high speed data bus (USB) did not work in orbit and had to be controlled via backup UART line.

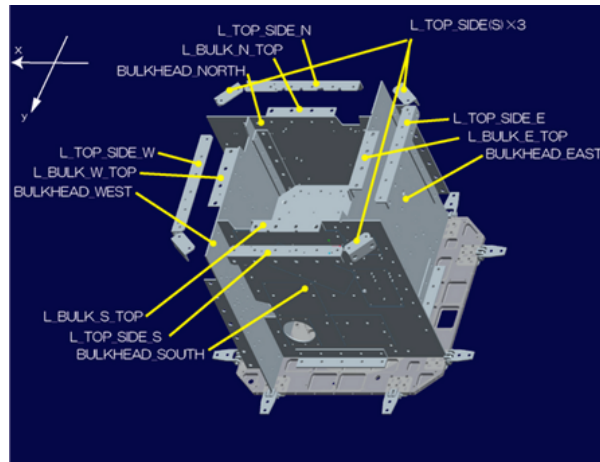
**Figure 3: Inner lattice frame of TSUBAME.**

The design of the Structure & Thermal sub-system (STR) started with a great focus on the vibration condition for the piggy-bag payload of the Japanese launching vehicle H-IIA, considered to be the worst condition. In order to satisfy the requirements, a rigid lattice frame nested in the outer panel was employed (Figure 3). Even though this structure actually fulfilled the required mechanical performance, few years later it was noticed that accessibility to the components, clearance for harnesses routing and radiation performance were sacrificed. The thermal design mostly failed at the beginning. In the observation with CMGs, the satellite consumed up to 90 W (50W of which for CMSs) which is one of the highest power consumption per unit surface area comparing with other satellites[3, 6]. To dissipate the heat in excess, the outer panels were covered with the OSR films instead of solar cells. A fault tolerant system was preferred for that small satellites to reduce the risk of accidental loss in the attitude control. However, since all the solar array panels (SAPs) were facing the same side of the satellite after the deployment, it was not permissible to accept any minor malfunctions in the ADCS. This situation made the ADCS to work stand-alone, which made the control software much more complicated.

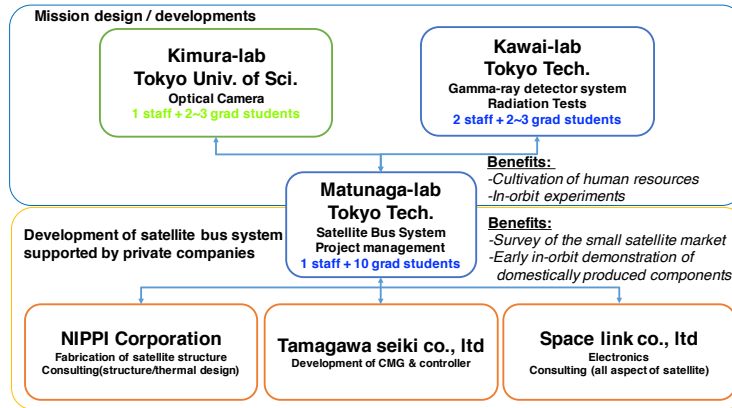
**Figure 4: Development regime of TSUBAME.**

The developmental regime of the TSUBAME project is described in Figure 4. The project team was organized by two universities (three laboratories) and three private companies which were involved in the team as research collaborators. The satellite had been mainly developed by ~15 graduate students who conducted simulation studies, design, tests, and document controls. This means that each sub-system had been developed by 2~3 graduate students. In addition, 2~3 experts were invited to attend the weekly team meeting as technical advisors. It should be noted that most of the graduate students tend to leave the school within three years in Tokyo Tech, therefore the turnover of the team member is rather high comparing to usual space companies. Fortunately, the

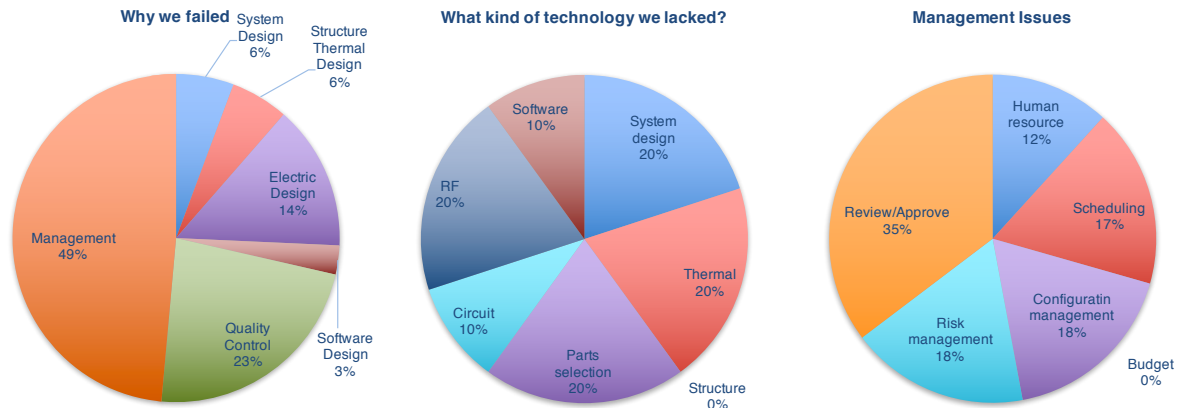
**Figure 5: Breakdown of the failures by category.**

failures from left to right in Table 4. Failures labeled (6), (8), and (10) Table 3 in are assumed to arise from a common reason, the burnt out of the same DC/DC converters. Figure 5 illustrates the ratio of these categories.

development phases were the most critical aspects of the project. This is not unusual, but the design errors should be identified before moving on to the next phase. As described in §3.2, the timeline of the project was accelerated by the launch schedule. This situation made the basis of the three steps development of BBM, EM and FM to collapse at the first BBM phase. This conclusion may be also confirmed by the high ratio of the management issues occupying nearly 50%, left panel of FIGURE.

The central panel of FIGURE describes the technologies lacked in the project. All the thermal issues listed here arise from the malfunction in the heat dissipation of the electronics in vacuum conditions. These problems were not encountered in the previous CubeSat projects because of their small power consumption. In addition, the thermal design of the entire satellite system was analyzed in component unit and had no concern with the inside of the components. On the other hand, most of the circuit designer were not conversant in thermal design. Actually, students do not learn similar practical techniques in the standard curriculum of Tokyo Tech.

The right panel of Figure 5 shows the management issues to be concerned. The team succeeded in financing with an enormous effort. It should be noticed that this is one of the positive sides of the early contract with DNEPR, which enabled to raise the funds. With respect to the science aspect, the X-ray polarimeter could have been a unique, unprecedented device at that time. Another positive point is the early realization of the launch. The other satellites projects that passed the launch opportunity are still on ground. If the launch had delayed for two years, our satellite would have competed against two large satellites from India and China/Swiss. On the other hand, this risky decision also made the development schedule to collapse as described in §3.2. and §5.1. This unfeasible schedule was the reason for missing bugs in the BBM phase. The key external factor is the unclear launch schedule which was postponed twice in two years, and it was not possible to wait until the completion of debugging. To avoid this fault, it is not desirable to take into account the postponement of the development period, while it is more preferable to estimate the development period much more precisely.
