Field surveys and numerical modeling of the August 2016 Typhoon Lionrock along the northeastern coast of Japan: the first typhoon making landfall in Tohoku region

Mohammad Heidarzadeh¹ · Takumu Iwamoto² · Tomohiro Takagawa² · Hiroshi Takagi³

Abstract

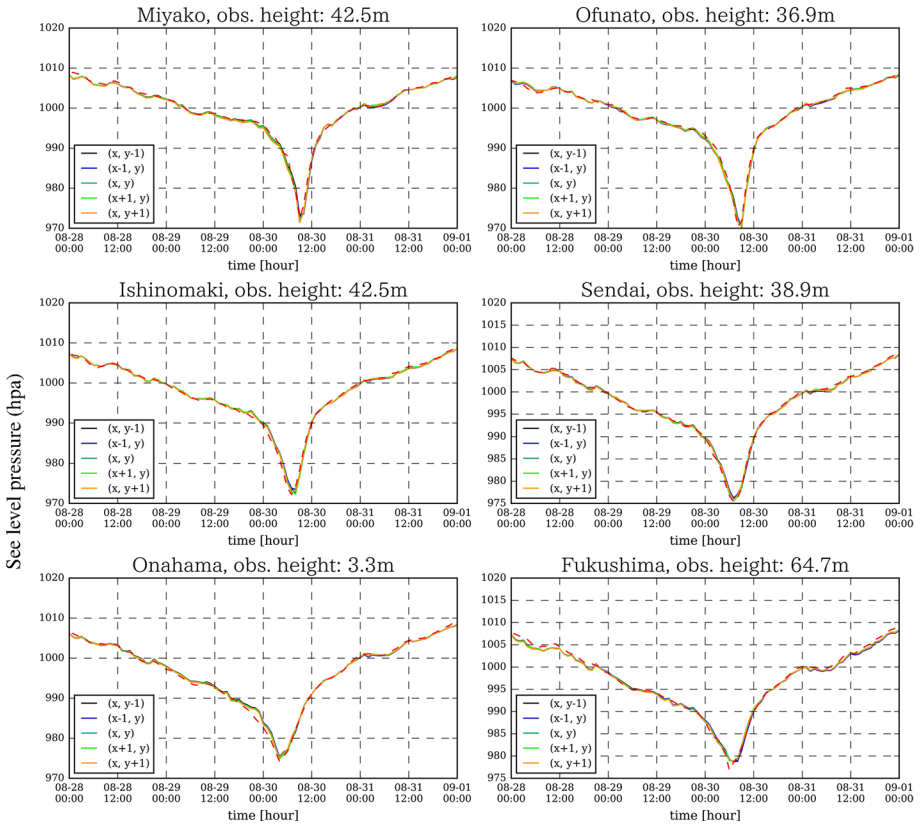
Fig. 5 Comparison of sea level pressure (hPa) at six observation points for the 2016 Typhoon Lionrock. The red line is for the observations, and other colors are the values from MSM-GPV

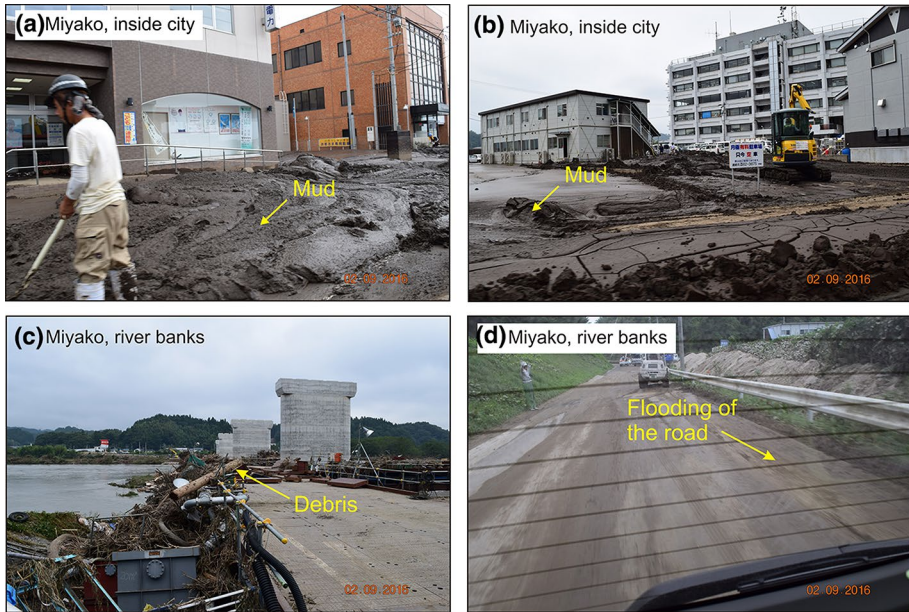
The heavy landfall caused by the Typhoon Lionrock generated floods in many rivers along the northeastern coast of Japan. We surveyed the city of Miyako which was flooded and was covered with heavy mud after the typhoon (Fig. 10a, b). Figure 10 shows the city is being cleared up of the mud using construction machines and manpower. The construction site of a river bridge also was visited which was covered by many wooden debris (Fig. 10c). According to site engineers, the flood height was ~5.5 m above the river’s normal level causing inundation of the nearby road (Fig. 10d).

Fig. 10 Flooding of the Miyako city (a, b) and the river banks (c, d) due to the 2016 Typhoon Lionrock. Approximate locations of the photographs are: 39.6431° N and 141.9597° E for panels “a” and “b” and 39.6305° N and 141.9245° E for panels “c” and “d”
