| Citation | Ocean Engineering, Vol. 307, , |

Locally amplified tsunami in Iida Bay due to the 2024 Noto Peninsula Earthquake

2024 Noto Peninsula earthquake
Iida bay
Tsunami amplification
Breakwater damage
Field survey
Numerical simulation

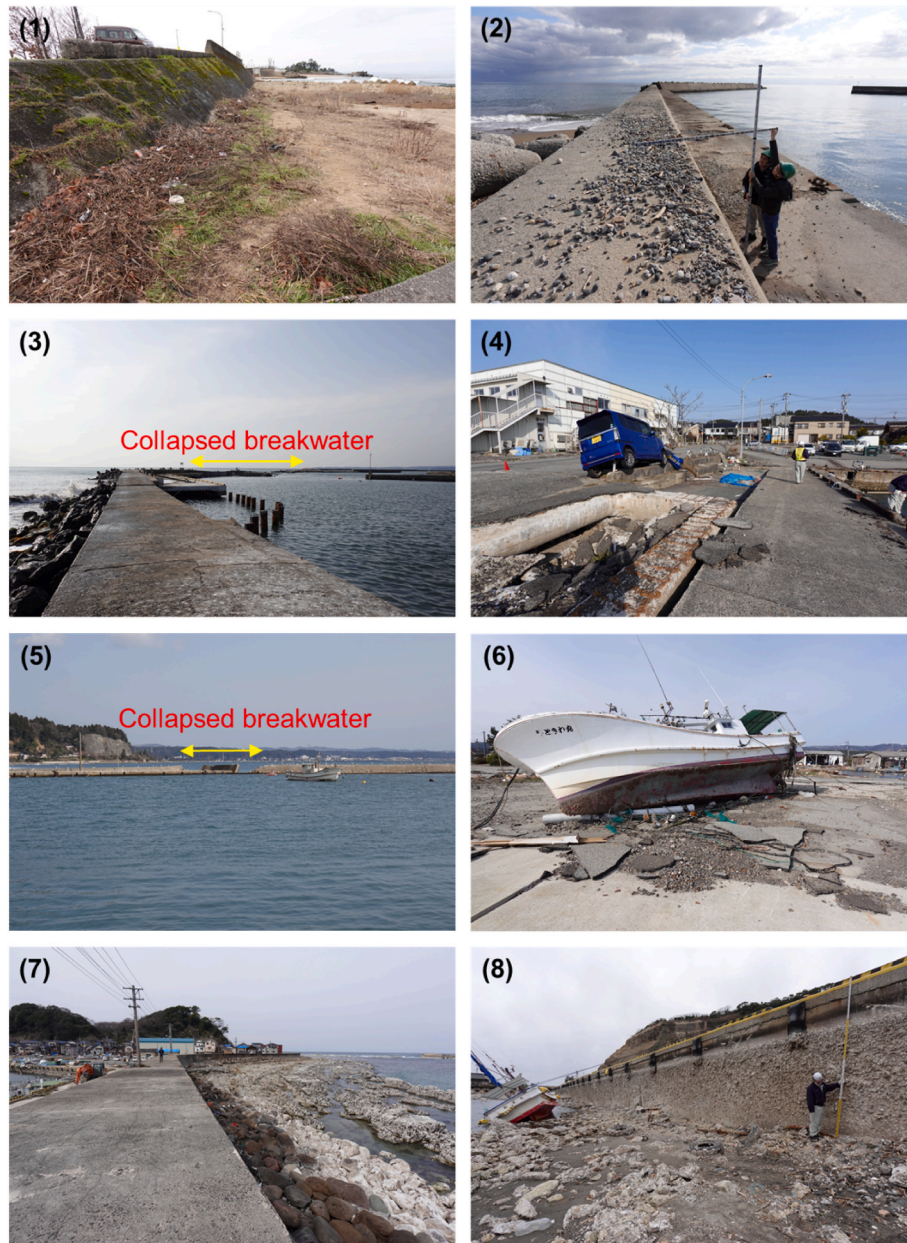
Fig. 3. Photographs acquired during our field surveys after the 2024 Noto Peninsula Earthquake. (1) Namerikawa City, Toyama Prefecture. Location: point a in Fig. 2 (137.320°E, 36.758°N), photo taken on 2024/2/2. (2) Higashihama Fishing Port, Ishikawa Prefecture. Location: point b in Fig. 2 (137.051°E, 36.978°N), photo taken on 2024/2/2. (3, 4) Iida Port, Ishikawa Prefecture. Location: point c in Fig. 2 (137.266°E, 37.436°N), photo taken on 2024/3/19. (5, 6) Ukai Fishing Port, Ishikawa Prefecture. Location: point d in Fig. 2 (137.245°E, 37.402°N), photo taken on 2024/3/19. (7) Wajima Port, Ishikawa Prefecture. Location: point e in Fig. 2 (136.902°E, 37.404°N), photo taken on 2024/3/19. (8) Kaiso Fishing Port, Ishikawa Prefecture, where an uplift of nearly 4 m occurred. Location: point f in Fig. 2 (136.728°E, 37.293°N), photo taken on 2024/3/19.

As shown in Fig. 3(1), tree branches and trash were deposited extensively in front of the coastal dike in Namerikawa, Toyama Prefecture; however, definitively attributing these deposits to the tsunami is challenging. On January 1, when the earthquake occurred, Toyama Bay experienced stormy weather. According to the wave observation system called NOWPHAS, a significant wave height of 2.52 m was observed in the Fushiki-Toyama port at 16:20, 10 min after the earthquake. This height was significantly higher than the wave heights of 0.09 m and 0.46 m observed on December 31 and January 2 at the same time, respectively. As shown in Fig. 4, water levels in Toyama Bay were monitored at three tide stations with their names of Toyama (Station 1), Fushiki-Toyama (Station 2), and Nanao (Station 3), where maximum water levels of 0.75 m, 0.83 m, and 0.37 m, respectively, were observed. At stations 1 and 2, the maximum water level was attained 25–27 min after the earthquake. However, the first and second tsunami waves, which were slightly smaller, arrived before the maximum water level. At station 3, located in the inner part of the bay (Nanao Bay), small water surface fluctuations occurred immediately after the earthquake; however, the main tsunami arrived later than at stations 1 and 2, approximately 40 min after the earthquake.

At Iida Port, a breakwater section on the north side collapsed (Fig. 3(3)). The tsunami caused substantial damage: numerous ships sank or were washed up on the wharf and numerous cars were washed away (Fig. 3(4)). The tsunami damage was also evident at Ukai Fishing Port, located 4 km south of Iida Port. Part of the breakwater on the north side of the port collapsed and fishing boats were washed ashore (Fig. 3(5,6)). The breakwaters on the north side of Ukai Fishing Port were damaged rather than the main breakwaters on the east side, suggesting that the

Higashihama Fishing Port (Fig. 3(2)) is approximately 50 km south of Iida Bay. The tsunami at this port is less than 2 m high (Fig. 2).

Although the earthquake and liquefaction damaged many parts of the port, the tsunami did not appear to have caused notable damage. However, sand and gravel were left on top of the breakwater, suggesting

the tsunami overflowed the breakwater (3 m above the water surface). Although the tsunami did not cause substantial damage to the port facilities as it did in Iida Bay, it may have affected ships and moorings in the port.

Our survey confirmed that a significant uplift of 1–4 m occurred in Wajima Port (Fig. 3(7)) and Kaiso Fishing Port (Fig. 3(8)). The uplifted seawater is thought to have generated a tsunami; however, no obvious damage from the tsunami was observed at these locations. According to the *Chunichi Shimbun newspaper* (2024), no major tsunami damage was reported from Kawaura Village, Suzu City at the northern end of the Noto Peninsula to Wajima City, indicating that the sudden uplift may have helped to reduce the impact of the tsunami.

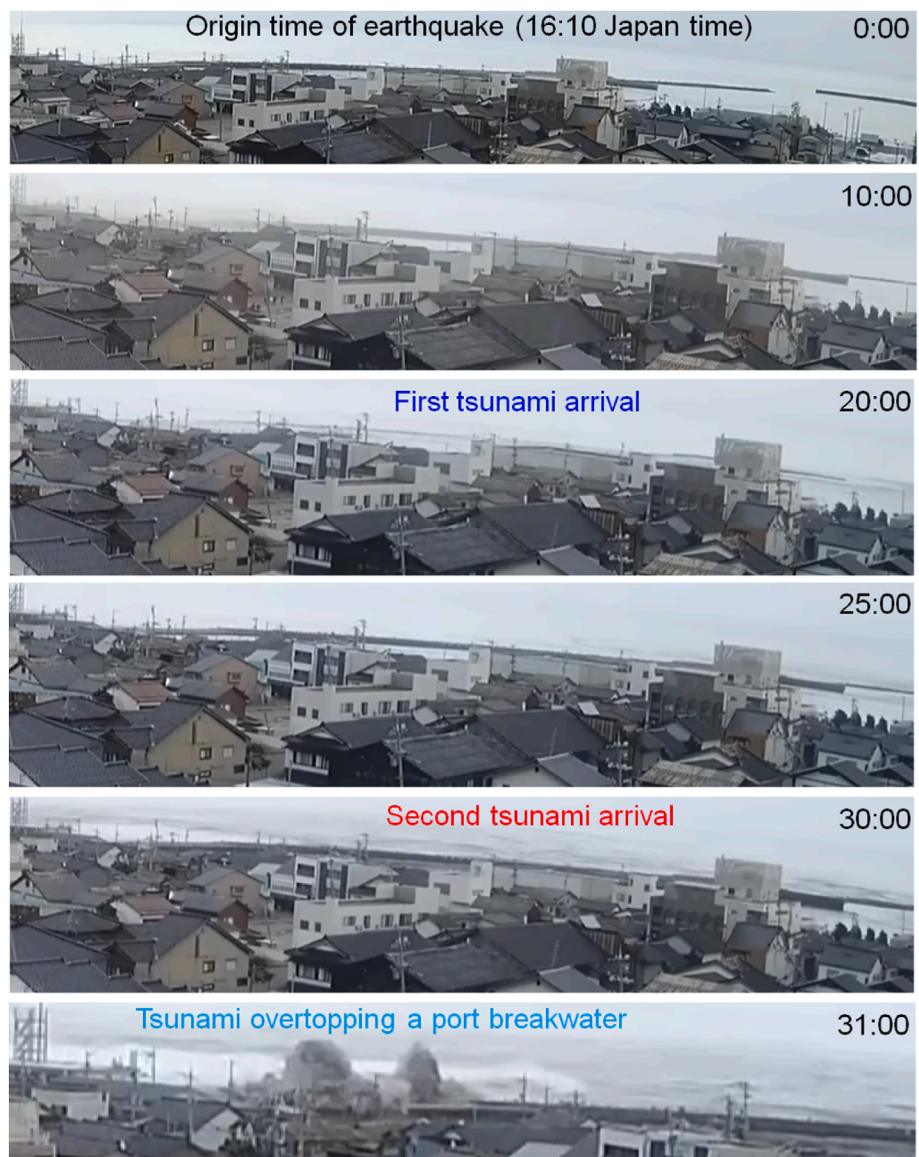
Fig. 7. Images from a monitoring camera overlooking Iida Bay installed on the roof of Suzu City Hall showing the arrivals of the tsunamis at Iida Port (ANN News: https://www.youtube.com/watch?v=T_839fN7ZNU&t=4s).

A monitoring camera overlooking Iida Bay installed on the roof of Suzu City Hall recorded the tsunami hitting Iida Port (**Fig. 7**). In this video, the first wave arrives around 20 min after the earthquake, which

is consistent with the numerical calculation results. The waves appear directly from offshore because the wave direction is perpendicular to the coastline. Tsunami overflow appears to occur in the northern section of

the breakwater (left side of the photograph in Fig. 7), with the water level rising to near the top of the breakwater at the port entrance. In the video, the water level drops at 25 min; therefore, the oscillatory period

of the first tsunami wave is estimated to have been less than 10 min. A clear second wave can be observed around 30 min after the earthquake. In addition to the tsunami advancing from offshore, white waves appear on the north side (left side of the photograph). A bore-like tsunami is moving along the coastline from north to south. At 31 min, the white waves violently hit the north breakwater of Iida Port. Therefore, the impact at this time may have caused to damage the breakwater (Fig. 3(3)). The splash caused by the tsunami collision reached the fourth floor of the evacuation tower behind the port (Fig. 8). As the fifth floor is 14.1 m above sea level, the splash was presumed to reach at least 10 m above sea level.

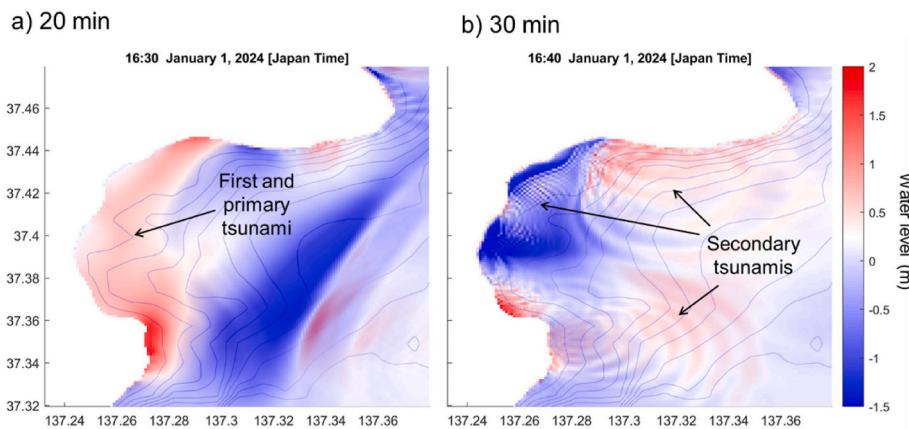
Fig. 9. First to fourth tsunami waves in the numerical simulation results. Bathymetry contour lines are drawn every 10 m.

Iida Bay revealed that second, third, and fourth waves with shorter periods arrived after the first wave (Fig. 9). The third and fourth waves were diffracted from the north and south capes, these multiple waves possibly intersected near Iida Port, amplifying the tsunami and expanding the damage around the port and the port facility itself.

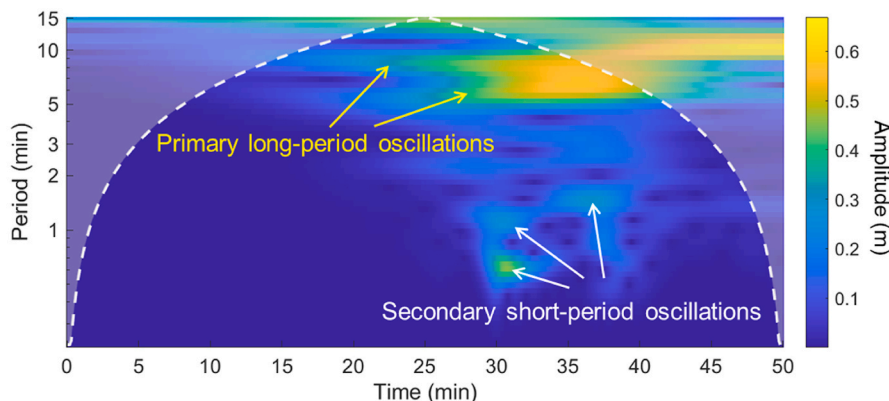
Fig. 10. Wavelet scalogram based on the numerical output of water level time series data near Iida Port.

Fig. 10 shows the results of the continuous wavelet transform using the MATLAB Wavelet Toolbox. It shows how the periodic components of the tsunami changed over time in the output of water level time series data near Iida Port. According to these results, the first wave appeared around 20 min after the earthquake, after which reflection appears to occur. The oscillation period of the primary tsunami energy is estimated to have been 5–10 min, which is consistent with the period inferred from

Fig. 7. In contrast, a short-period tsunami component with less than 2 min can be detected within 30–40 min of the earthquake. These secondary tsunami energies are considered to correspond to the 2nd, 3rd, and 4th waves in Fig. 9. While the tsunami energy from the first wave remained in the bay, the second and subsequent tsunamis overlapped, and this is thought to have caused significant flood damage around Iida Port and Ukai Fishing Port.
