Title	Levee Damage and Bridge Scour by 2019 Typhoon Hagibis in Kanto Region, Japan
Authors	Tadao Enomoto, Kazuki Horikoshi, Keisuke Ishikawa, Hirotoshi Mori, Akihiro Takahashi, Toshiyasu Unno, Kenji Watanabe
Citation	Soils and Foundations, Vol. 61, Issue 2, pp. 566-585
Pub. date	2021, 4

Geo-Disaster Report

Levee damage and bridge scour by 2019 typhoon Hagibis in Kanto Region, Japan

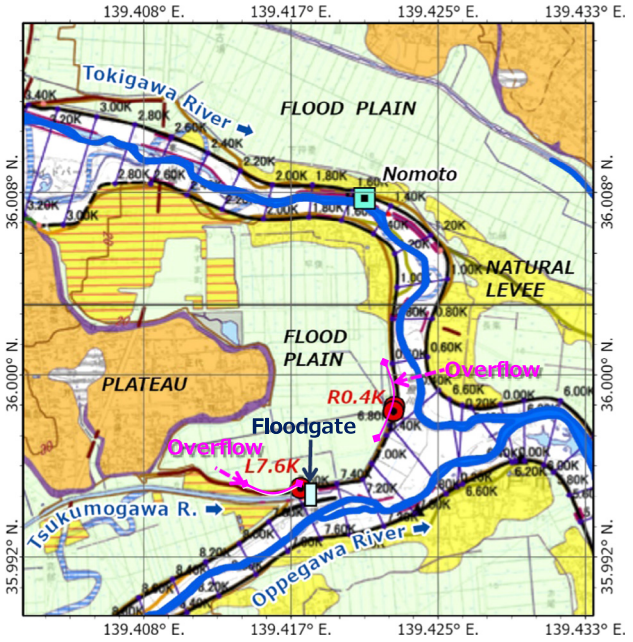
The breaches at 7.6 k on the left levee of the Oppegawa River and at 0.4 k on the right levee of the Tokigawa River are located near the inflow of the Tokigawa River into the Oppegawa River, as shown in Fig. 5. The breached point at L7.6 k is at the corner directly upstream of the floodgate of the Tsukumogawa River, which joins the Oppegawa River, and it extends for around 40 m to the left levee of the Tsukumogawa River. The breached point at R0.4 k is located on the outer levee of a gentle bend in the Tokigawa River near its confluence with the Oppegawa River, and it extends for around 90 m. This area is surrounded by levees and terraces of the Tokigawa and Oppegawa Rivers, and around 160 ha of this area was inundated by levee breaches and overflows.

Fig. 5. Landform classification map for flood control in vicinity of breaches. The landform classification map was obtained from the base map information of the Geospatial Information Authority of Japan (https://cyberjapandata.gsi.go.jp/xyz/lcmfc2/12/3634/1608.png).

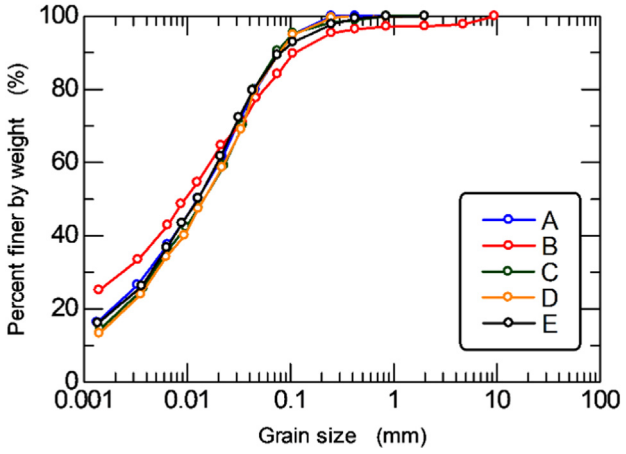
Fig. 8. Cross-section of breached levee at R0.4 k and grain size distribution curves for soils taken from points shown in picture. The data were obtained from the report by the Investigation Committee for the Levee Breach by the 2019 Typhoon Hagibis in the Kanto Region (2020).

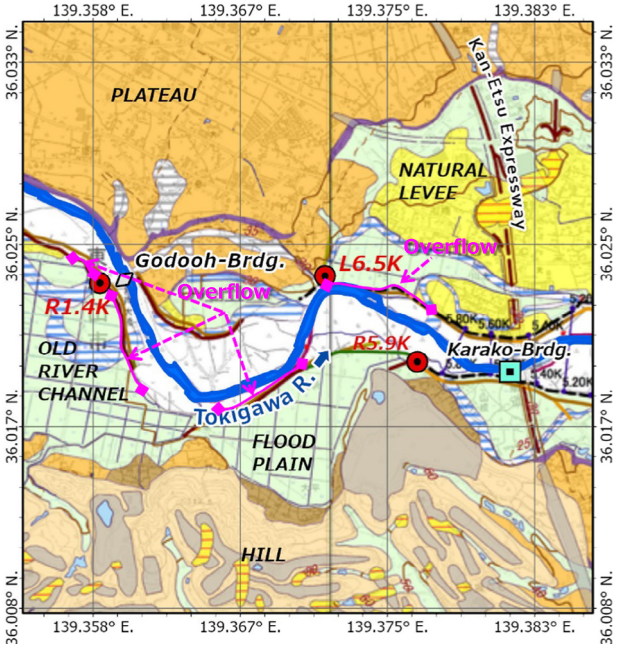
The breached point at 6.5 k on the left levee of the Tokigawa River is located at the water-colliding front of the Tokigawa River and near the confluence of the tributaries of the Tokigawa River, as shown in Fig. 9. Near the breached area, breaches also occurred at R5.9 k on the opposite side of the river and at R1.4 k upstream of the Godooh Bridge, which is managed by Saitama Prefecture. These breached levees were temporary ones. Approximately 140 ha of the plain was inundated owing to overtopping in a series of sections. Fig. 10 shows the levee breach at L6.5 k, where the levee was breached for around 30 m. Fig. 11 shows the situation of the slope on the protected side, which is continuous from the breached point. To

Fig. 9. Landform classification map for flood control in vicinity of breaches. The landform classification map was obtained from the base map information of the Geospatial Information Authority of Japan (https://cyberjapandata.gsi.go.jp/xyz/lcmfc2/13/7267/3216.png).

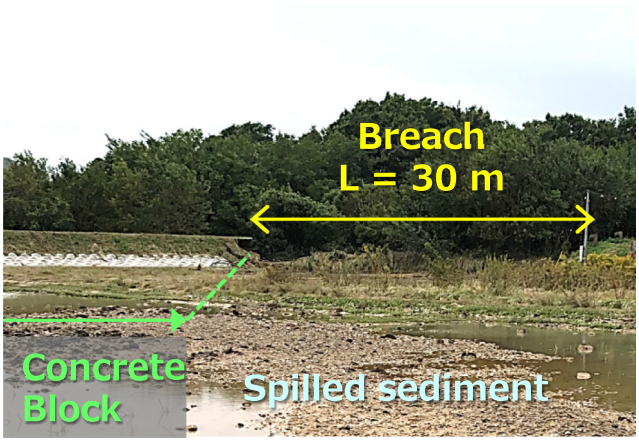
Fig. 10. Breach at 5.6 k on left levee of Tokigawa River.

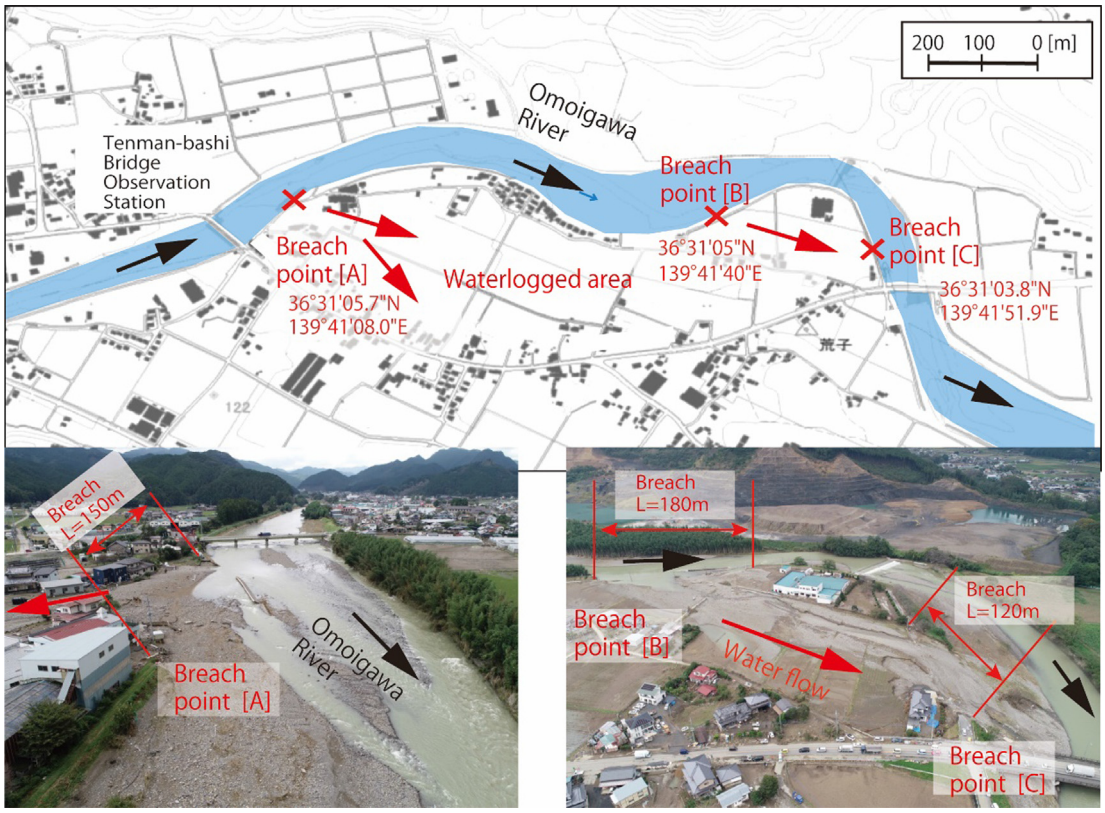
Four levees were breached along the Omoigawa River due to a large amount of water flow (see Fig. 13 for locations). Due to the multiple breaches, about 152 ha of the urban area of the city was flooded and 237 houses were flooded. Fig. 14 shows the situation at the breached points on the Omoigawa River near the Tenman-bashi Bridge in the Kuchiawano and Kuno areas of Kanuma City, and photographs of three out of the four breached levee points on the Omoigawa River. The levee of the Omoigawa River was breached and flooded at a meandering point of the river flow. Most of the levees in the surrounding area are old levees. The water flowed into the urban area from Breach Point A and the residential area was flooded. The inundated water from Breach Point B to the urban area returned to the river from Breach Point C. Fig. 15 shows the time history of the river water levels measured at the Tenman-bashi Bridge Observation Station on the Omoigawa River. Since the observation station was located in the flooded area, the data were lost during the flood.

Fig. 14. Locations of breached points on Omoigawa River (in Tone River system) near Tenman-bashi Bridge in Kuchiawano and Kuno areas, Kanuma City, Tochigi Prefecture (Map and photos provided by Tochigi Prefectural Office with English translation).

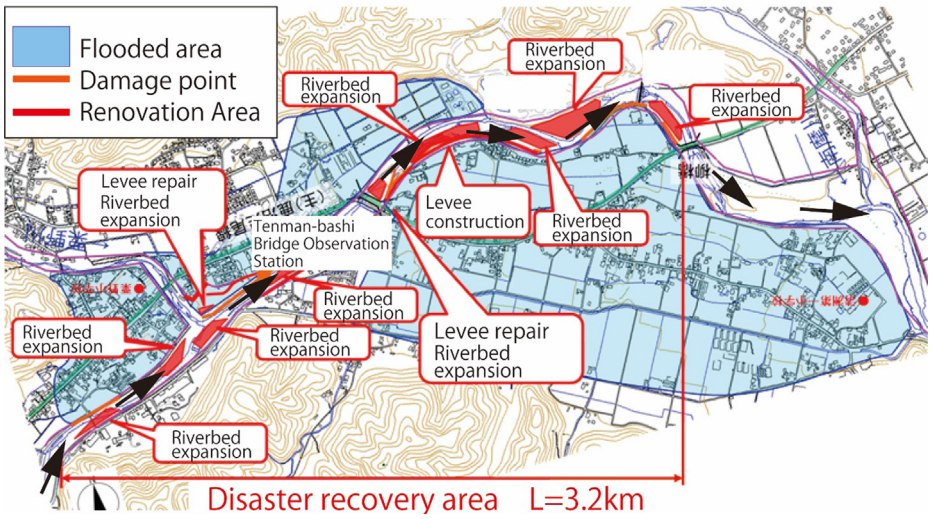
Fig. 16. Overview of plan for restoration and repair services for damaged areas on Omoigawa River (Map provided by Tochigi Prefectural Office with English translation).

Fig. 16 shows the repair works laid out by the Tochigi Prefectural Government for the surrounding areas. There is a plan to widen the beds upstream and downstream of the river, in the vicinity of the flooded area, to secure the flow of water and to repair the levees.

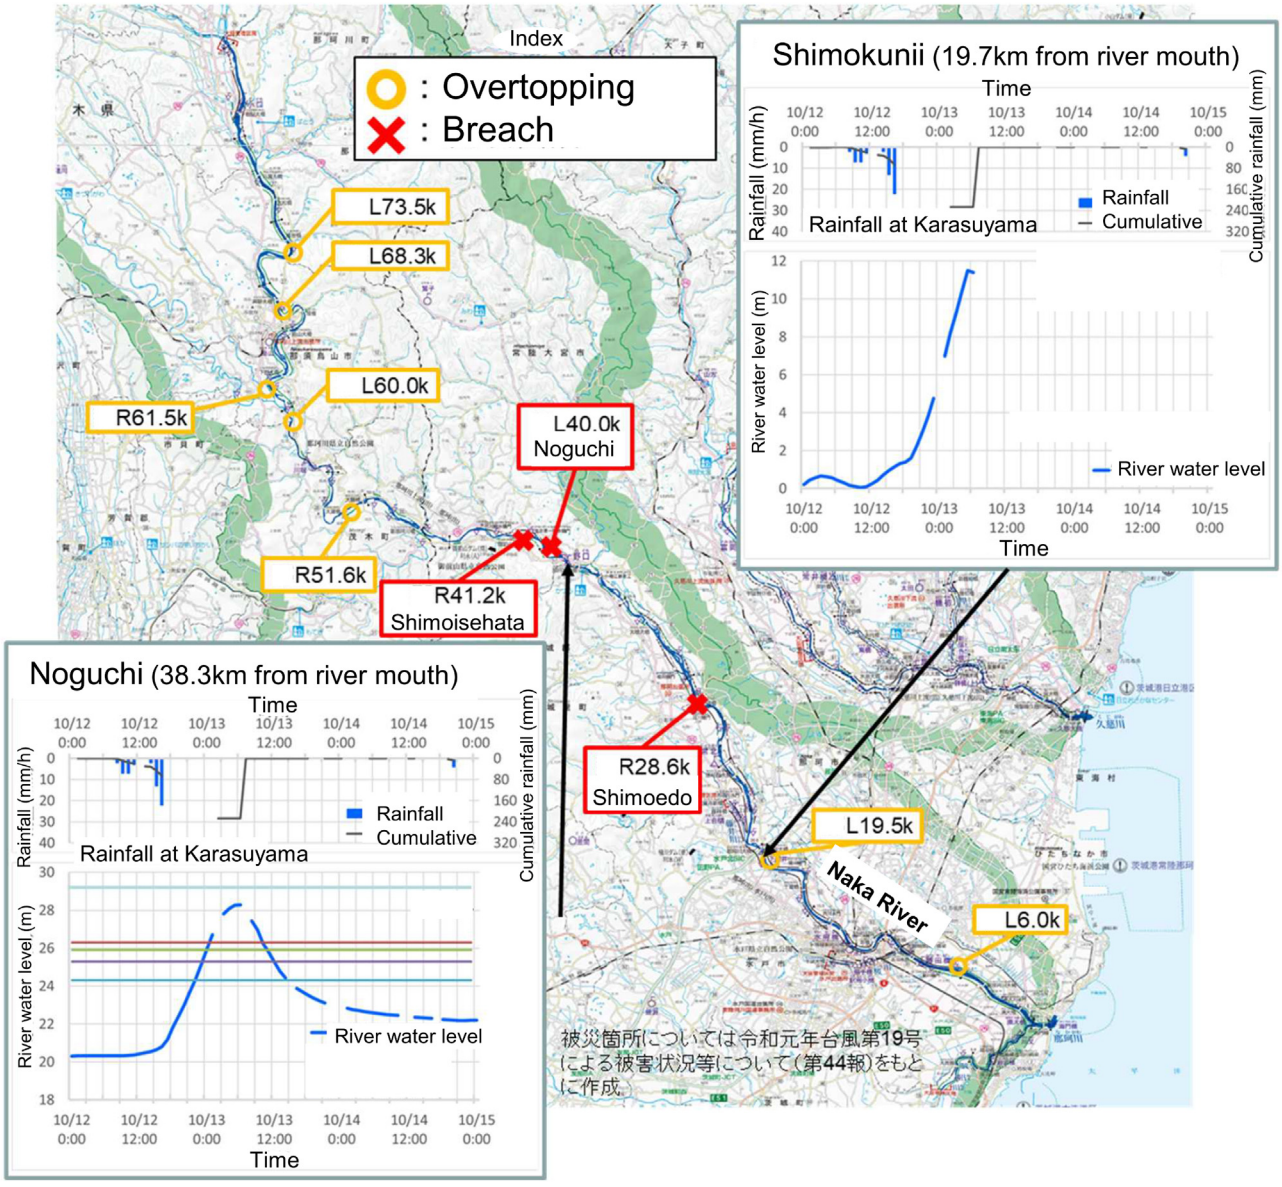
The levee breaches along the Naka River took place at five locations because of the flood caused by the typhoon. The locations of representative levee breaches are presented by red crosses in Fig. 17 and black crosses in Fig. 13. The rainfall observed at the Torinoko Observatory located in Ibaraki Prefecture was 268.0 mm for 48 h; this breaks the previous record of rainfall of 151.4 mm for 48 h due to Typhoon No. 6 (Doksuri) in 2012. Fig. 17 also shows a hydrograph for the Noguchi Observatory near the breaches along the Naka River. The blue line shows the river water level and the blue bar shows the rainfall. It can be seen that the river water level rose sharply with the approach of the typhoon starting on the evening of 12th October 2019. The peak of the river water occurred early in the morning on 13th October 2019, which indicates that the duration of the flood was relatively short, although the typhoon brought intense rainfall.

Fig. 17. Locations of some breaches in Naka River system and hydrographs (Investigation Committee for the Levee Breach by the 2019 Typhoon Hagibis in the Kanto Region (2020) with English translation).

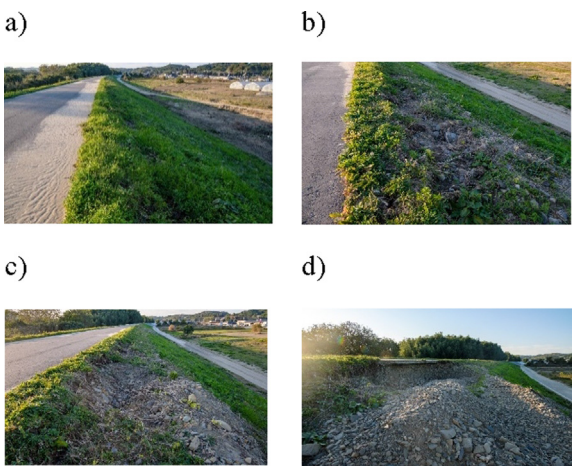
- Step 1: The beginning of vegetation erosion due to overtopping was seen at the shoulder of the levee (Fig. 19a)).
- Step 2: Small grain size soil began to flow out due to the overtopped water (Fig. 19b)).
- Step 3: Then, larger grain size soil was washed away (Fig. 19c)).
- Step 4: The failure of the levee by erosion took place at its shoulder (Fig. 19d)).

Fig. 19. Process of erosion of land-side slope by overtopping: (a) Step 1, (b) Step 2, (c) Step 3, and (d) Step 4.

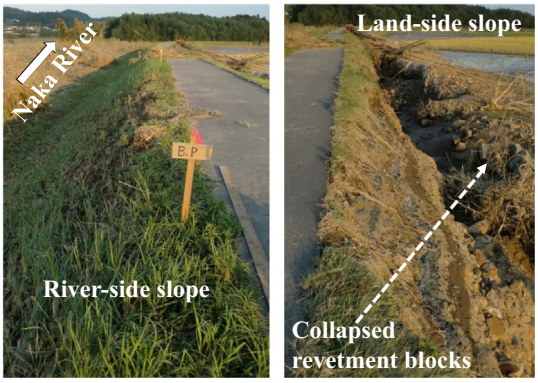
At Shimoisehata in Hitachi-ohmiya City, Ibaraki Prefecture, the failure of the right levee at 41.2 k occurred. The scene of the temporary restoration works is shown in Fig. 20. The collapsed section was about 250 m in length, 4.9 m in slope length, and 3.7 m in crest width. Fig. 21 shows the river-side and land-side slopes adjacent to the collapsed section. The river-side slope had no damage, while marked traces of erosion were found on the land-side slope despite the fact that it has been protected by revetment blocks before the typhoon. According to the construction blueprint by the MLIT, the whole area around the breached section had crest pavements and revetment blocks for the river-side slope, while the land-side slope may have been covered with revetment blocks,

Fig. 21. River-side and land-side slopes adjacent to collapsed section at 41.2 k of Naka River.

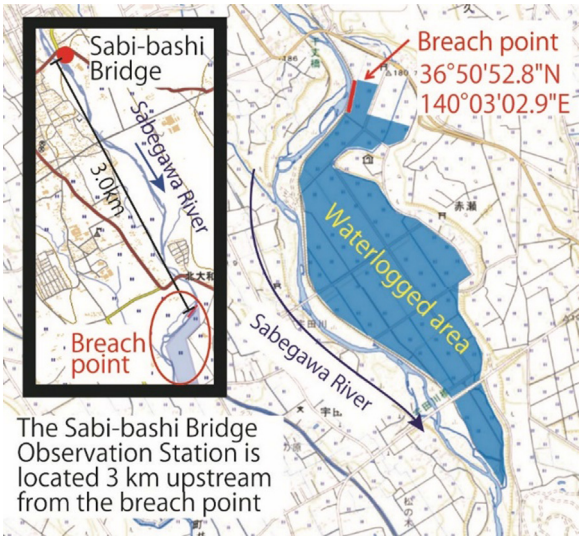
Fig. 23 shows the time history of the river water levels measured at the Sabi-bashi Bridge Observation Station on the Sabigawa River. The observation station is located in the suburbs of the flooded point. Fig. 24 shows the location of the breached point and waterlogged area along the Sabigawa River. The river bends steeply to the right toward the downstream side at the breached point. The levee in that area, including the broken section, is old and was made of dredged sediment from the river. The embankment material is sandy soil, containing a large amount of cobbles the size of a fist. Fig. 25 shows the damaged levee at the breached point. Along with sandy soil, the embankment also contains many boulders. The cross-section of the damaged levee shows that the embankment was made of sandy soil and there was no core made of low-permeability material. Based on the conditions of the breached levee, soil of the embankment, surrounding topography, and river, the flood-induced wetting of the levee presumably made the levee unstable and resulted in its collapse due to external forces, such as increased water pressure. Most of the levees in the surrounding area are also old. As the material of the levees in this area comprise sandy soil with cobbles/boulders, they are prone to collapse depending on the topography and rainfall conditions. The emergency response to this breach was completed in about 10 days and consisted of constructing a temporary water barrier using large sandbags. Repairs to the levee, including the damaged sections, are planned for the future.

Fig. 24. Location of breached point and waterlogged area in Sabigawa River (Map provided by Tochigi Prefectural Office with English translation).

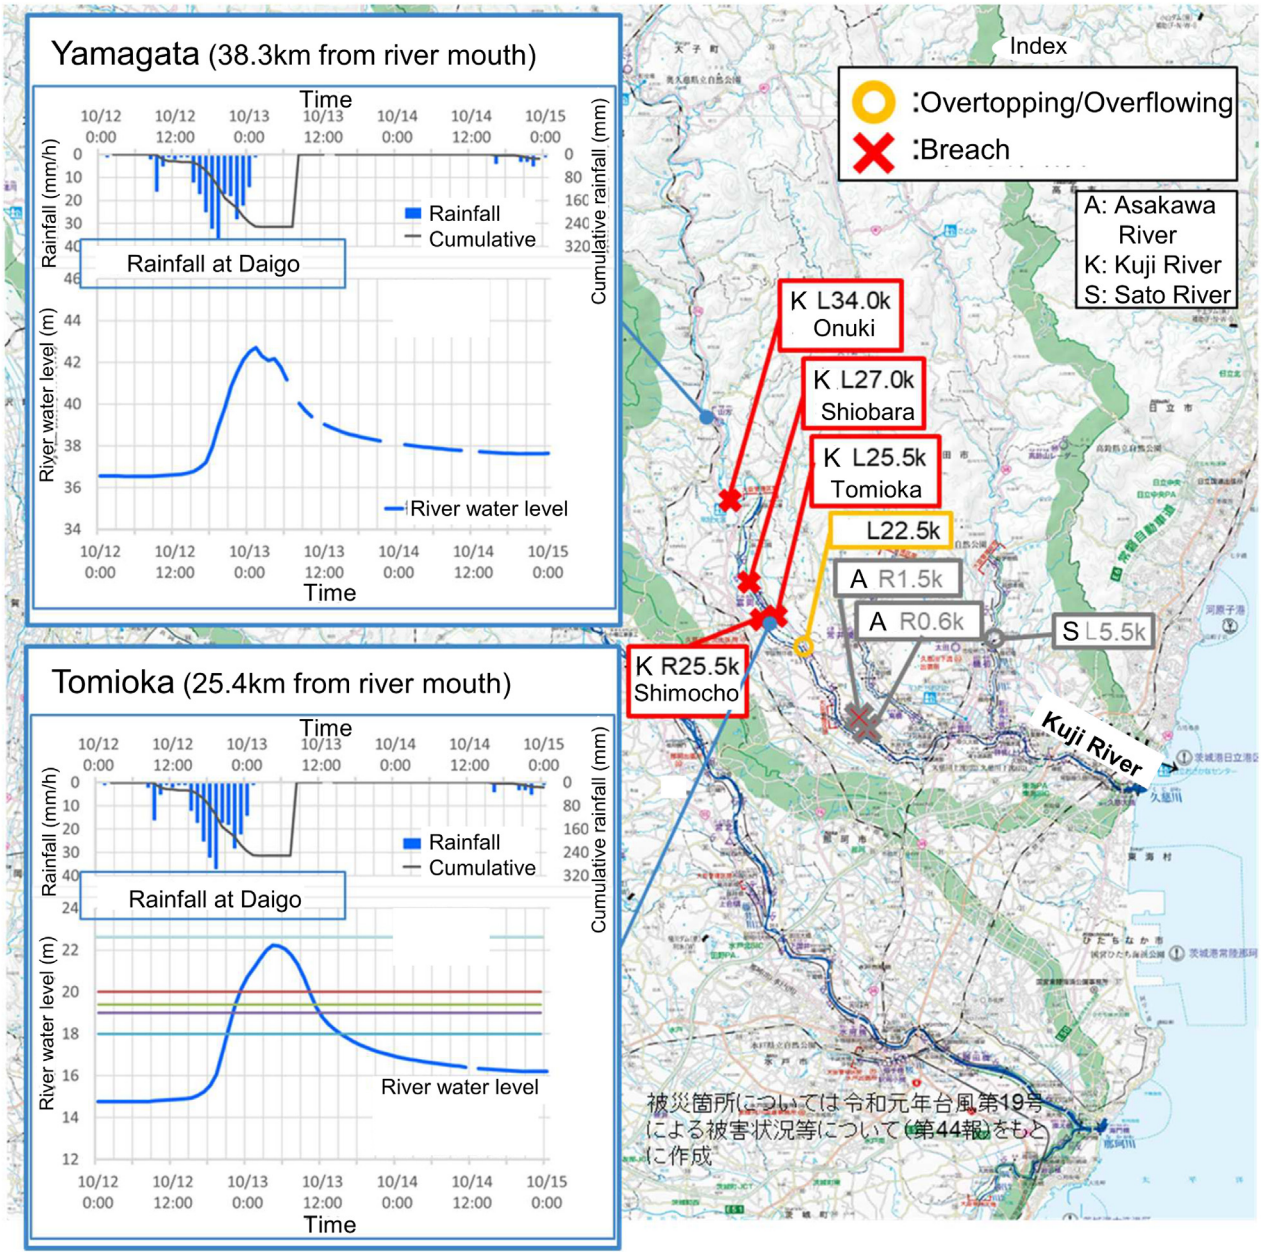
taries, such as the Sato River and the Asakawa River. The representative breached locations are indicated by the red and grey crosses in Fig. 26. The rainfall observed at Kegano Observatory, located at the upstream side of the breaches, was 207 mm for 48 h. This amount of rainfall is record-breaking as compared with the previous record of 185 mm for 48 h due to Typhoon No. 10 in 1986. Fig. 26 also shows the hydrograph for the Tomioka Observatory near the breaches in the Kuji River system. The blue line shows the river water level and the blue bar shows the rainfall. The river water level rose sharply with the approach of the typhoon starting on the evening of 12th October 2019. The peak of the river water occurred early in the morning of 13th October 2019, which indicates that the flood trend was similar to that of the Naka River system.

Fig. 26. Locations of representative breaches in Kuji River system and hydrographs (Investigation Committee for the Levee Breach by the 2019 Typhoon Hagibis in the Kanto Region (2020) with English translation).

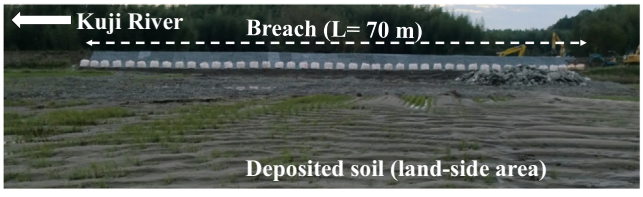
At Onuki in Hitachi-ohmiya City, Ibaraki Prefecture, the failure of the left levee at 34.0 k occurred at a length of about 60 m. The slope length of the collapsed section was about 5 m. As shown in Fig. 27, large sandbags were placed on the levee toe in the temporary restoration works. Considering the facts that (1) no traces of sand boils or piping were found in the field investigations conducted about two weeks after the event and (2) soils were deposited behind the collapsed section, as shown in Fig. 27, the

breach might have been caused by the erosion of the land-side slope due to overtopping. As seen in Fig. 28, both side surfaces of the undamaged levee that was adjacent to the breached section has been covered with crest pavements and revetment blocks. According to the aerial photograph, most of the breached section had also been covered with the pavements and blocks prior to the typhoon. As mentioned earlier (i.e., the right levee of 41.2 k on the Naka River), the effects of the crest pavements and revetment blocks for both side slopes on reducing overtopping-induced damage are still unclear.

Fig. 27. Temporary restoration works of left levee at 34.0 k of Kuji River and deposited soils in land-side area.

Fig. 28. Crest pavements and revetment blocks for river-side and land-side slopes constructed before failure at 34.0 k of the Kuji River.

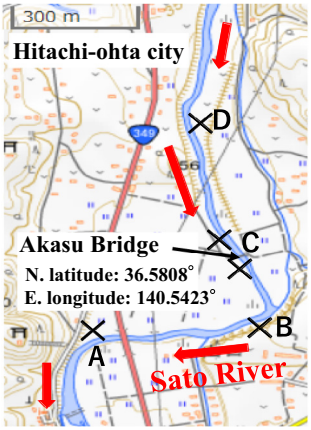
(1) The overtopping occurred possibly due to the sharp curve of the river channel (Fig. 29).
(2) The river water flowed back to the river channel after overtopping.
(3) The backwater, whose water level on the protected side was higher than that in the river channel, caused the erosion of the river-side slope. The cross-section of the levee was gradually reduced, and finally, the breach occurred.

Fig. 29. Locations of levee breaches at Sato River. The standard map was obtained from the base map information of the Geospatial Information Authority of Japan. (https://cyberjapandata.gsi.go.jp/xyz/std/15/29176/12801.png, https://cyberjapandata.gsi.go.jp/xyz/std/15/29176/12802.png).

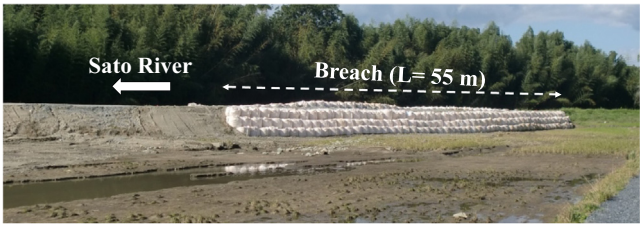
On the upstream side, about 400 m from Point C (i.e., at Point D in Fig. 29), the failure of the left levee occurred at a length of about 55 m (Fig. 32). The slope length and crest width of the collapsed section were about 4.5 and 3 m, respectively. Large sandbags were used to temporarily fill in the breached section as part of the restoration works.

Fig. 32. Temporary restoration works of left levee of Sato River at Point D in Fig. 29.

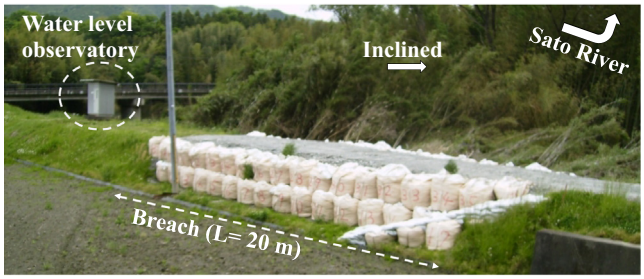
At the downstream side, about 500 m from Point B (i.e., at Point A in Fig. 29), the failure of the right levee, about 20 m in length, 4 m in slope length, and 3.5 m in crest width, occurred as shown in Fig. 34. The foundation of the water level observatory, constructed on the river-side shoulder and located on the downstream side about 16 m from the breached area, shown in Fig. 34, was severely damaged by scour. On the downstream side of the observatory, traces of the erosion of the river-side shoulder were found at a length of 22 m, as shown in Fig. 35. Moreover, as seen in Figs. 34 and 35, bamboo bushes on the river-side shoulder were inclined toward the river-side. When considering these factors, the possible process of the breach could be explained as follows.

Fig. 34. Temporary restoration works of right levee of Sato River at Point A in Fig. 29.

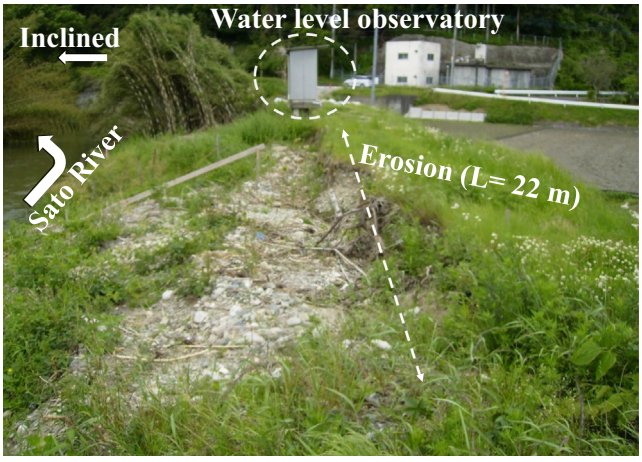
Fig. 35. Traces of erosion of river-side shoulder observed at downstream side from Point A in Fig. 29.

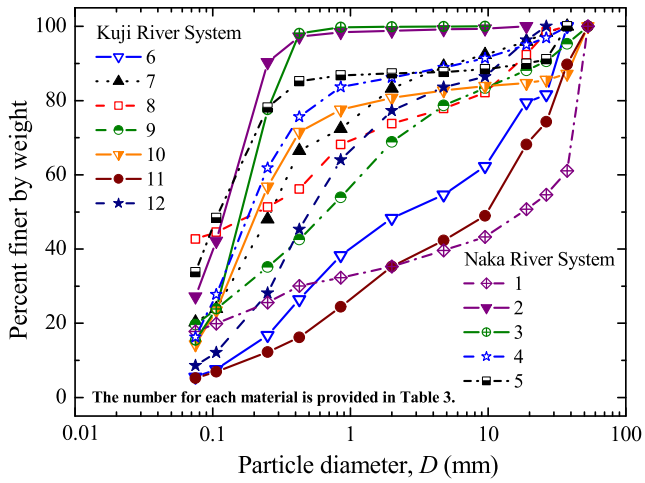
At the time of the above-mentioned survey, fill materials were retrieved for the laboratory tests from the land-side slope surfaces of each undamaged levee section adjacent to the damaged area at a depth shallower than about 0.1 m. At some sites, the fill materials were retrieved from the inside of levees and the river-side slope surfaces.

Fig. 36. Grading curves of fill materials retrieved from breached levees reported in Sections 4 and 5.

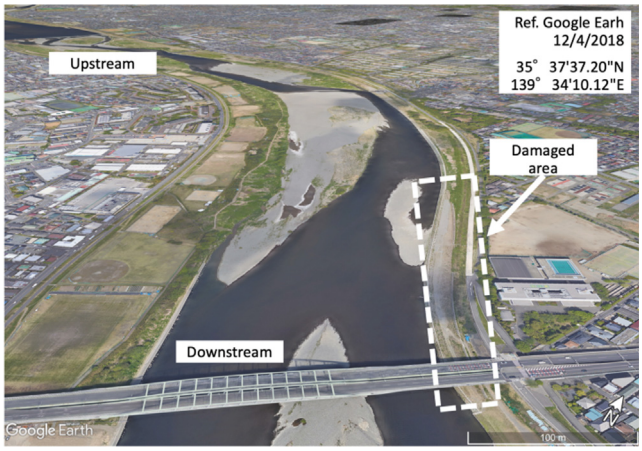
The erosion of the flood channel, i.e., enlarged stream channel occupied during periods of high water, occurred in the Motoizumi area of Komae City, Tokyo (around 35.627736N, 139.568626E). The length of the eroded section was about 340 m (Ministry of Land, Infrastructure, Transport and Tourism, 2020a). Fig. 37 provides a bird's eye view of the levee at 23.4 k on the Tamagawa River before the typhoon. In this section, there is the low-water revetment that consists of concrete blocks and gabions. Fig. 38 shows the state of the flood channel after the typhoon. A 1-m section of the surface of the flood channel, i.e., backfill soil of the low-water revetment, was eroded due to the flooding.

Fig. 37. Bird's eye view of levee at 23.4 k on Tamagawa River before typhoon.

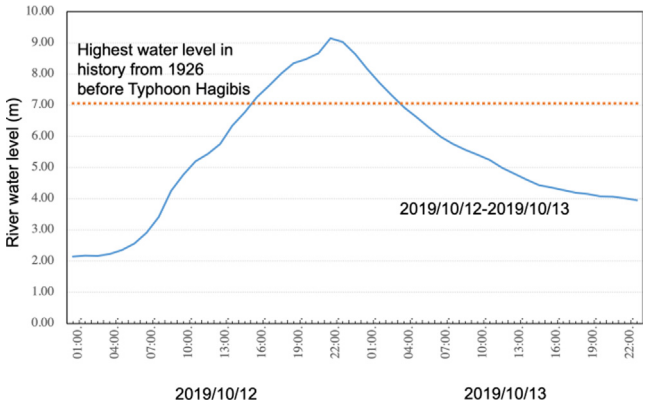
The Tamagawa River was partially flooded at Futako-tamagawa in Setagaya Ward, Tokyo. Overflow in the no-levee section (35.611955N, 139.625151E) occurred at the upstream of the Futako Bridge near Futako-tamagawa Station. The river water level exceeded the highest water level recorded in the past and the elevation at the no-levee section during the typhoon. Fig. 39 shows the time history of the water level observed at the Tamagawa Water Level Observation Station (Ministry of Land, Infrastructure, Transport and Tourism, 2020b). Tempo-

Fig. 39. Time history of river water level observed at Tamagawa Observation Station during typhoon. Data was obtained from the database maintained by the Ministry of Land, Infrastructure, Transport and Tourism, Japan (http://www1.river.go.jp/).

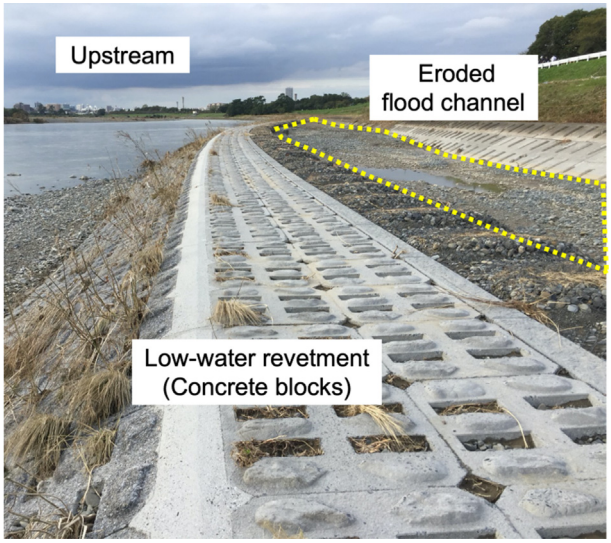
Fig. 38. Levee damage on left levee at 23.4 k on Tamagawa River.

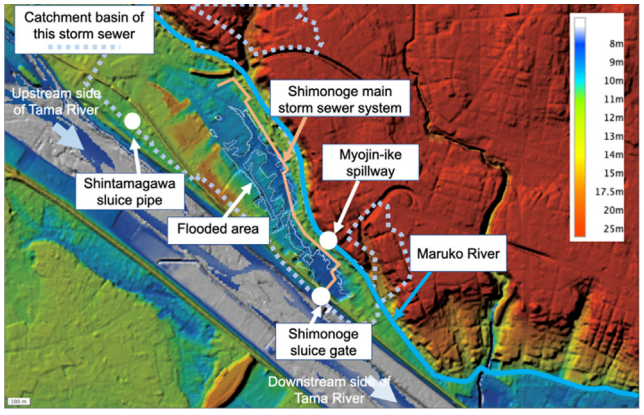
the Tamagawa River. In the Noge area of Setagaya Ward, Tokyo, 151 buildings, including a hospital, were damaged by inland flooding (Setagaya Ward, 2020). Noge is located between the Tamagawa River and the Maruko River, as shown in Fig. 40. In this area, the Shimonoge main storm sewer system was developed for topographical reasons. The dashed line in Fig. 40 indicates the area covered by this storm sewer system. At ordinary times, rainwater is drained via the Shimonoge sluice gate to the Tamagawa River through the storm sewer system. The Noge area also has two additional rainwater drainage facilities, Shintamagawa sluice pipe connected to the Tamagawa River and Myojin-ike spillway connected to the Maruko River.

Fig. 40. Elevation map of Noge area and area flooded by typhoon with information by Setagaya Ward (2020). The colour elevation map was obtained from the base map information of the Geospatial Information Authority of Japan (https://cyberjapandata.gsi.go.jp/xyz/relief/13/7273/3227.png, https://cyberjapandata.gsi.go.jp/xyz/relief/13/7273/3228.png).

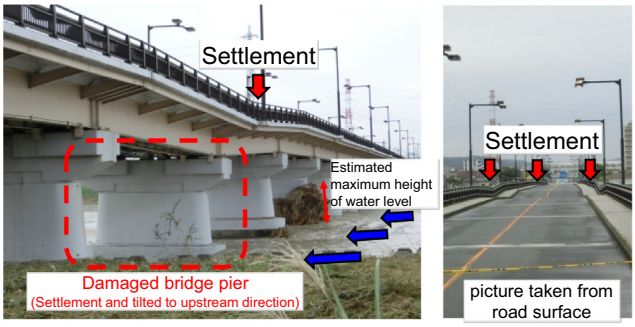
Fig. 41 shows the damaged Hino Bridge (see Fig. 2 for the location). The Hino Bridge was constructed in 1926 as a bridge that crosses the Tamagawa River. The foundation type was an open caisson made of reinforced concrete with a width of about 3.3 m and a depth of about 5.4 m. This bridge used to be along an important road that was employed as National Route 20 until March 2007. As shown in Fig. 41, the pier settled and tilted in the upstream

Fig. 41. Damaged river bridge pier caused by scour.

direction due to scour, and it took about seven months to repair it. To carry out the restoration work of the damaged pier, it was necessary to secure a construction approach road and construction yard around the damaged pier, so

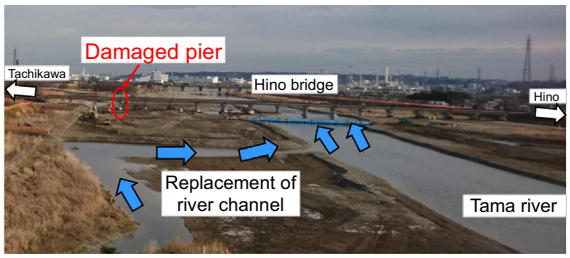
Fig. 42. River channel replacement for restoration work of Hino Bridge.

that a large-scale river channel replacement could be carried out (Fig. 42). It can be learned from this case that, once a scouring disaster occurs, the recovery work often takes a long time. Thus, it is important to take measures to prevent such disasters, as much as possible, by establishing a practical method for distinguishing the piers at high risk for scouring. As a characteristic of the recent scour damage to river bridges, bridge piers located in high water beds, which are supposed to have a low risk of scouring damage, are often damaged. The aforementioned Hino Bridge followed this exact disaster pattern, and details on it are provided in the next subsection.

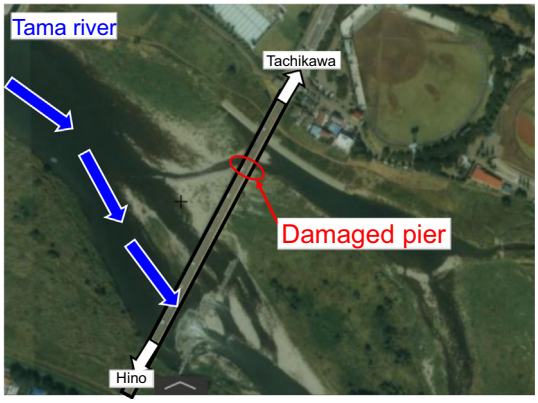
In the 1990s, the river flow of the Tamagawa River was on the opposite side (right side) of the damaged pier (Fig. 43), and countermeasures, such as riverbed protection works, were mainly taken on the right side, which was considered to be at high risk for scouring. However, around 2010, water began to flow on the left side of the river where the damaged pier exists. This was probably due to the slow movement of a sandbar. Maintenance (general inspections) of river bridge structures is conducted in accordance with the standards or technical guidelines, and measures and reinforcement are carried out as necessary. However, it is difficult for field engineers to predict the increase in scour risk due to changes in the river flow conditions, as seen in the case of the Hino Bridge.

Fig. 43. River flow of Tamagawa River around 1990. The picture was obtained from the map information of the Geospatial Information Library, Geospatial Information Authority of Japan (http://geolib.gsi.go.jp//)
