## Delayed Shear Crack Formation of Shallow RC Box Culverts in Service

N. Chijiwa<sup>1</sup>, X. Zhu<sup>2</sup>, H. Ohno<sup>3</sup>, S. Tanabe<sup>4</sup>, K. Nakarai<sup>5</sup> and K. Maekawa<sup>6</sup>

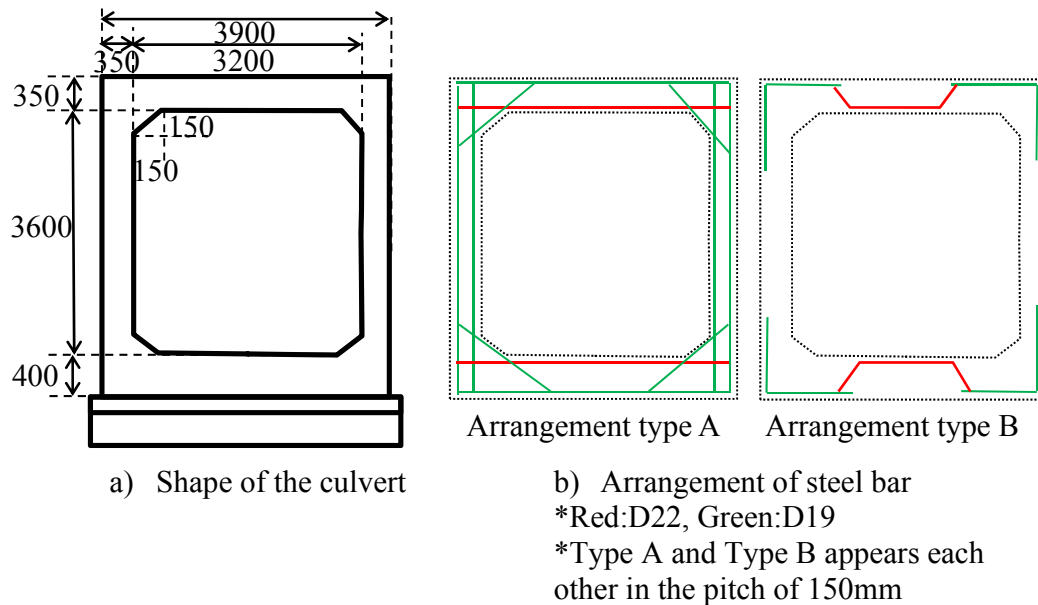
The dimensioning and detailing of the tunnel section suffering from excessive deflection are shown in Figure 2. This culvert was constructed in 1982. The thickness of the top slab is 35cm and the height of the fill above the culvert is relatively low, ranging from 5.04m to 6.98m. The dry sand is used as for backfilling material. This culvert has been used for urban utility and cabling, and it is in service as well. In order to keep the stable local ambient conditions, air ventilation is conducted with blower fan machines, and the temperature is kept about  $25 \pm 2$  degree Celsius. Then, the internal surfaces of the culvert have been exposed to continuous drying ( $RH=30 \pm 10\%$ ). The outer surface exposed to soil foundation was kept almost wet during its whole life and the ground water level is about at half of the side walls. It is

Figure 2 Design detail of the culvert
