Title	Delayed Shear Crack Formation of Shallow RC Box Culverts in Service
Author	N. Chijiwa, X. Zhu, H. Ohno, S. Tanabe, K. Nakarai, K. Maekawa
Journal/Book name	Mechanics and Physics of Creep, Shrinkage and Durability of Concrete and Concrete Structures (CONCREEP-10), , , pp. 1579-1586
Issue date	2015, 9
URL	<a href="http://dx.doi.org/10.1061/9780784479346.184">http://dx.doi.org/10.1061/9780784479346.184</a>
Note	このファイルは著者（最終）版です。 This file is author (final) version

## **Delayed Shear Crack Formation of Shallow RC Box Culverts in Service**

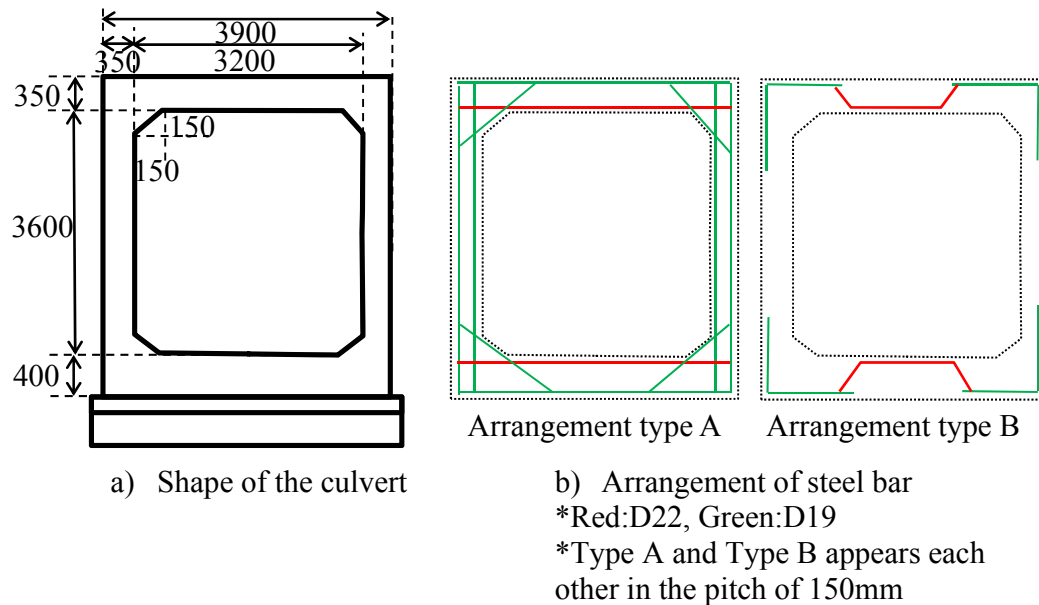
Figure 2 Design detail of the culvert

The dimensioning and detailing of the tunnel section suffering from excessive deflection are shown in Figure 2. This culvert was constructed in 1982. The thickness of the top slab is 35cm and the height of the fill above the culvert is relatively low, ranging from 5.04m to 6.98m. The dry sand is used as for backfilling material. This culvert has been used for urban utility and cabling, and it is in service as well. In order to keep the stable local ambient conditions, air ventilation is conducted with blower fan machines, and the temperature is kept about  $25 \pm 2$  degree Celsius. Then, the internal surfaces of the culvert have been exposed to continuous drying ( $RH=30 \pm 10\%$ ). The outer surface exposed to soil foundation was kept almost wet during its whole life and the ground water level is about at half of the side walls. It is

observed by the periodical monitoring that the number of cracks in the culvert has been increasing and the crack width has also become wider with time. Some cracks have reached reinforcing bars, but the steel corrosion is not observed at this moment because of less supply of moisture due to dry states. As a matter of fact, water leakage was found at several locations inside the culvert, but they are not from the top slab but the side walls and construction joints.
