Title	Levee Damage and Bridge Scour by 2019 Typhoon Hagibis in Kanto Region, Japan
Authors	Tadao Enomoto, Kazuki Horikoshi, Keisuke Ishikawa, Hirotoshi Mori, Akihiro Takahashi, Toshiyasu Unno, Kenji Watanabe
Citation	Soils and Foundations, Vol. 61, Issue 2, pp. 566-585
Pub. date	2021, 4

Geo-Disaster Report

Levee damage and bridge scour by 2019 typhoon Hagibis in Kanto Region, Japan

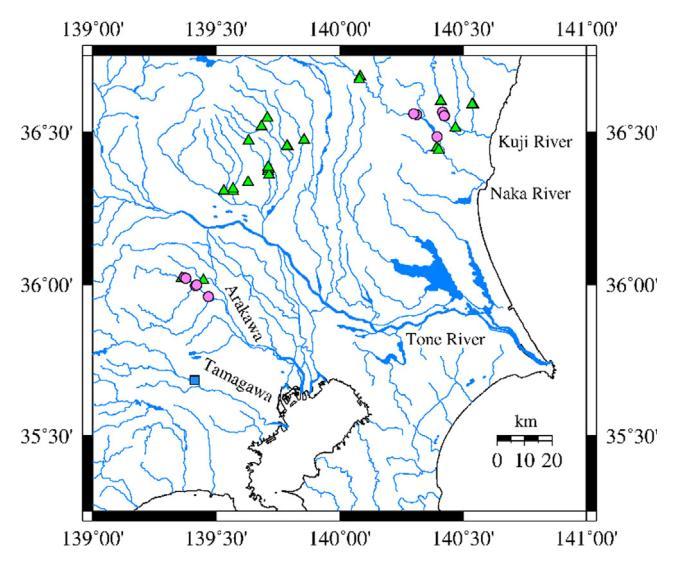
Fig. 2. Locations of levee breaches and bridge scour in Kanto region. The circles indicate the levees managed by the national government, while the triangles indicate those managed by local governments. The square indicates the Hino Bridge at which the scour was found.

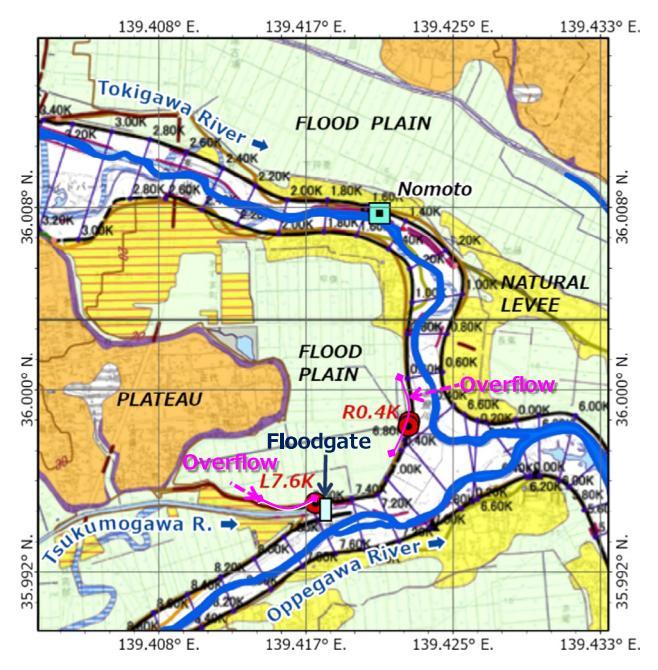
The breaches at 7.6 k on the left levee of the Oppegawa River and at 0.4 k on the right levee of the Tokigawa River are located near the inflow of the Tokigawa River into the Oppegawa River, as shown in Fig. 5. The breached point at L7.6 k is at the corner directly upstream of the floodgate of the Tsukumogawa River, which joins the Oppegawa River, and it extends for around 40 m to the left levee of the Tsukumogawa River. The breached point at R0.4 k is located on the outer levee of a gentle bend in the Tokigawa

Fig. 5. Landform classification map for flood control in vicinity of breaches. The landform classification map was obtained from the base map information of the Geospatial Information Authority of Japan (https://cyberjapandata.gsi.go.jp/xyz/lcmfc2/12/3634/1608.png).

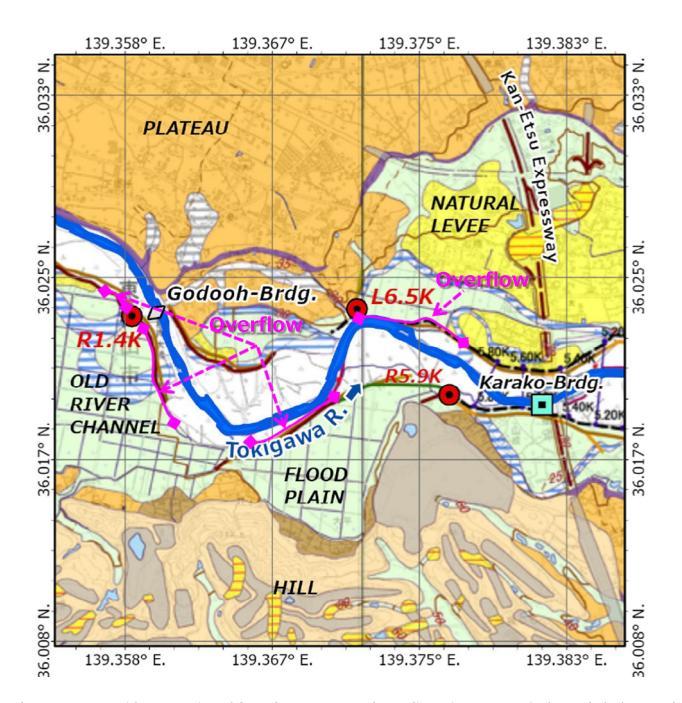
The breached point at 6.5 k on the left levee of the Tokigawa River is located at the water-colliding front of the Tokigawa River and near the confluence of the tributaries of the Tokigawa River, as shown in Fig. 9. Near the breached area, breaches also occurred at R5.9 k on the opposite side of the river and at R1.4 k upstream of the Godooh Bridge, which is managed by Saitama Prefecture. These breached levees were temporary ones. Approximately 140 ha of the plain was inundated owing to overtopping in a series of sections. Fig. 10 shows the levee breach at L6.5 k, where the levee was breached for around 30 m. Fig. 11 shows the situation of the slope on the protected side, which is continuous from the breached point. To

Fig. 9. Landform classification map for flood control in vicinity of breaches. The landform classification map was obtained from the base map information of the Geospatial Information Authority of Japan (https://cyberjapandata.gsi.go.jp/xyz/lcmfc2/13/7267/3216.png).

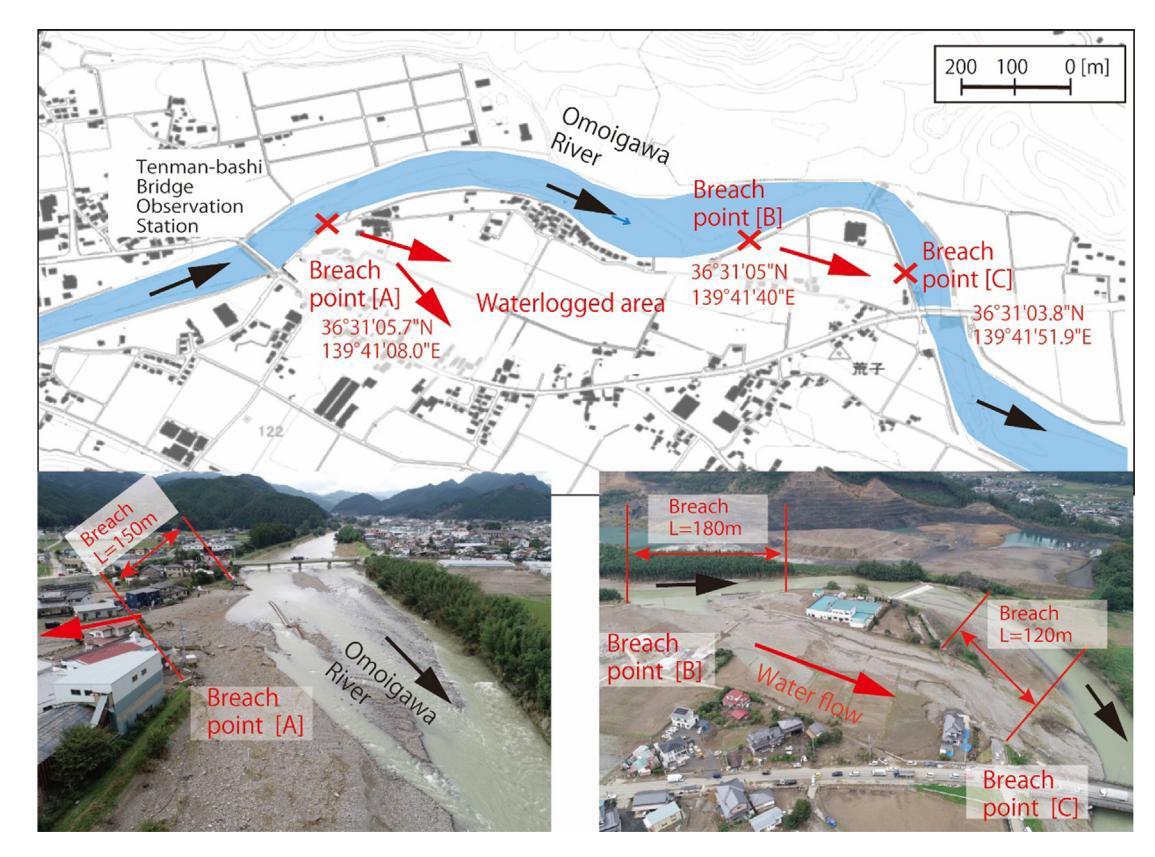
Four levees were breached along the Omoigawa River due to a large amount of water flow (see Fig. 13 for locations). Due to the multiple breaches, about 152 ha of the urban area of the city was flooded and 237 houses were flooded. Fig. 14 shows the situation at the breached points on the Omoigawa River near the Tenman-bashi Bridge in the Kuchiawano and Kuno areas of Kanuma City, and photographs of three out of the four breached levee points on the Omoigawa River. The levee of the Omoigawa River was breached and flooded at a meandering point of the river flow. Most of the levees in the surrounding area are old levees. The water flowed into the urban area from Breach Point A and the residential area was flooded. The inundated water from Breach Point B to the urban area returned to the river from Breach Point C. Fig. 15 shows the time history of the river water levels measured at the Tenman-bashi Bridge Observation Station on the Omoigawa River. Since the observation station was located in the flooded area, the data were lost during the flood.

Fig. 14. Locations of breached points on Omoigawa River (in Tone River system) near Tenman-bashi Bridge in Kuchiawano and Kuno areas, Kanuma City, Tochigi Prefecture (Map and photos provided by Tochigi Prefectural Office with English translation).

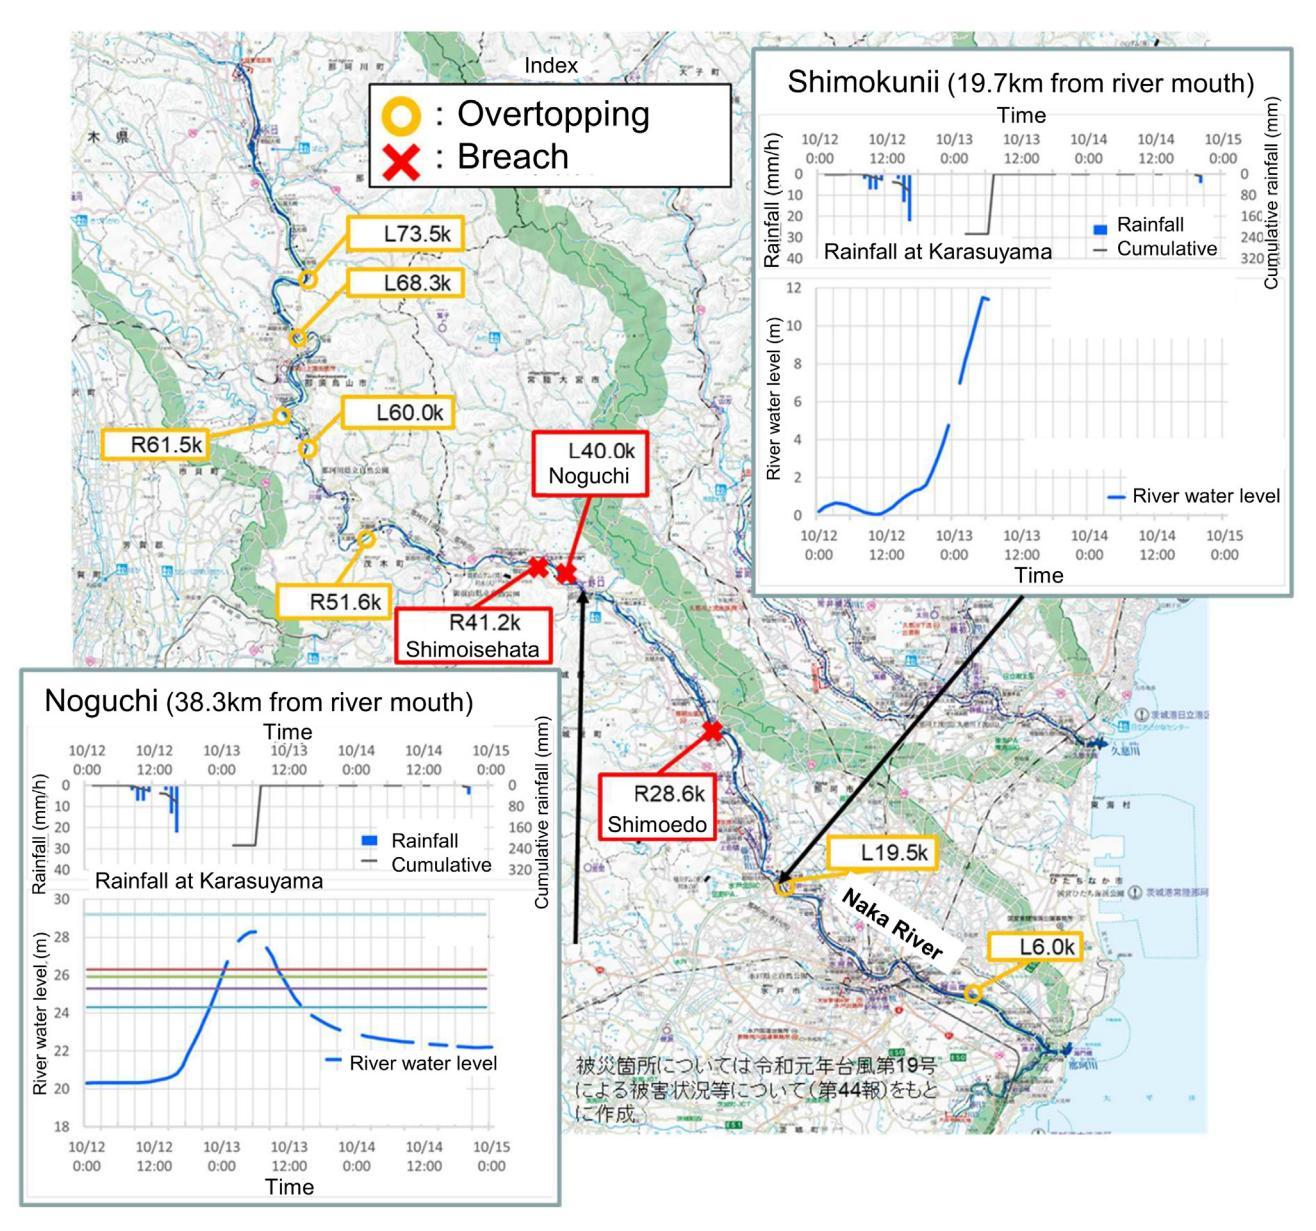
The levee breaches along the Naka River took place at five locations because of the flood caused by the typhoon. The locations of representative levee breaches are presented by red crosses in Fig. 17 and black crosses in Fig. 13. The rainfall observed at the Torinoko Observatory located in Ibaraki Prefecture was 268.0 mm for 48 h; this breaks the previous record of rainfall of 151.4 mm for 48 h due to Typhoon No. 6 (Doksuri) in 2012. Fig. 17 also shows a hydrograph for the Noguchi Observatory near the breaches along the Naka River. The blue line shows the river water level and the blue bar shows the rainfall. It can be seen that the river water level rose sharply with the approach of the typhoon starting on the evening of 12th October 2019. The peak of the river water occurred early in the morning on 13th October 2019, which indicates that the duration of the flood was relatively short, although the typhoon brought intense rainfall.

Fig. 17. Locations of some breaches in Naka River system and hydrographs (Investigation Committee for the Levee Breach by the 2019 Typhoon Hagibis in the Kanto Region (2020) with English translation).

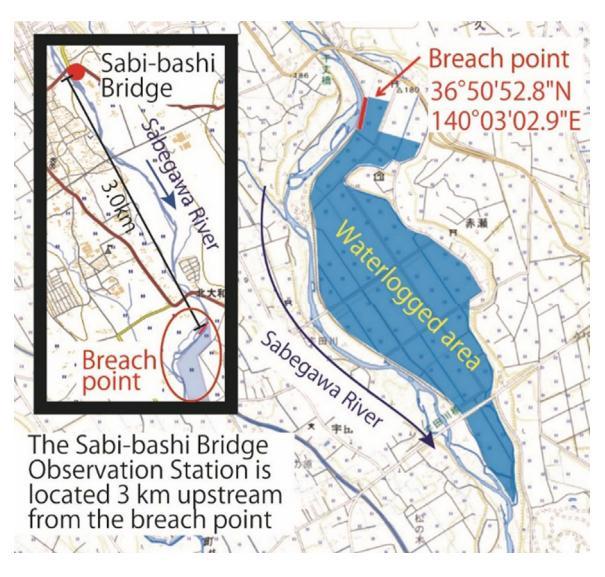
Fig. 23 shows the time history of the river water levels measured at the Sabi-bashi Bridge Observation Station on the Sabigawa River. The observation station is located in the suburbs of the flooded point. Fig. 24 shows the location of the breached point and waterlogged area along the Sabigawa River. The river bends steeply to the right toward the downstream side at the breached point. The levee in that area, including the broken section, is old and was made of dredged sediment from the river. The embank-

Fig. 24. Location of breached point and waterlogged area in Sabigawa River (Map provided by Tochigi Prefectural Office with English translation).

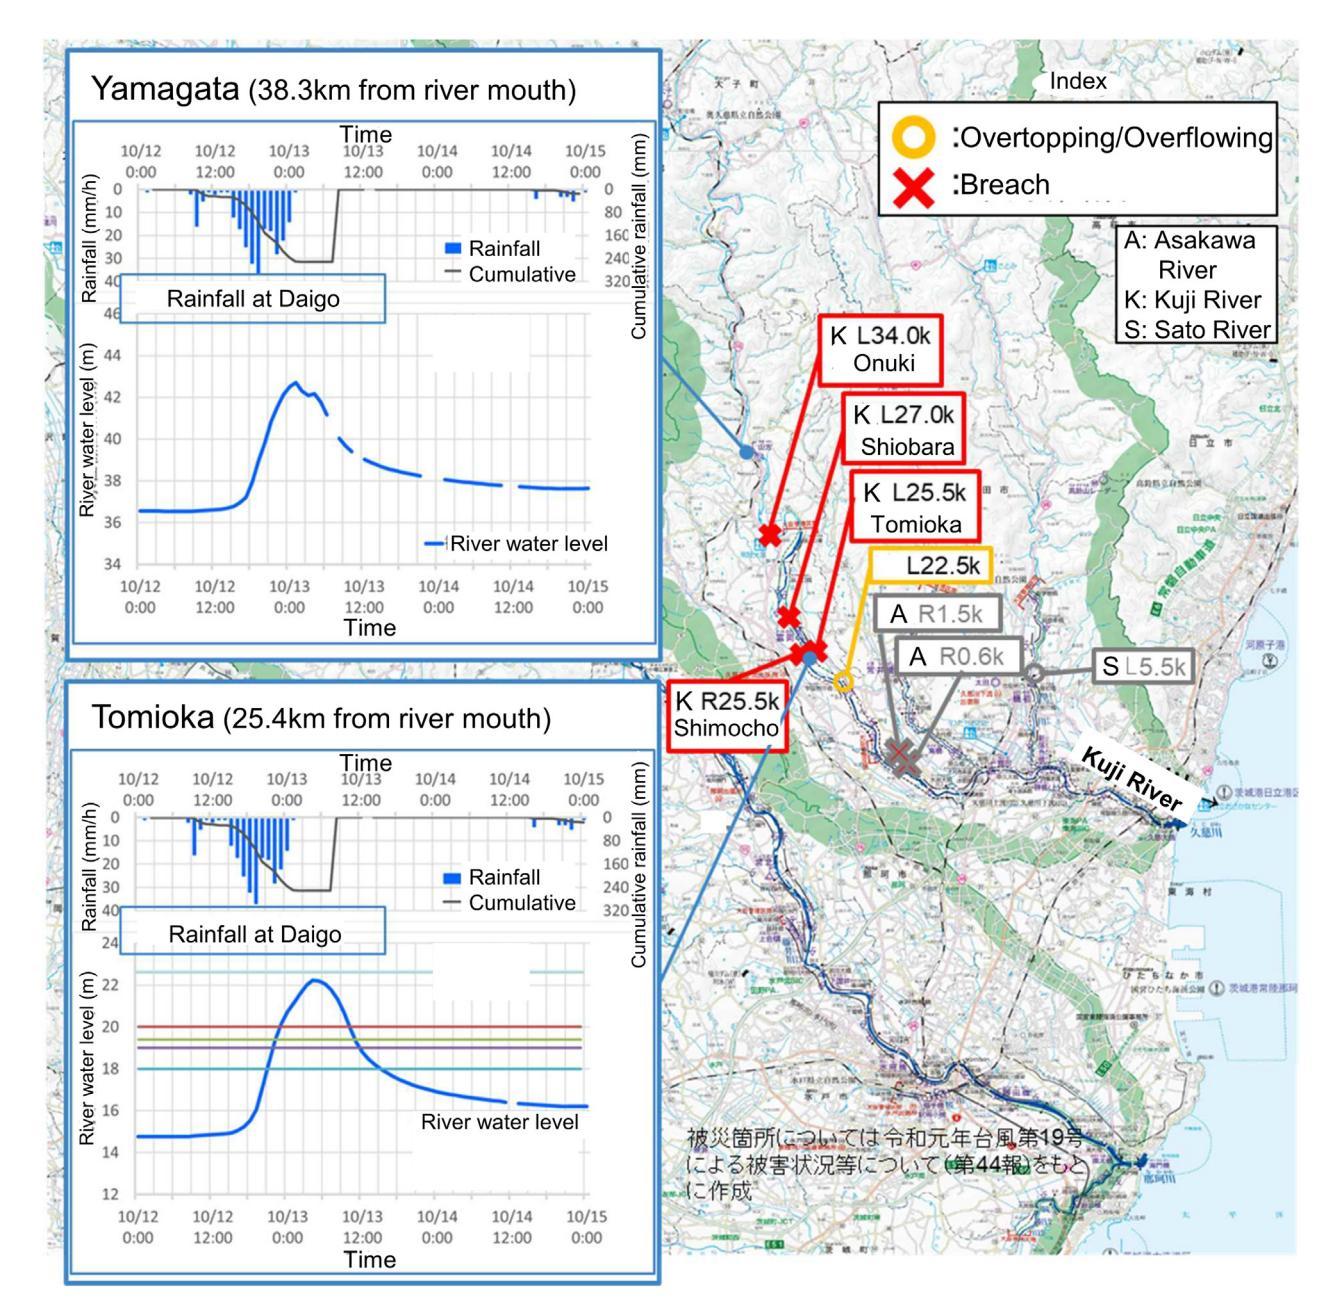
taries, such as the Sato River and the Asakawa River. The representative breached locations are indicated by the red and grey crosses in Fig. 26. The rainfall observed at Kegano Observatory, located at the upstream side of the breaches, was 207 mm for 48 h. This amount of rainfall is record-breaking as compared with the previous record of 185 mm for 48 h due to Typhoon No. 10 in 1986. Fig. 26 also shows the hydrograph for the Tomioka Observatory near the breaches in the Kuji River system. The blue line shows the river water level and the blue bar shows the rainfall. The river water level rose sharply with the approach of the typhoon starting on the evening of 12th October 2019. The peak of the river water occurred early in the morning of 13th October 2019, which indicates that

Fig. 26. Locations of representative breaches in Kuji River system and hydrographs (Investigation Committee for the Levee Breach by the 2019 Typhoon Hagibis in the Kanto Region (2020) with English translation).

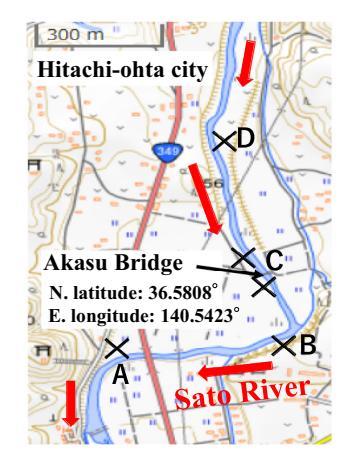
- (1) The overtopping occurred possibly due to the sharp curve of the river channel (Fig. 29).
- (2) The river water flowed back to the river channel after overtopping.
- (3) The backwater, whose water level on the protected side was higher than that in the river channel, caused the erosion of the river-side slope. The cross-section of the levee was gradually reduced, and finally, the breach occurred.

Fig. 29. Locations of levee breaches at Sato River. The standard map was obtained from the base map information of the Geospatial Information Authority of Japan. (https://cyberjapandata.gsi.go.jp/xyz/std/15/29176/12801.png, https://cyberjapandata.gsi.go.jp/xyz/std/15/29176/12802.png).

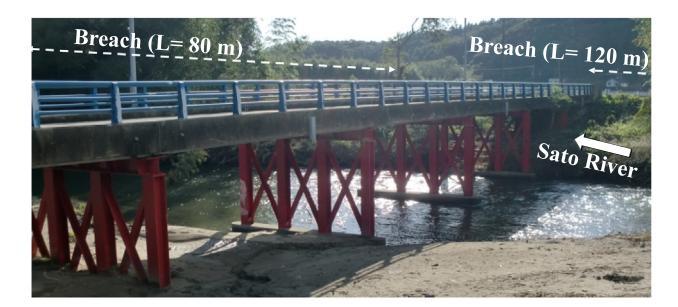
occurred across the Akasu Bridge, as shown in Fig. 30. These two damaged sections were about 80 and 120 m in length, respectively, 2–3 m in slope length, and 4–4.5 m in crest width. As seen in Fig. 31, the Akasu Bridge has six spans in spite of its short length. According to photos taken by a neighbourhood resident, the bridge girder and piers caught driftwood generated by this flood, suggesting that the rise in the river was accelerated locally by the trapped driftwood and might have led to the breach attributed to the erosion of the land-side slope caused by overtopping.

Fig. 31. Akasu Bridge constructed across Sato River.

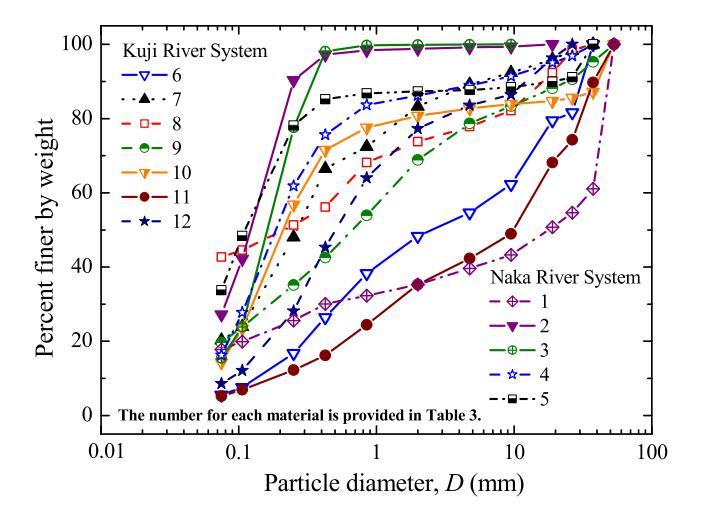
Fig. 36 shows the grain size distribution of the retrieved materials. The values for the maximum and mean particle diameters (D_{max} and D_{50}), fines content (F_c), uniformity coefficient (U_c), and plasticity index (I_p) of those materials are summarised in Table 3. These test results revealed that

Fig. 36. Grading curves of fill materials retrieved from breached levees reported in Sections 4 and 5.

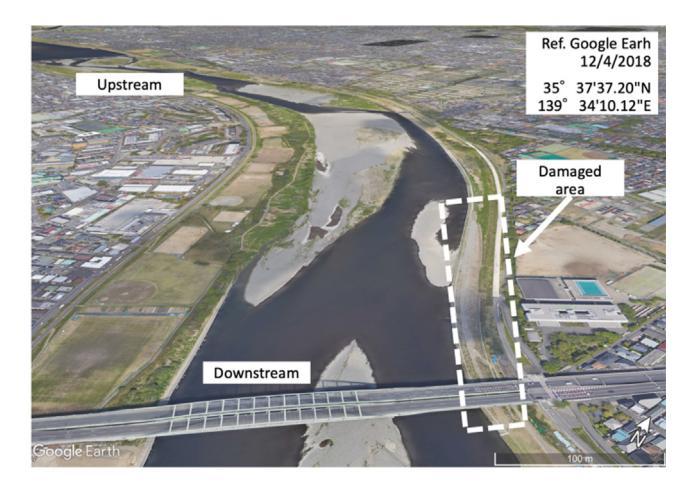
The erosion of the flood channel, i.e., enlarged stream channel occupied during periods of high water, occurred in the Motoizumi area of Komae City, Tokyo (around 35.627736N, 139.568626E). The length of the eroded section was about 340 m (Ministry of Land, Infrastructure, Transport and Tourism, 2020a). Fig. 37 provides a bird's eye view of the levee at 23.4 k on the Tamagawa River before the typhoon. In this section, there is the low-water revetment that consists of concrete blocks and gabions. Fig. 38 shows the state of the flood channel after the typhoon. A 1-m section of the surface of the flood channel, i.e., backfill soil of the low-water revetment, was eroded due to the flooding.

Fig. 37. Bird's eye view of levee at 23.4 k on Tamagawa River before typhoon.

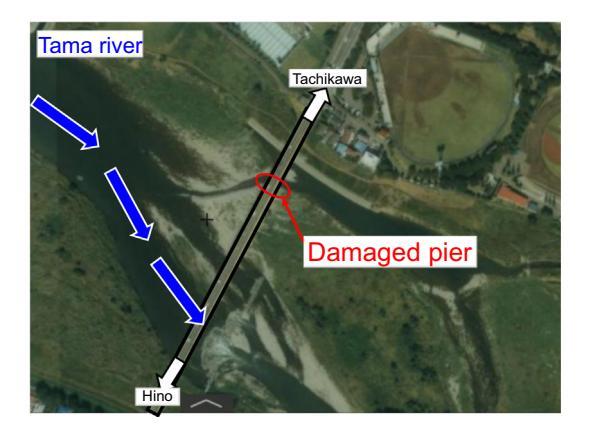
In the 1990s, the river flow of the Tamagawa River was on the opposite side (right side) of the damaged pier (Fig. 43), and countermeasures, such as riverbed protection works, were mainly taken on the right side, which was considered to be at high risk for scouring. However, around 2010, water began to flow on the left side of the river where the damaged pier exists. This was probably due to the slow movement of a sandbar. Maintenance (general inspections) of river bridge structures is conducted in accordance with the standards or technical guidelines, and measures and reinforcement are carried out as necessary. However, it is difficult for field engineers to predict the increase in scour risk due to changes in the river flow conditions, as seen in the case of the Hino Bridge.

Fig. 43. River flow of Tamagawa River around 1990. The picture was obtained from the map information of the Geospatial Information Library, Geospatial Information Authority of Japan (http://geolib.gsi.go.jp//)
