Geo-Disaster Report

Levee damage and bridge scour by 2019 typhoon Hagibis in Kanto Region, Japan

Keywords: Typhoon Hagibis; Levee breach; Overtopping; Inland flooding; Bridge scour

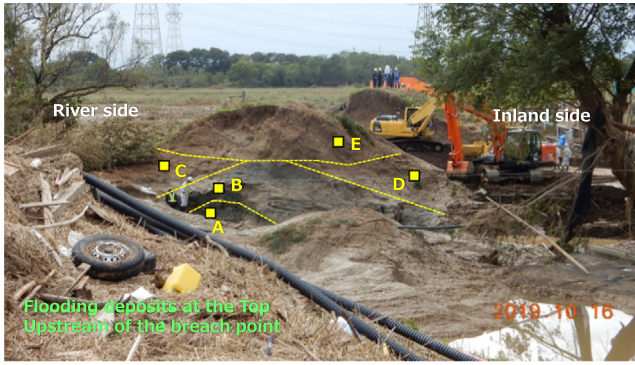
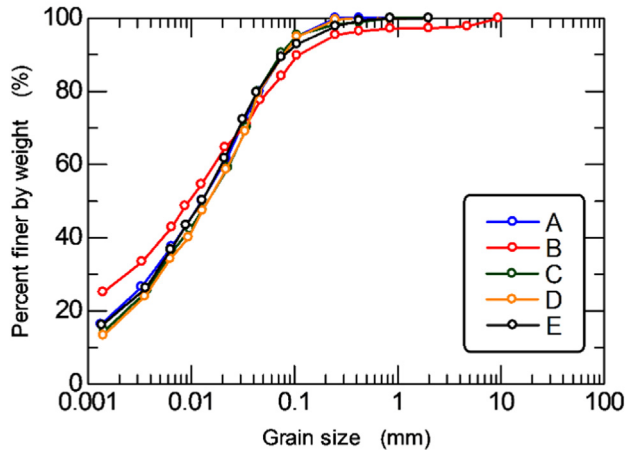
levee being made of a silt-based clay soil and the foundation ground being made of an alluvial soft clay soil. The cause of the failure was considered to be the erosion of the levee due to overtopping.

Fig. 8. Cross-section of breached levee at R0.4 k and grain size distribution curves for soils taken from points shown in picture. The data were obtained from the report by the Investigation Committee for the Levee Breach by the 2019 Typhoon Hagibis in the Kanto Region (2020).

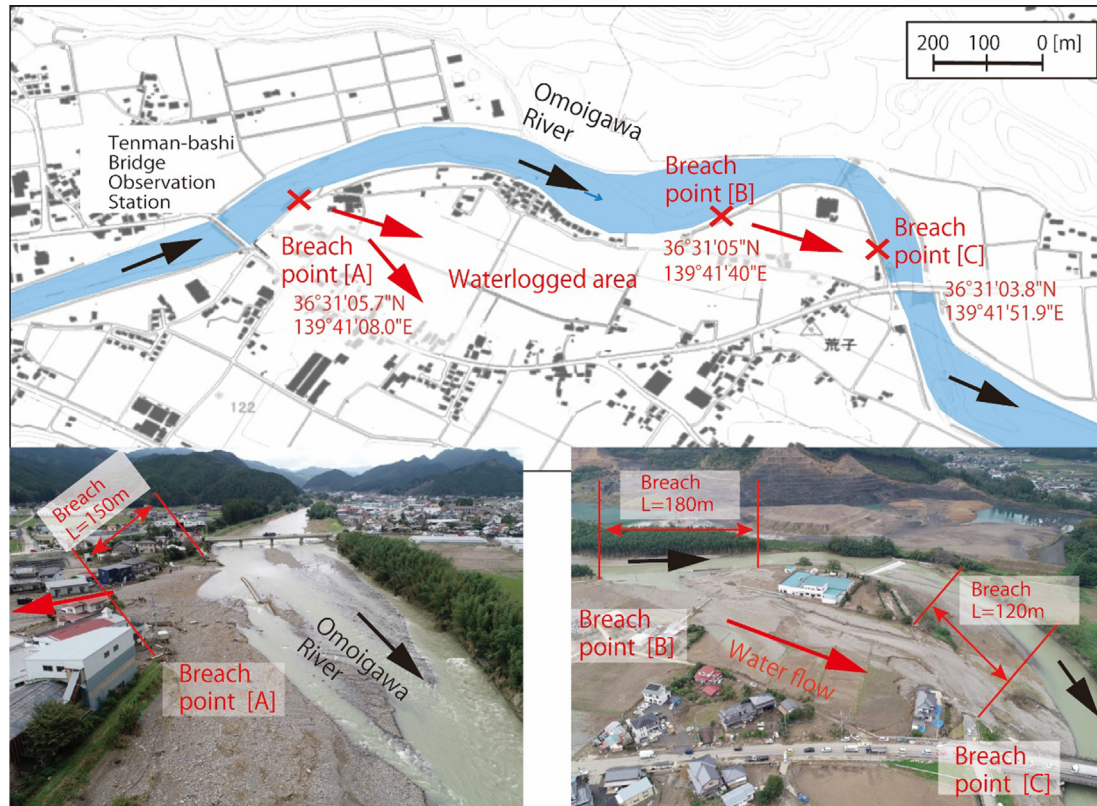
Four levees were breached along the Omoigawa River due to a large amount of water flow (see Fig. 13 for locations). Due to the multiple breaches, about 152 ha of the urban area of the city was flooded and 237 houses were flooded. Fig. 14 shows the situation at the breached points on the Omoigawa River near the Tenman-bashi Bridge in the Kuchiawano and Kuno areas of Kanuma City, and photographs of three out of the four breached levee points on the Omoigawa River. The levee of the Omoigawa River was breached and flooded at a meandering point of the river flow. Most of the levees in the surrounding area are

Fig. 14. Locations of breached points on Omoigawa River (in Tone River system) near Tenman-bashi Bridge in Kuchiawano and Kuno areas, Kanuma City, Tochigi Prefecture (Map and photos provided by Tochigi Prefectural Office with English translation).

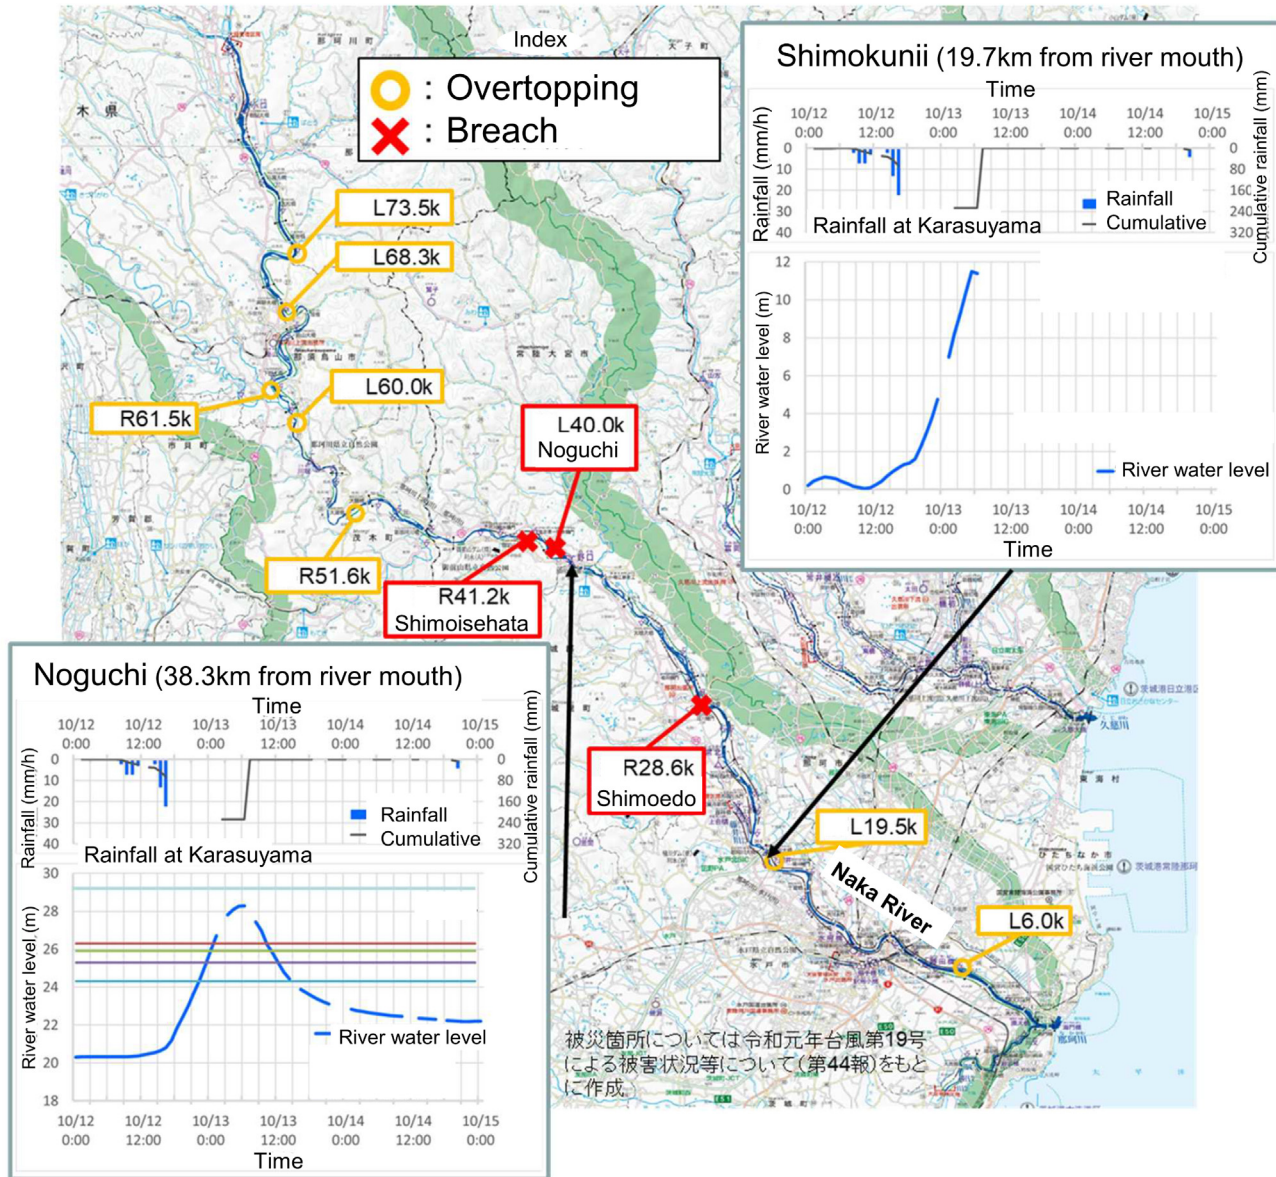
The levee breaches along the Naka River took place at five locations because of the flood caused by the typhoon. The locations of representative levee breaches are presented by red crosses in Fig. 17 and black crosses in Fig. 13. The rainfall observed at the Torinoko Observatory located in Ibaraki Prefecture was 268.0 mm for 48 h; this breaks the previous record of rainfall of 151.4 mm for 48 h due to Typhoon No. 6 (Doksuri) in 2012. Fig. 17 also shows a hydrograph for the Noguchi Observatory near the breaches along the Naka River. The blue line shows the river water level and the blue bar shows the rainfall. It can be seen that the river water level rose sharply with the approach of the typhoon starting on the evening of 12th October 2019. The peak of the river water occurred early in the morning on 13th October 2019, which indicates that the duration of the flood was relatively short, although the typhoon brought intense rainfall.

Fig. 17. Locations of some breaches in Naka River system and hydrographs (Investigation Committee for the Levee Breach by the 2019 Typhoon Hagibis in the Kanto Region (2020) with English translation).

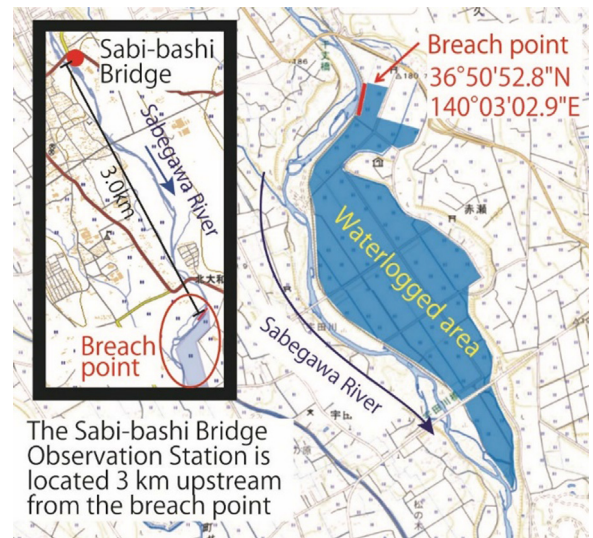
Fig. 23 shows the time history of the river water levels measured at the Sabi-bashi Bridge Observation Station on the Sabigawa River. The observation station is located in the suburbs of the flooded point. Fig. 24 shows the location of the breached point and waterlogged area along the Sabigawa River. The river bends steeply to the right toward the downstream side at the breached point. The levee in that area, including the broken section, is old and was made of dredged sediment from the river. The embank-

Fig. 24. Location of breached point and waterlogged area in Sabigawa River (Map provided by Tochigi Prefectural Office with English translation).

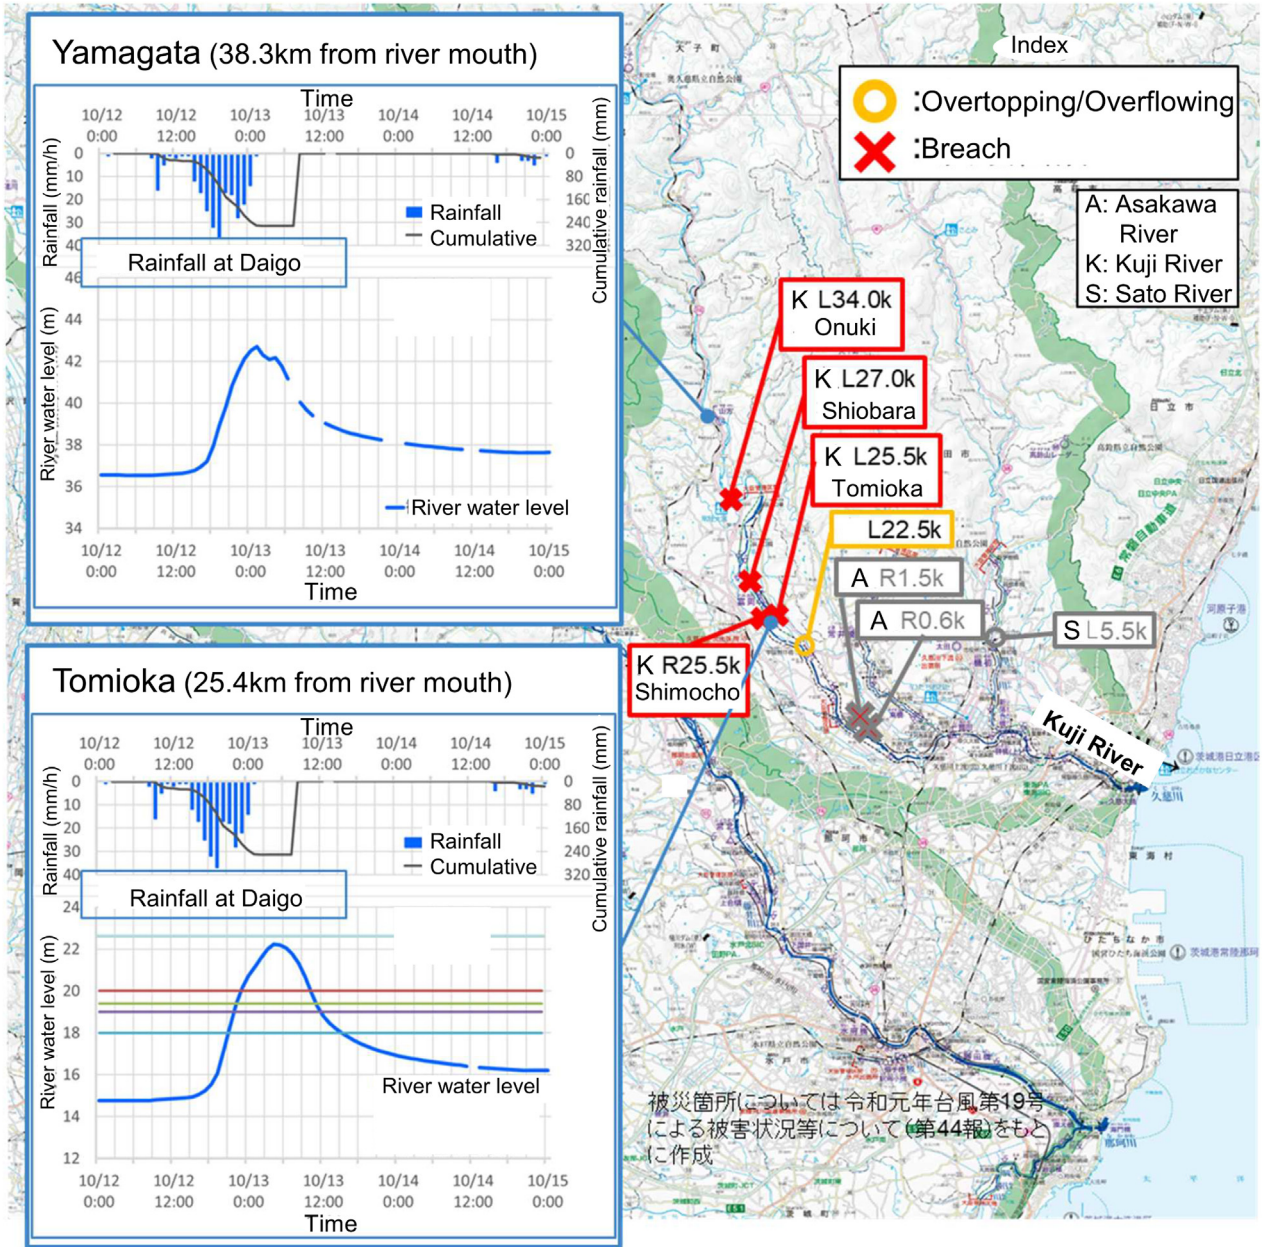
taries, such as the Sato River and the Asakawa River. The representative breached locations are indicated by the red and grey crosses in Fig. 26. The rainfall observed at Kegano Observatory, located at the upstream side of the breaches, was 207 mm for 48 h. This amount of rainfall is record-breaking as compared with the previous record of 185 mm for 48 h due to Typhoon No. 10 in 1986. Fig. 26 also shows the hydrograph for the Tomioka Observatory near the breaches in the Kuji River system. The blue line shows the river water level and the blue bar shows the rainfall. The river water level rose sharply with the approach of the typhoon starting on the evening of 12th October 2019. The peak of the river water occurred early in the morning of 13th October 2019, which indicates that

Fig. 26. Locations of representative breaches in Kuji River system and hydrographs (Investigation Committee for the Levee Breach by the 2019 Typhoon Hagibis in the Kanto Region (2020) with English translation).

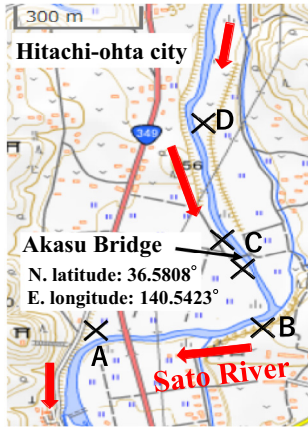
- (1) The overtopping occurred possibly due to the sharp curve of the river channel (Fig. 29).
- (2) The river water flowed back to the river channel after overtopping.
- (3) The backwater, whose water level on the protected side was higher than that in the river channel, caused the erosion of the river-side slope. The cross-section of the levee was gradually reduced, and finally, the breach occurred.

Fig. 29. Locations of levee breaches at Sato River. The standard map was obtained from the base map information of the Geospatial Information Authority of Japan. (<https://cyberjapandata.gsi.go.jp/xyz/std/15/29176/12801.png>, <https://cyberjapandata.gsi.go.jp/xyz/std/15/29176/12802.png>).

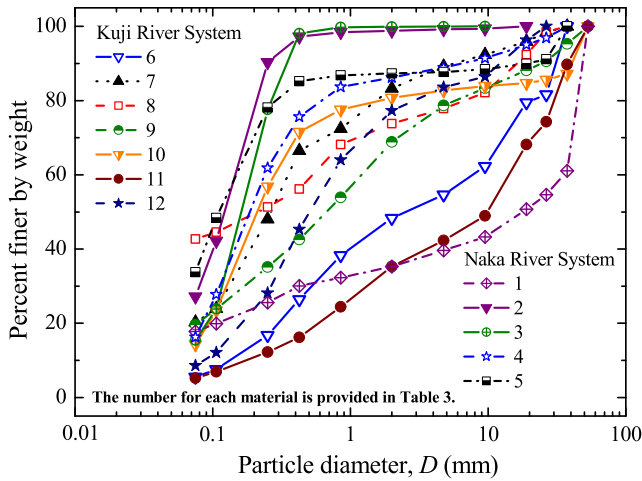
Fig. 36 shows the grain size distribution of the retrieved materials. The values for the maximum and mean particle diameters (D_{max} and D_{50}), fines content (F_c), uniformity coefficient (U_c), and plasticity index (I_p) of those materials are summarised in Table 3. These test results revealed that

Fig. 36. Grading curves of fill materials retrieved from breached levees reported in Sections 4 and 5.

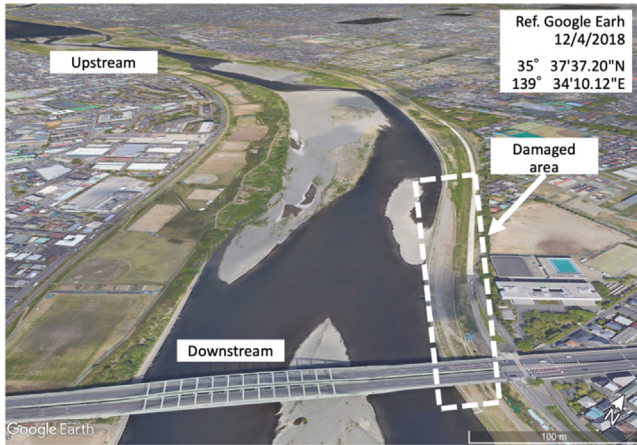
The erosion of the flood channel, i.e., enlarged stream channel occupied during periods of high water, occurred in the Motoizumi area of Komae City, Tokyo (around 35.627736N, 139.568626E). The length of the eroded section was about 340 m (Ministry of Land, Infrastructure, Transport and Tourism, 2020a). Fig. 37 provides a bird's eye view of the levee at 23.4 k on the Tamagawa River before the typhoon. In this section, there is the low-water revetment that consists of concrete blocks and gabions. Fig. 38 shows the state of the flood channel after the typhoon. A 1-m section of the surface of the flood channel, i.e., backfill soil of the low-water revetment, was eroded due to the flooding.

Fig. 37. Bird's eye view of levee at 23.4 k on Tamagawa River before typhoon.

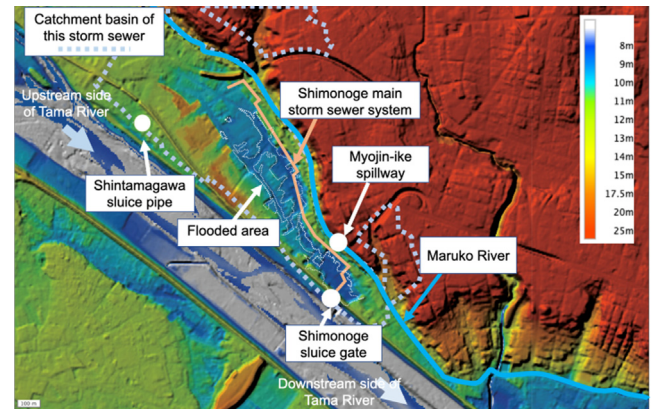
the Tamagawa River. In the Noge area of Setagaya Ward, Tokyo, 151 buildings, including a hospital, were damaged by inland flooding (Setagaya Ward, 2020). Noge is located between the Tamagawa River and the Maruko River, as shown in Fig. 40. In this area, the Shimonoge main storm sewer system was developed for topographical reasons. The dashed line in Fig. 40 indicates the area covered by this storm sewer system. At ordinary times, rainwater is drained via the Shimonoge sluice gate to the Tamagawa River through the storm sewer system. The Noge area also has two additional rainwater drainage facilities, Shintamagawa sluice pipe connected to the Tamagawa River and Myojin-ike spillway connected to the Maruko River.

Fig. 40. Elevation map of Noge area and area flooded by typhoon with information by Setagaya Ward (2020). The colour elevation map was obtained from the base map information of the Geospatial Information Authority of Japan (<https://cyberjapandata.gsi.go.jp/xyz/relief/13/7273/3227.png>, <https://cyberjapandata.gsi.go.jp/xyz/relief/13/7273/3228.png>).

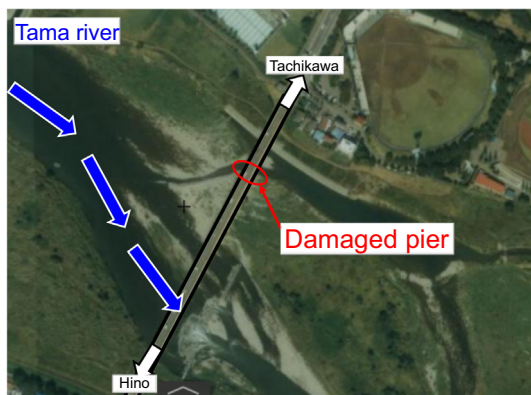
In the 1990s, the river flow of the Tamagawa River was on the opposite side (right side) of the damaged pier (Fig. 43), and countermeasures, such as riverbed protection works, were mainly taken on the right side, which was considered to be at high risk for scouring. However, around 2010, water began to flow on the left side of the river where the damaged pier exists. This was probably due to the slow movement of a sandbar. Maintenance (general inspections) of river bridge structures is conducted in accordance with the standards or technical guidelines, and measures and reinforcement are carried out as necessary. However, it is difficult for field engineers to predict the increase in scour risk due to changes in the river flow conditions, as seen in the case of the Hino Bridge.

Fig. 43. River flow of Tamagawa River around 1990. The picture was obtained from the map information of the Geospatial Information Library, Geospatial Information Authority of Japan (<http://geolib.gsi.go.jp/>)
