| Citation | Soils and Foundations, Vol. 61, Issue 2, pp. 566-585 |

Geo-Disaster Report

# Levee damage and bridge scour by 2019 typhoon Hagibis in Kanto Region, Japan

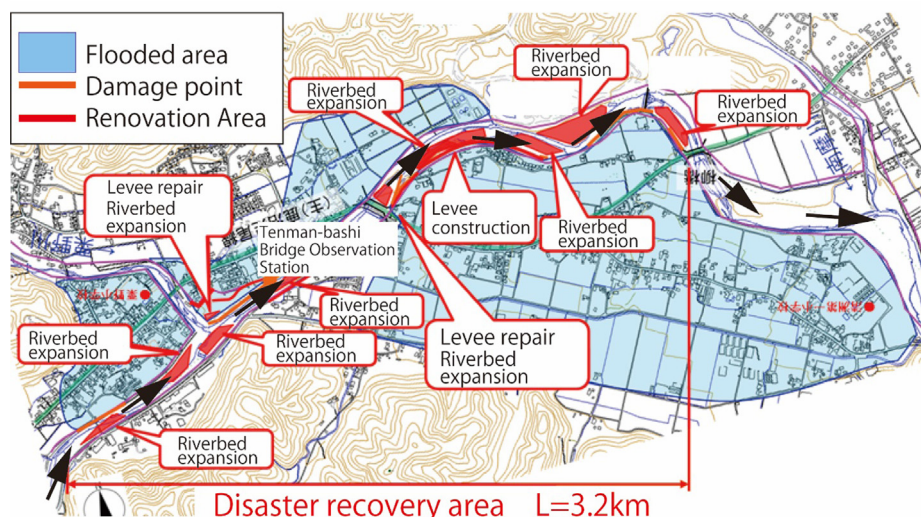
Fig. 16. Overview of plan for restoration and repair services for damaged areas on Omoigawa River (Map provided by Tochigi Prefectural Office with English translation).

Fig. 16 shows the repair works laid out by the Tochigi Prefectural Government for the surrounding areas. There is a plan to widen the beds upstream and downstream of the river, in the vicinity of the flooded area, to secure the flow of water and to repair the levees.

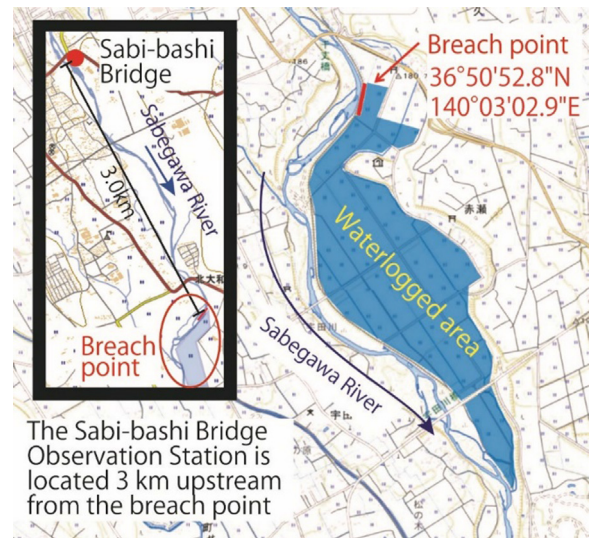
Fig. 23 shows the time history of the river water levels measured at the Sabi-bashi Bridge Observation Station on the Sabigawa River. The observation station is located in the suburbs of the flooded point. Fig. 24 shows the location of the breached point and waterlogged area along the Sabigawa River. The river bends steeply to the right toward the downstream side at the breached point. The levee in that area, including the broken section, is old and was made of dredged sediment from the river. The embank-

Fig. 24. Location of breached point and waterlogged area in Sabigawa River (Map provided by Tochigi Prefectural Office with English translation).

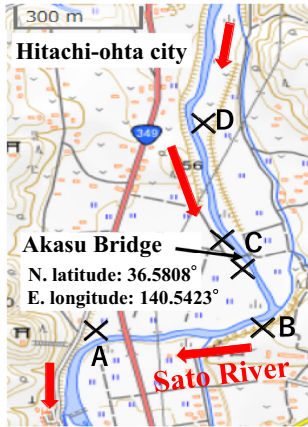
At the downstream side, about 500 m from Point B (i.e., at Point A in Fig. 29), the failure of the right levee, about 20 m in length, 4 m in slope length, and 3.5 m in crest width, occurred as shown in Fig. 34. The foundation of the water level observatory, constructed on the river-side shoulder and located on the downstream side about 16 m from the breached area, shown in Fig. 34, was severely damaged by scour. On the downstream side of the observatory, traces of the erosion of the river-side shoulder were found at a length of 22 m, as shown in Fig. 35. Moreover, as seen in Figs. 34 and 35, bamboo bushes on the river-side shoulder were inclined toward the river-side. When considering these factors, the possible process of the breach could be explained as follows.

- (1) The overtopping occurred possibly due to the sharp curve of the river channel (Fig. 29).
- (2) The river water flowed back to the river channel after overtopping.
- (3) The backwater, whose water level on the protected side was higher than that in the river channel, caused the erosion of the river-side slope. The cross-section of the levee was gradually reduced, and finally, the breach occurred.

Fig. 29. Locations of levee breaches at Sato River. The standard map was obtained from the base map information of the Geospatial Information Authority of Japan. (<https://cyberjapandata.gsi.go.jp/xyz/std/15/29176/12801.png>, <https://cyberjapandata.gsi.go.jp/xyz/std/15/29176/12802.png>).

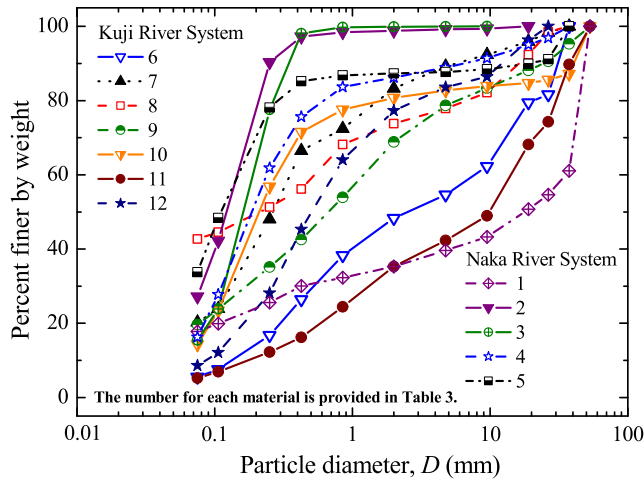
Fig. 36 shows the grain size distribution of the retrieved materials. The values for the maximum and mean particle diameters ( $D_{max}$  and  $D_{50}$ ), fines content ( $F_c$ ), uniformity coefficient ( $U_c$ ), and plasticity index ( $I_p$ ) of those materials are summarised in Table 3. These test results revealed that

Fig. 36. Grading curves of fill materials retrieved from breached levees reported in Sections 4 and 5.

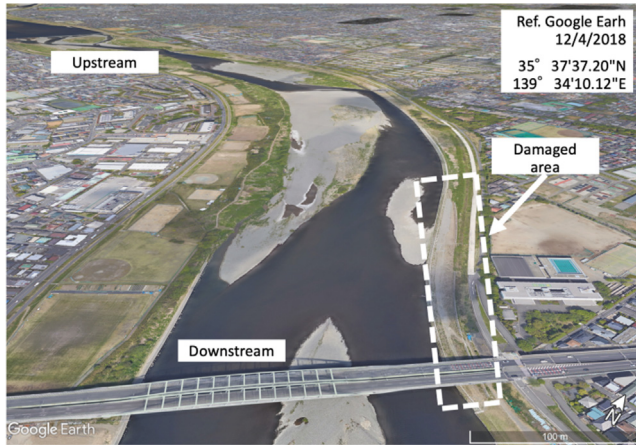
The erosion of the flood channel, i.e., enlarged stream channel occupied during periods of high water, occurred in the Motoizumi area of Komae City, Tokyo (around 35.627736N, 139.568626E). The length of the eroded section was about 340 m (Ministry of Land, Infrastructure, Transport and Tourism, 2020a). Fig. 37 provides a bird's eye view of the levee at 23.4 k on the Tamagawa River before the typhoon. In this section, there is the low-water revetment that consists of concrete blocks and gabions. Fig. 38 shows the state of the flood channel after the typhoon. A 1-m section of the surface of the flood channel, i.e., backfill soil of the low-water revetment, was eroded due to the flooding.

Fig. 37. Bird's eye view of levee at 23.4 k on Tamagawa River before typhoon.

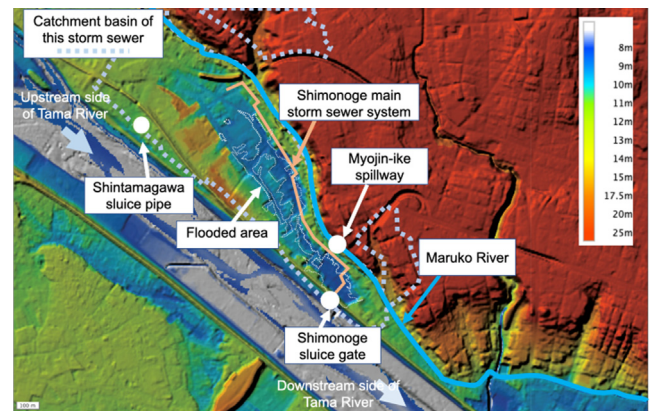
the Tamagawa River. In the Noge area of Setagaya Ward, Tokyo, 151 buildings, including a hospital, were damaged by inland flooding (Setagaya Ward, 2020). Noge is located between the Tamagawa River and the Maruko River, as shown in Fig. 40. In this area, the Shimonoge main storm sewer system was developed for topographical reasons. The dashed line in Fig. 40 indicates the area covered by this storm sewer system. At ordinary times, rainwater is drained via the Shimonoge sluice gate to the Tamagawa River through the storm sewer system. The Noge area also has two additional rainwater drainage facilities, Shintamagawa sluice pipe connected to the Tamagawa River and Myojin-ike spillway connected to the Maruko River.

Fig. 40. Elevation map of Noge area and area flooded by typhoon with information by Setagaya Ward (2020). The colour elevation map was obtained from the base map information of the Geospatial Information Authority of Japan (<https://cyberjapandata.gsi.go.jp/xyz/relief/13/7273/3227.png>, <https://cyberjapandata.gsi.go.jp/xyz/relief/13/7273/3228.png>).

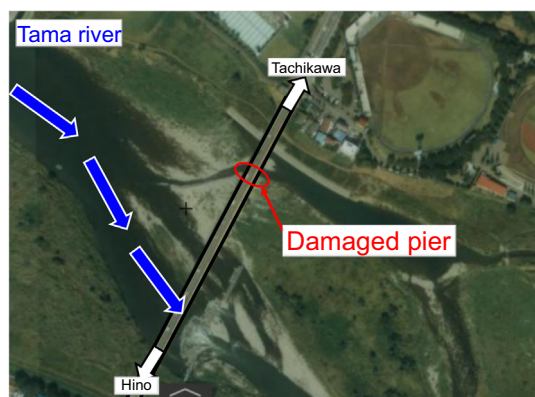
In the 1990s, the river flow of the Tamagawa River was on the opposite side (right side) of the damaged pier (Fig. 43), and countermeasures, such as riverbed protection works, were mainly taken on the right side, which was considered to be at high risk for scouring. However, around 2010, water began to flow on the left side of the river where the damaged pier exists. This was probably due to the slow movement of a sandbar. Maintenance (general inspections) of river bridge structures is conducted in accordance with the standards or technical guidelines, and measures and reinforcement are carried out as necessary. However, it is difficult for field engineers to predict the increase in scour risk due to changes in the river flow conditions, as seen in the case of the Hino Bridge.

Fig. 43. River flow of Tamagawa River around 1990. The picture was obtained from the map information of the Geospatial Information Library, Geospatial Information Authority of Japan (<http://geolib.gsi.go.jp/>)
