Performance recovery of a repaired 4-storey reinforced concrete structure subjected to shake-table testing

Understanding the effects of repair on reinforced concrete (RC) structures is critical to evaluating their performance in future earthquakes. In this research, a system-level approach is taken by repairing a previously damaged ¼ scale 4-storey RC structure and subjecting it to a series of dynamic excitations via shake table testing. The repair was undertaken using common construction materials with the primary motivation of restoring original performance. The performance of the repaired structure was compared to that of the original structure prior to repairs. It was found that overall initial stiffness of the structure was recovered to 66% of the original initial stiffness and was generally higher in floors where more intensive repair works were undertaken. Damping capacity was quantified via equivalent viscous damping ratio using three different methods. Regardless of the calculation method, the damping capacity recovery was around 80% for low-moderate drifts and 100% for high drifts. While collapse was not induced in the structure, drift ratio demands of over 5% could be a

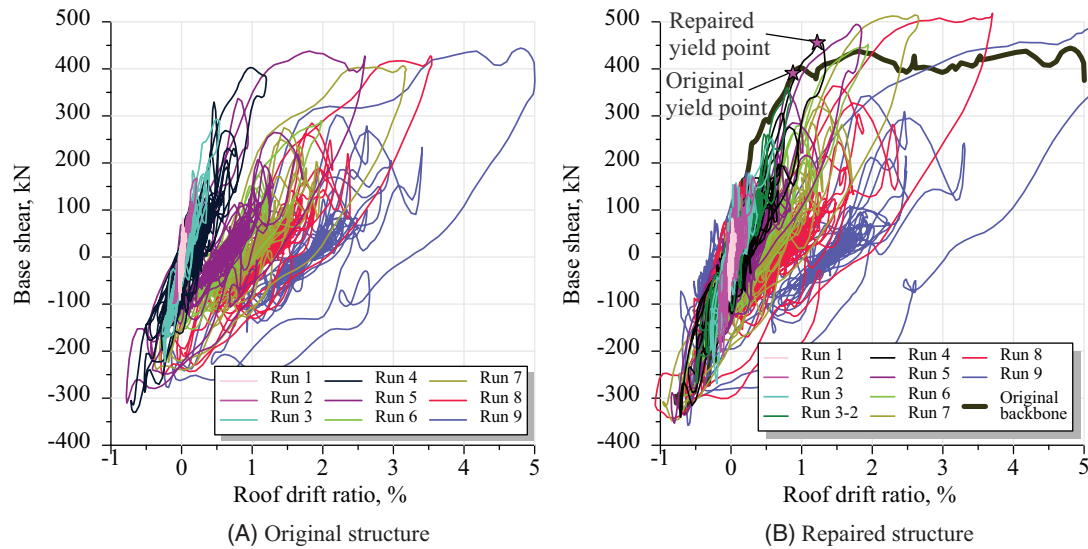
FIGURE 9 Base shear-roof drift ratio response of the (A) Original structure and (B) Repaired structure

The base shear-roof drift ratio relationship for the Original and Repaired structures are shown in Figure 9A and B, respectively. The envelope of the Original structure is traced as a grey line in Figure 9B for ease of comparison. Roof drift ratio was calculated as the cumulative sum of the inter-story drifts from each floor divided by the total height of the structure. The “yield points” of the Original and Repaired structures are also plotted in Figure 9B. The “yield point” corresponds to the formation of a full beam-sway mechanism in the structure. The full beam-sway mechanism was judged to have formed when strain in longitudinal reinforcement in all measured flexural hinges (beams, columns, and walls) exceeded the yield strain. From the comparison of Figure 9A and B the following observations can be readily made: (1) the stiffness of the Repaired structure leading up to the yield point is lower than that of the Original structure, (2) the apparent yield point of the Repaired structure has shifted to the right of the Original structure’s yield point, (3) the hysteresis loops in the Repaired structure do not exhibit any obvious increase in pinching characteristics compared to the Original structure (i.e., no significant reinforcement bond degradation, or shear sliding along cracks), and (4) the strength of the Repaired structure is considerably higher than that of the Original structure. These aspects will be discussed in detail in the next section.

From Figure 9B, the yield point has shifted from 0.97% in the Original structure to 1.3% in the Repaired structure. This shift is not thought to be due to a reduction in post-cracking stiffness (e.g., due to Bauschinger effect) because the Run 4 hysteretic curve of the Repaired structure passes directly through the Original structure's yield point, as can be seen in Figure 9B. Rather, this shift is thought to be due to member sections developing higher yield curvatures due to higher section yield strengths.²⁹ This observation suggests that the overall structural strength increase seen in Figure 9 is due to inherent strength increase of individual members rather than a change in modal vibration characteristics. Based on the yield point definition in Figure 9B, the “overall” yield secant stiffness of the Repaired structure recovered to 87% of the Original structure.

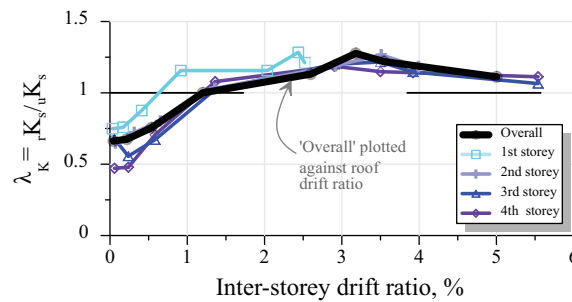
FIGURE 11 Recovery of secant stiffness, λ_K , for overall structure and for each storey

The recovery of structural stiffness is an important consideration in estimating potential future force and deformation demands on the structure. In this section, secant stiffness recovery is investigated over several excitations of the Repaired structure. As the response hysteresis loops are rounded due to inherent damping, in this paper secant stiffness of each Run is calculated as the average of the secant stiffness to maximum base shear and the secant stiffness to maximum deformation of that Run. Yield secant stiffness is calculated using the yield points in Figure 9B. The recovery factor, λ_K , of the secant stiffness of the Repaired structure, ${}_rK_s$, to that of the Original structure, ${}_oK_s$ (where secant stiffness is calculated from the origin of the respective Run 1), is shown in Figure 11 for each comparable Run. The recovery factor is shown for both the “overall” response (i.e., using roof drift ratio) as well as that for each individual story, where accelerometer and inter-story drift data was used to get individual story stiffnesses. The “overall” initial stiffness of the Repaired structure (i.e., secant stiffness of Run 1) recovered to 66% of the Original structure. This number is similar to the 75% recovery ratio estimated from ambient vibration measurements, with the difference being due to the nature of the secant stiffness averaging method described above. These results show that despite a systematic and relatively extensive epoxy injection procedure the initial stiffness could not be fully recovered. This is likely due to a substantial number of cracks being too narrow or simply imperceptible to be effectively injected. Leading up to Run 4, secant stiffness recovery tends to be higher in the bottom stories (e.g., $\lambda_K = 0.75$ at first story for Run 1) compared to the top stories ($\lambda_K = 0.47$ at top story for Run 1). This tendency is consistent with the data in Figure 10 where lower stories exhibited relatively lower peak inter-story

drifts, and again suggests that the repair was more effective in the lower stories. Following Run 4, the Repaired structure exceeded the strength of the Original structure, resulting in secant stiffness higher than unity thereafter.
