Title	Performance recovery of a repaired 4-storey reinforced concrete structure subjected to shake-table testing
Authors	Alex Shegay, Kota Miura, Akira Mikawa, Masaki Maeda, Matsutaro Seki
Citation	Earthquake Engineering & Structural Dynamics, Volume 52, Issue 5, pp. 1339-1359
Pub. date	2023, 1
DOI	https://doi.org/10.1002/eqe.3818
Creative Commons	Information is in the article.

Performance recovery of a repaired 4-storey reinforced concrete structure subjected to shake-table testing

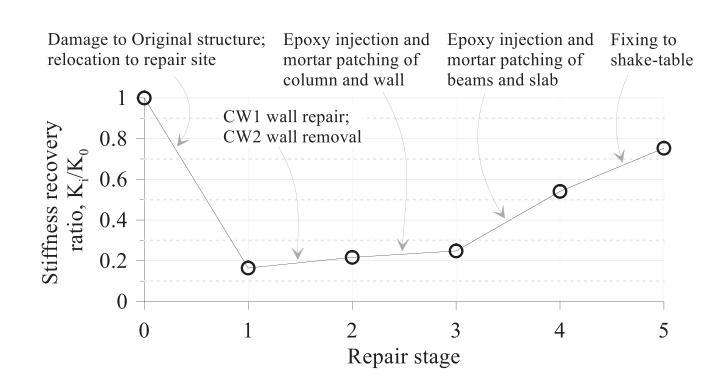
where K_0 is the stiffness of the Original undamaged structure and K_i is the stiffness of the Repaired structure following the *i*th repair stage. The results of Equation (3) for each repair stage are plotted in Figure 7. From Figure 7 it can be observed that repairs to the wall (stage 2) and columns (stage 3) resulted in incremental increases in structural stiffness of 32% and 17% (relative to stage 1), respectively. Repair of the beams and slabs, (stage 4; corresponding to the largest volume of crack epoxy injection), resulted in the largest increase of stiffness relative to stage 1 of 151%. After re-attaching the structure to the shake-table (stage 5), the final Repaired structure's natural period was measured to have recovered to 87% of the Original structure's natural period (i.e., relative to stage 0), suggesting an overall stiffness recovery of 75%. This is considerably higher than the 70% recovery of natural period (50% stiffness recovery) achieved in a full-scale, 7-storey, repaired structure in a previous study.¹⁷ It is thought that the comprehensive epoxy injection repair policy adopted in the

FIGURE 7 Estimated stiffness recovery factor from natural period measurements at each repair stage

present study (compared to¹⁷ where only "major cracks" were injected) is the main reason for the higher stiffness recovery achieved.

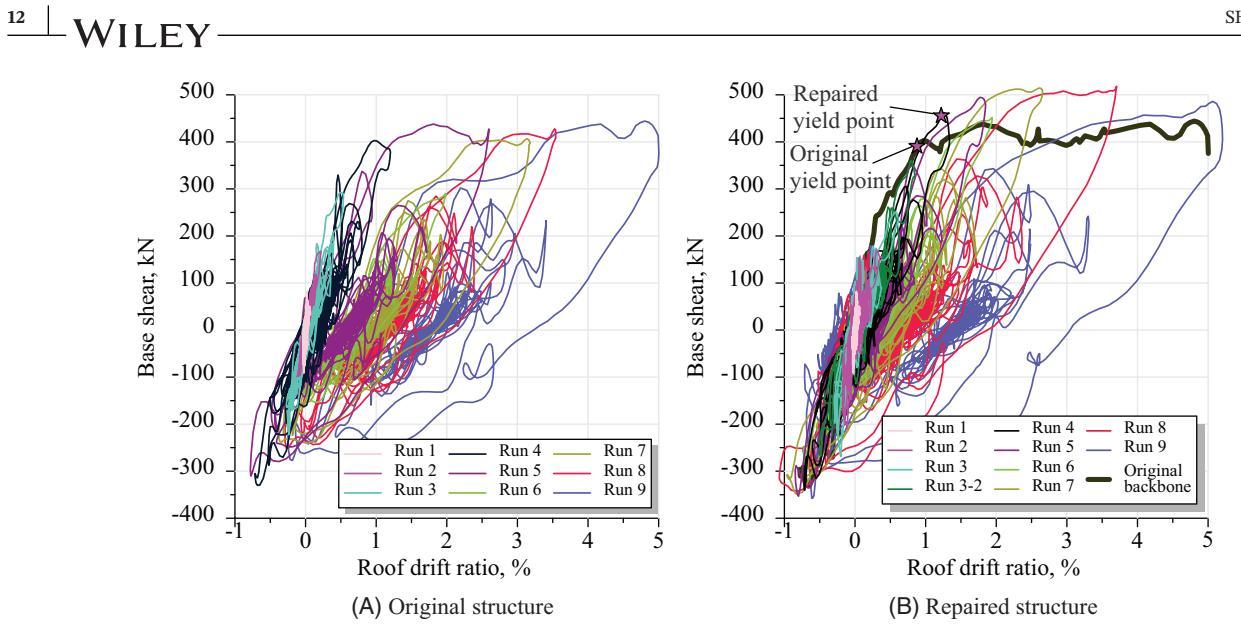
FIGURE 9 Base shear-roof drift ratio response of the (A) Original structure and (B) Repaired structure

The base shear-roof drift ratio relationship for the Original and Repaired structures are shown in Figure 9A and B, respectively. The envelope of the Original structure is traced as a grey line in Figure 9B for ease of comparison. Roof drift ratio was calculated as the cumulative sum of the inter-story drifts from each floor divided by the total height of the structure. The "yield points" of the Original and Repaired structures are also plotted in Figure 9B. The "yield point" corresponds to the formation of a full beam-sway mechanism in the structure. The full beam-sway mechanism was judged to have formed when strain in longitudinal reinforcement in all measured flexural hinges (beams, columns, and walls) exceeded the yield strain. From the comparison of Figure 9A and B the following observations can be readily made: (1) the stiffness of the Repaired structure leading up to the yield point is lower than that of the Original structure, (2) the apparent yield point of the Repaired structure has shifted to the right of the Original structure's yield point, (3) the hysteresis loops in the Repaired structure do not exhibit any obvious increase in pinching characteristics compared to the Original structure (i.e., no significant reinforcement bond degradation, or shear sliding along cracks), and (4) the strength of the Repaired structure is considerably higher than that of the Original structure. These aspects will be discussed in detail in the next section.

Therefore, a combination of reinforcement strain hardening and strain aging are thought to be the principal causes for the observed strength increase. The presence of strain aging also helps explain the absence of Bauschinger effect in Figure 9, as previous studies have demonstrated that the Bauschinger effect is "reset" by strain aging.³⁵ Previous studies on strain aged reinforcement have indicated that a strength increase of 10%-20% of the original yield stress can be expected, and that this value is somewhat independent of the maximum previously exerted strain. $^{34-37}$ To confirm whether strain aging was a cause of the observed strength increase in the present study, longitudinal reinforcement used in the beams (D6 bars), columns and walls (D10 bars) were tested. The test procedure involved subjecting the reinforcement to an initial tensile strain ranging from 1%-6% (strain ranges recorded in members of the Original structure); unloading and allowing the bars to age; and finally reloading the bars until tensile fracture. The aging process was accelerated by heat treating the bars at 100° C for 4 h, to simulated 1-year of strain aging³⁸ (the period between testing of the Original and Repaired structures). The stress-strain curves for the "original" non-aged reinforcement and strain-aged reinforcement are shown in Figure 15. It can be seen that after the strain aging process the yield stress of both the D6 and D10 reinforcement exceeded the envelope of the "original" reinforcement. The strain aged reinforcement curves also exhibit reemergence of the yieldplateau, which would otherwise not be present had reloading occurred immediately after unloading from the initial strain. This provides evidence for the disappearance of the Bauschinger effect and an explanation of why the backbone of the Repaired structure in Figure 9B passes through the yield point of the Original structure. The increase in stress directly attributed to strain aging (i.e., excluding the effect of strain hardening) for each bar diameter is shown in Figure 16. It can be seen that while the magnitude of the stress increase is different for the D6 and D10 reinforcement, it is essentially independent of the initially applied peak strain level, provided yielding has occurred. On average, the increase in stress is 57 MPa for D6 reinforcement and 81 MPa for D10 reinforcement. Expressed as a percentage relative to the expected stress at the corresponding strain level for a non-aged bar, this becomes 12% and 19% for D6 and D10 reinforcement, respectively.

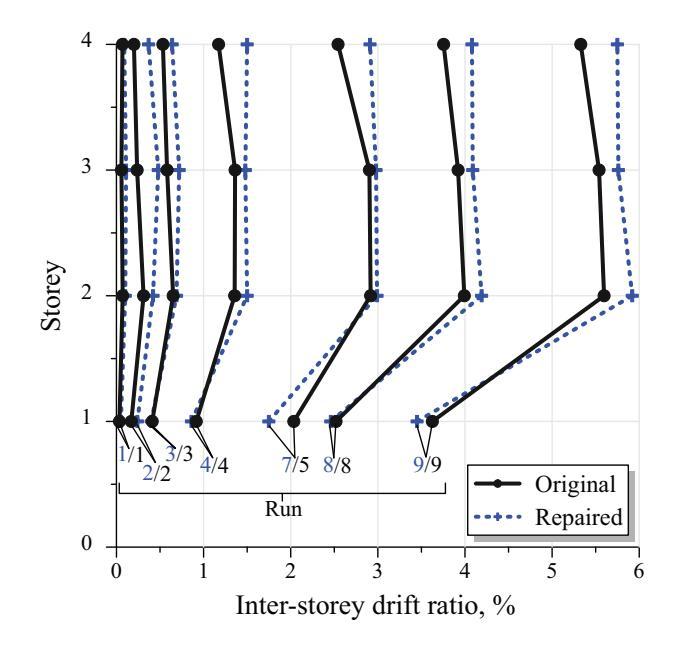
Maximum inter-story drift ratio distributions of the Original and Repaired structures are compared in Figure 10. Runs included in the comparison are those that achieve similar maximum roof drift ratios in both experimental programs (hereinafter "comparable Runs"). The purpose of this comparison is to make qualitative judgment on the shape of the drift ratio distribution rather than compare absolute magnitude. The maximum inter-story drift ratio distribution shape is very similar between the Original and Repaired structures suggesting no significant changes in the mode of vibration. Some minor difference is observed in the Repaired structure where the top inter-story drift ratio is slightly higher relative to the lower floors, when compared to the Original structure. This difference suggests that in the Repaired structure, upper stories are softer relative to the lower stories compared to the Original structure. Higher stiffness recovery in the lower floors is expected because of the higher intensity repair implemented (replacement of reinforcement and concrete) compared to the upper floors (epoxy injection only). Additionally, concrete cracks in the upper stories were generally narrower compared to that of the lower stories (particularly for columns and walls), resulting in likely reduced epoxy resin penetration depth.

FIGURE 10 Maximum inter-story drift ratio distribution for runs resulting in similar peak roof drift ratio

Similarity in the maximum deformation profiles shown in Figure 10 suggests that the strength increase was unlikely due to changes in the vibration mode shape. The effect of the cast-iron block wall installed in the Y-direction is also not thought to be significant due to the early development of a crack under weak-direction loading at the base of the wall.

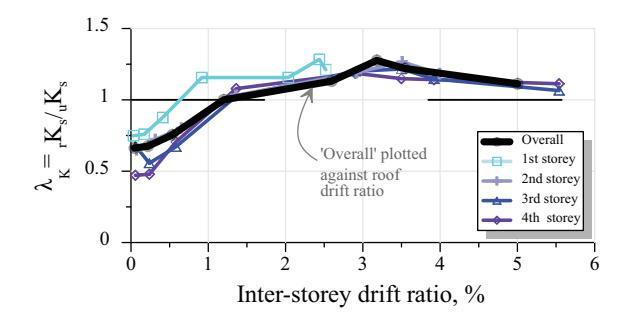
FIGURE 11 Recovery of secant stiffness, λ_K , for overall structure and for each storey

The recovery of structural stiffness is an important consideration in estimating potential future force and deformation demands on the structure. In this section, secant stiffness recovery is investigated over several excitations of the Repaired structure. As the response hysteresis loops are rounded due to inherent damping, in this paper secant stiffness of each Run is calculated as the average of the secant stiffness to maximum base shear and the secant stiffness to maximum deformation of that Run. Yield secant stiffness is calculated using the yield points in Figure 9B. The recovery factor, λ_K , of the secant stiffness of the Repaired structure, $_{r}K_{s}$, to that of the Original structure, $_{u}K_{s}$ (where secant stiffness is calculated from the origin of the respective Run 1), is shown in Figure 11 for each comparable Run. The recovery factor is shown for both the "overall" response (i.e., using roof drift ratio) as well as that for each individual story, where accelerometer and inter-story drift data was used to get individual story stiffnesses. The "overall" initial stiffness of the Repaired structure (i.e., secant stiffness of Run 1) recovered to 66% of the Original structure. This number is similar to the 75% recovery ratio estimated from ambient vibration measurements, with the difference being due to the nature of the secant stiffness averaging method described above. These results show that despite a systematic and relatively extensive epoxy injection procedure the initial stiffness could not be fully recovered. This is likely due to a substantial number of cracks being too narrow or simply imperceptible to be effectively injected. Leading up to Run 4, secant stiffness recovery tends to be higher in the bottom stories (e.g., $\lambda_K = 0.75$ at first story for Run 1) compared to the top stories ($\lambda_K = 0.47$ at top story for Run 1). This tendency is consistent with the data in Figure 10 where lower stories exhibited relatively lower peak inter-story

drifts, and again suggests that the repair was more effective in the lower stories. Following Run 4, the Repaired structure exceeded the strength of the Original structure, resulting in secant stiffness higher than unity thereafter.

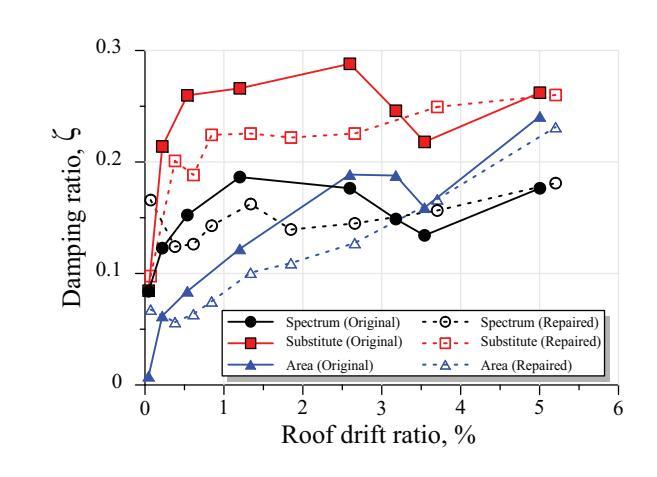
FIGURE 12 Equivalent viscous damping ratio of the Original and Repaired structures evaluated using three methods

Damping is necessary in structures to dissipate the input energy from earthquakes; therefore, it is critical to understand how much damping capacity can be recovered through structural repairs. Three calculation methods were used to evaluate the equivalent viscous damping ratio, ζ_{eq} , for each comparable Run. The "spectrum" method utilized the capacity spectrum approach, where for each Run the design demand spectrum in Figure 3 (scaled to the respective Run magnitude in Table 5) was adjusted by a damping reduction factor, F_h , in Equation (4), until an intersection with the capacity curve of the structure was obtained.³⁰ The corresponding damping ratio, $\zeta_{spectrum}$, was then back calculated from F_h using Equation (4).¹⁹ As Equation (4) is an empirical formula, the "spectrum" method will naturally yield empirical estimates of damping ratio. In the "substitute" method all energy dissipated during the entire dynamic response history is assumed to be due to viscous damping. Using an equivalent single degree of freedom response of the structure, the substitute damping ratio, $\zeta_{substitute}$, can then be calculated using Equations (5–6).³¹ This method assumes that all of the energy input into the structure is dissipated through viscous damping, and thus provides a single "average" damping value over the duration of the excitation. Finally, in the "area" method the equivalent viscous damping ratio, ζ_{area} , is calculated using Equations (7–8), where the ΔW is taken as the area inside the largest half-cycle hysteresis loop of each Run and W_e is the strain energy corresponding to the maximum deformation of that cycle.³² In this calculation method it is assumed that the structure is under resonant, steady-state response, though this is not the case in random vibration. The damping ratio calculated via each method and for each comparable Run of the Original and Repaired structures is plotted against the maximum roof drift ratio of the corresponding Run in Figure 12.

From Figure 12 it can be seen that the absolute value of the equivalent viscous damping ratio varies significantly between each calculation method. The level of variability tends to decrease with increasing roof drift ratio of the structure. The "substitute" method results in the highest damping ratios (above 20% for both Original and Repaired structures). The "spectrum" method produces higher damping ratios than the "area" method up until roof drifts of around 3%, after which the trend is reversed, such that the "area" method produces higher damping ratios. The large variability in the damping ratio between methods is not unexpected given the fundamentally different theoretical and empirical assumptions in the calculations. These differences have been previously shown to have a dependence on the structural period, ductility and hysteresis shape.³³ In this study, the focus is given on the level of recovery of damping ratio rather than the absolute magnitudes. To calculate the damping capacity recovery factor, λ_d , the damping ratios for the Repaired structure were normalized by that of the Original structure for comparable Runs. The results are shown in Figure 13 (Run 1 and 2 data are excluded as large scatter was obtained when executing the quotient operation in the elastic region of the response). The comparison shows that despite large differences in the absolute damping ratio values seen in Figure 12, the magnitude of the damping recovery factor is generally in agreement between all three calculation methods for the Runs shown. The damping capacity recovery factor is approximately $\lambda_d \approx 80\%$ up to 2.7% roof drift (i.e., Run 7/5 in Figure 13). This suggests that the damping capacity is only partially recovered at low-moderate seismic demands. The loss of damping capacity is attributed to imperfect restoration of the concrete performance (e.g., deficiencies in epoxy injection technique to reseal all cracks). On the other hand, at higher drifts (Run 8/8 and Run 9/9) corresponding to higher levels of damage, the damping capacity recovery factor is close to or slightly exceeding 1.0. At these high drift demands, concrete is generally fully cracked and so energy dissipation capacity is largely governed by the plastic deformation of reinforcement; thus, reduction in damping capacity is not expected provided there is no degradation in performance of reinforcement. Given these results, in simplified models of repaired structures that utilize some form of equivalent linearization of the beam-sway structural system, using a lower bound damping capacity recovery factor of 80% may be appropriate.

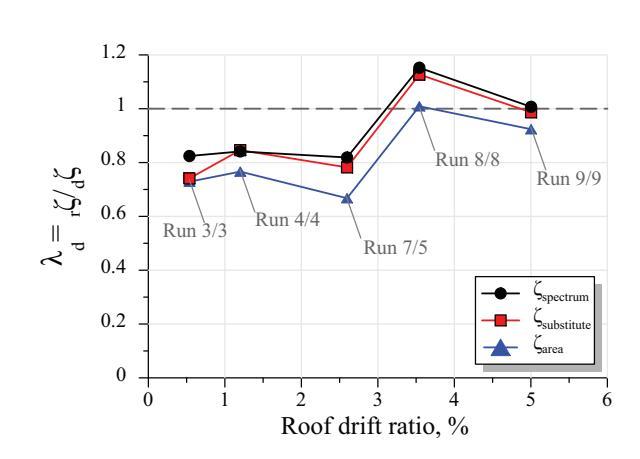
FIGURE 13 Recovery of damping ratio for each Run (Original/Repaired)

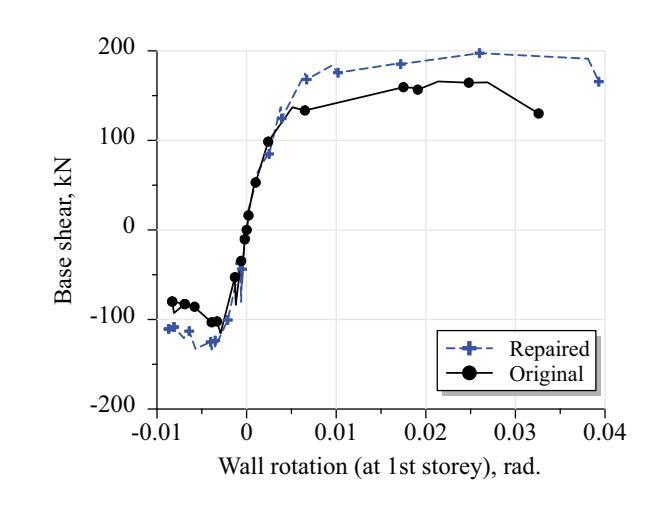
FIGURE 14 Plastic h inge rotation-base shear curve of the instrumented CW1 wall (Run 6 not shown)

Structural members in beam-sway structures must possess adequate deformation capacity to ensure sufficient earthquake energy absorption can occur. Structural members experiencing reduced deformation capacity due to repairs may no longer possess the necessary ductility to justify the shear force reduction factors assumed in the design. While neither the Original nor the Repaired structures were allowed to reach a level of total collapse during the experiments (due to safety concerns), some inferences can be made on deformation capacity based on the available data. The only X-direction members to have experienced failure in both testing programs were the CW1 walls (Figure 8D). The measured wall rotation-base shear backbones of the CW1 wall response in the Original and Repaired structures are shown in Figure 14. It can be observed from Figure 14 that both the Original and Repaired walls experienced significant strength degradation in the final run, which coincided with observation of concrete crushing and longitudinal reinforcement buckling in the corners of the wall (Figure 8D). The maximum rotation of the CW1 wall in the Repaired structure prior to the significant strength degradation (0.038 rad.) exceeded that of the Original structure wall (0.027 rad.), suggesting that deformation capacity was fully recovered. Higher deformation capacity of the CW1 walls in the Repaired structure is thought to be due to the replacement concrete being slightly softer than the original material (Table 3) combined with the softening of the beams that frame into the wall, allowing higher section curvatures to be attained in the wall. This data suggests a deformation capacity recovery factor λ_{dc} = 1.0 is appropriate for flexural walls, which is also in agreement with the value in the FEMA 306 guidelines. From the perspective of system-level performance, though the maximum deformation capacity at collapse is unknown, it can be seen in Figure 10 that inter-story drift ratio exceeded 5% in both structures. This is generally outside the typical range of drift demands expected on buildings, so it can be said that for a practical range of drift demands, deformation capacity was fully recovered following repairs.

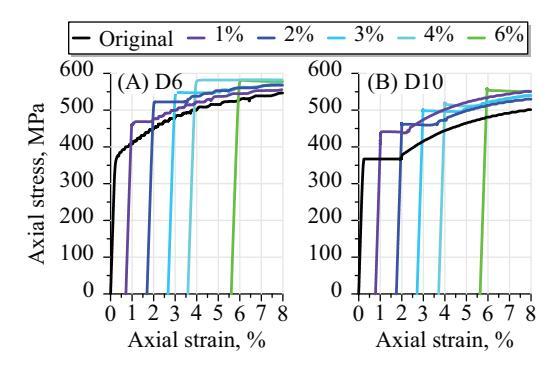
FIGURE 15 Stress-strain relationship of D6 and D10 reinforcement before and after strain aging

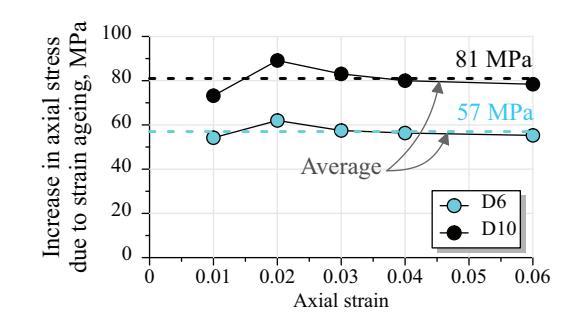
FIGURE 16 Increase in strength attributed to strain aging for D6 and D10 reinforcement
