Geo-Disaster Report

# Levee damage and bridge scour by 2019 typhoon Hagibis in Kanto Region, Japan

**Keywords:** Typhoon Hagibis; Levee breach; Overtopping; Inland flooding; Bridge scour

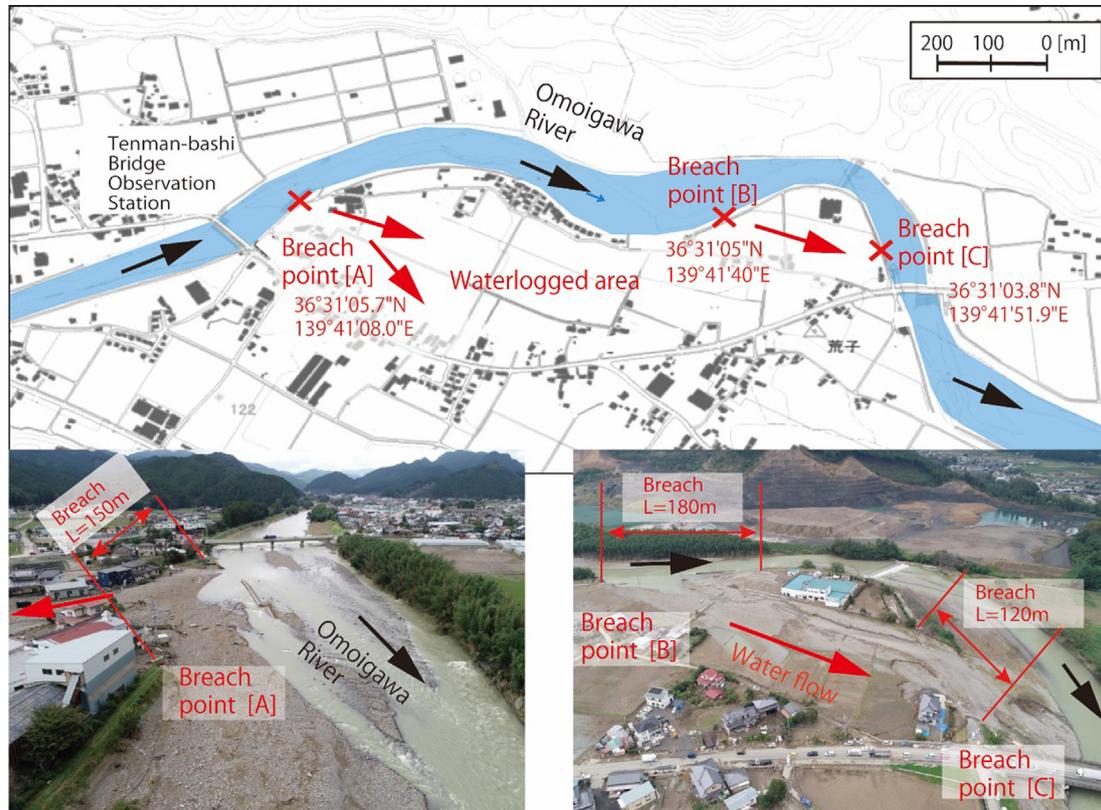
Four levees were breached along the Omoigawa River due to a large amount of water flow (see Fig. 13 for locations). Due to the multiple breaches, about 152 ha of the urban area of the city was flooded and 237 houses were flooded. Fig. 14 shows the situation at the breached points on the Omoigawa River near the Tenman-bashi Bridge in the Kuchiawano and Kuno areas of Kanuma City, and photographs of three out of the four breached levee points on the Omoigawa River. The levee of the Omoigawa River was breached and flooded at a meandering point of the river flow. Most of the levees in the surrounding area are

Fig. 14. Locations of breached points on Omoigawa River (in Tone River system) near Tenman-bashi Bridge in Kuchiawano and Kuno areas, Kanuma City, Tochigi Prefecture (Map and photos provided by Tochigi Prefectural Office with English translation).

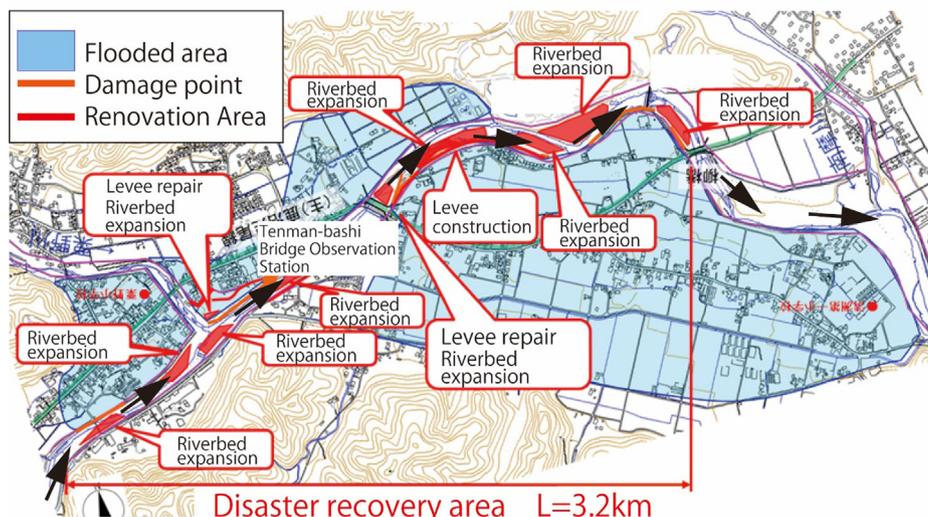
Fig. 16. Overview of plan for restoration and repair services for damaged areas on Omoigawa River (Map provided by Tochigi Prefectural Office with English translation).

Fig. 16 shows the repair works laid out by the Tochigi Prefectural Government for the surrounding areas. There is a plan to widen the beds upstream and downstream of the river, in the vicinity of the flooded area, to secure the flow of water and to repair the levees.

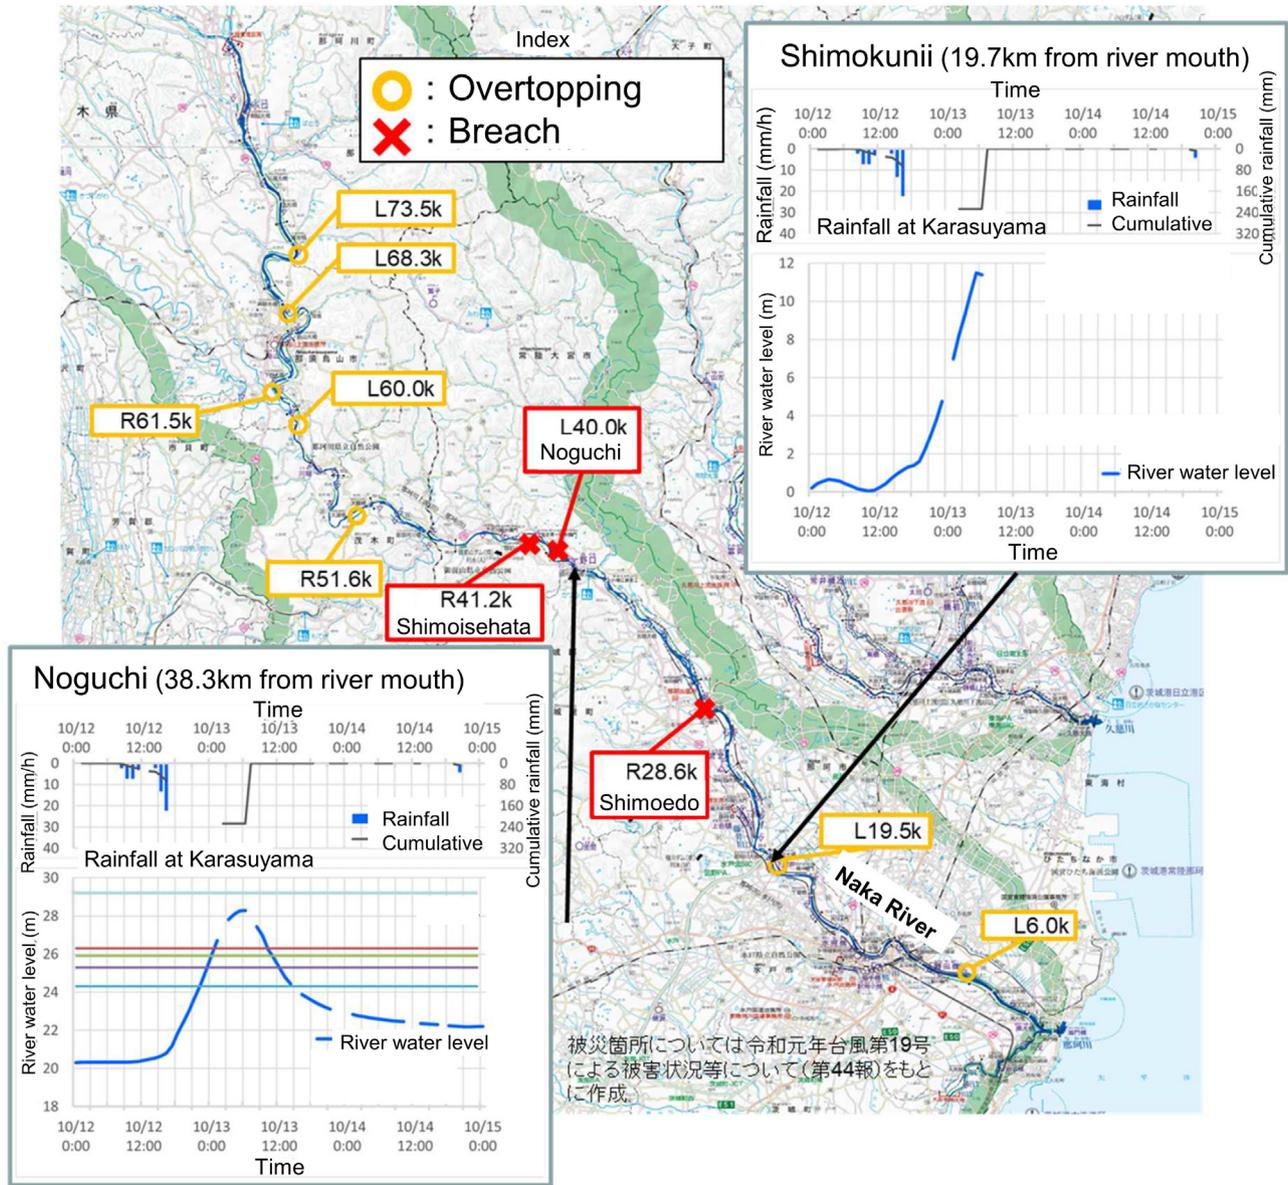
The levee breaches along the Naka River took place at five locations because of the flood caused by the typhoon. The locations of representative levee breaches are presented by red crosses in Fig. 17 and black crosses in Fig. 13. The rainfall observed at the Torinoko Observatory located in Ibaraki Prefecture was 268.0 mm for 48 h; this breaks the previous record of rainfall of 151.4 mm for 48 h due to Typhoon No. 6 (Doksuri) in 2012. Fig. 17 also shows a hydrograph for the Noguchi Observatory near the breaches along the Naka River. The blue line shows the river water level and the blue bar shows the rainfall. It can be seen that the river water level rose sharply with the approach of the typhoon starting on the evening of 12th October 2019. The peak of the river water occurred early in the morning on 13th October 2019, which indicates that the duration of the flood was relatively short, although the typhoon brought intense rainfall.

Fig. 17. Locations of some breaches in Naka River system and hydrographs (Investigation Committee for the Levee Breach by the 2019 Typhoon Hagibis in the Kanto Region (2020) with English translation).

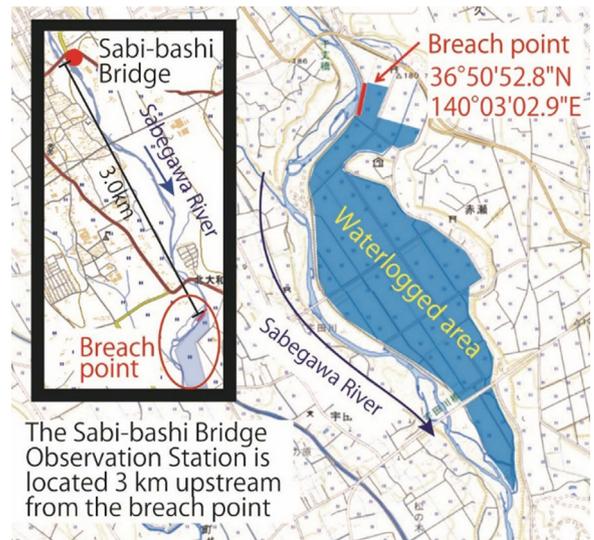
Fig. 23 shows the time history of the river water levels measured at the Sabi-bashi Bridge Observation Station on the Sabigawa River. The observation station is located in the suburbs of the flooded point. Fig. 24 shows the location of the breached point and waterlogged area along the Sabigawa River. The river bends steeply to the right toward the downstream side at the breached point. The levee in that area, including the broken section, is old and was made of dredged sediment from the river. The embank-

Fig. 24. Location of breached point and waterlogged area in Sabigawa River (Map provided by Tochigi Prefectural Office with English translation).

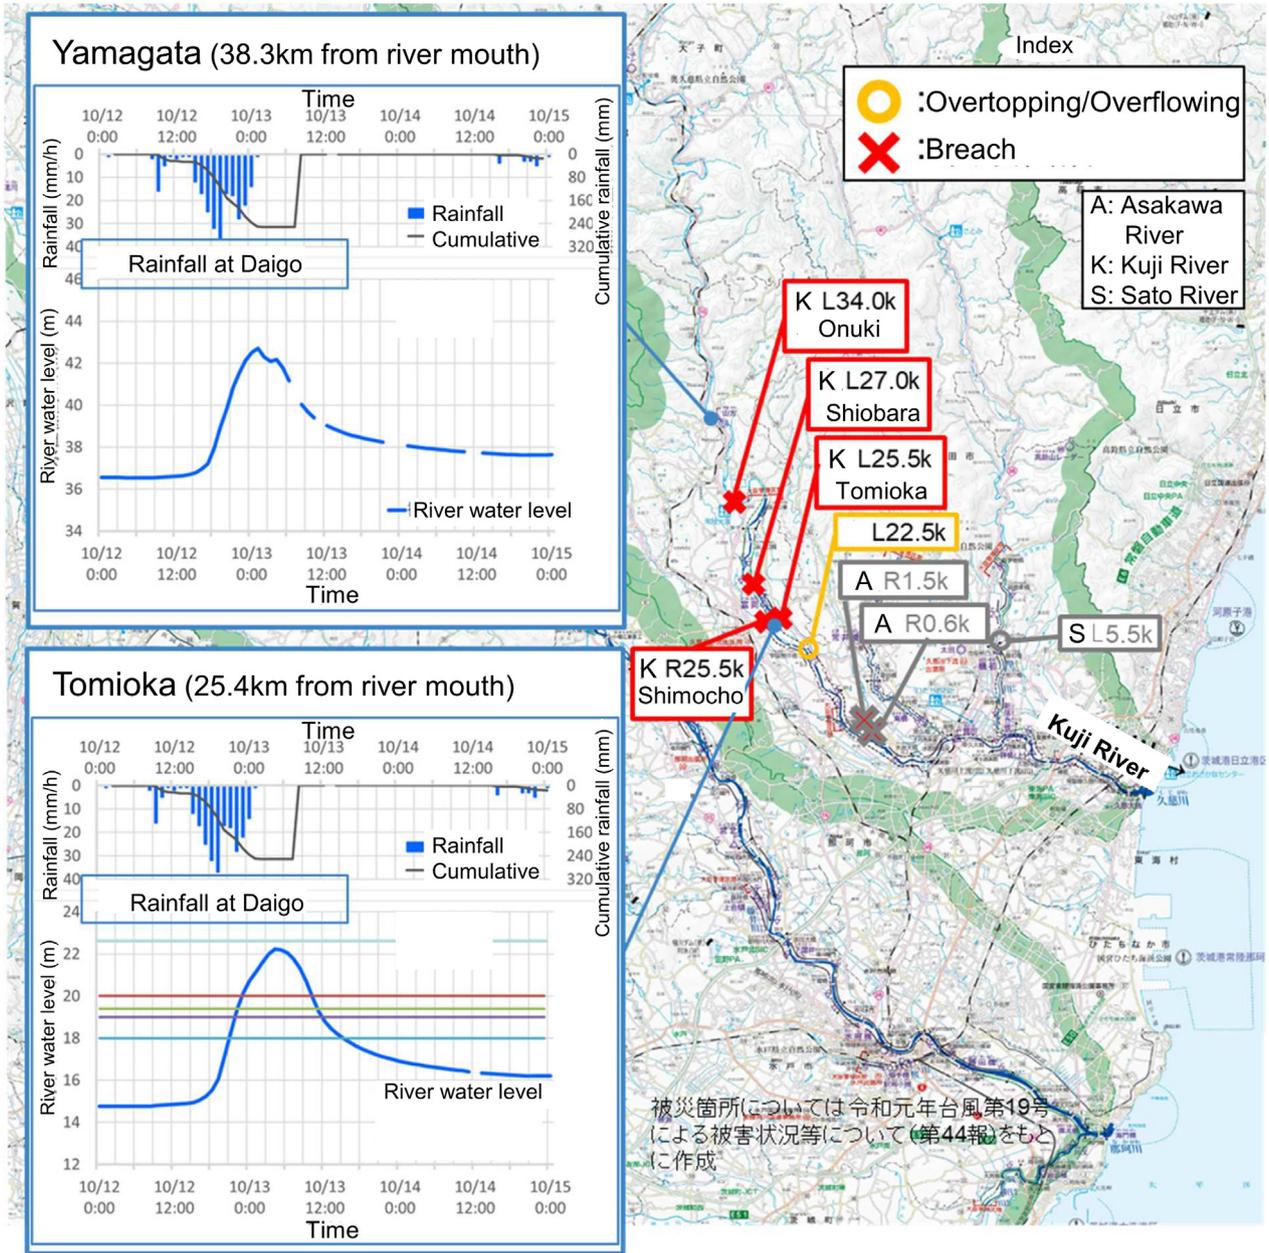
taries, such as the Sato River and the Asakawa River. The representative breached locations are indicated by the red and grey crosses in Fig. 26. The rainfall observed at Kegano Observatory, located at the upstream side of the breaches, was 207 mm for 48 h. This amount of rainfall is record-breaking as compared with the previous record of 185 mm for 48 h due to Typhoon No. 10 in 1986. Fig. 26 also shows the hydrograph for the Tomioka Observatory near the breaches in the Kuji River system. The blue line shows the river water level and the blue bar shows the rainfall. The river water level rose sharply with the approach of the typhoon starting on the evening of 12th October 2019. The peak of the river water occurred early in the morning of 13th October 2019, which indicates that

Fig. 26. Locations of representative breaches in Kuji River system and hydrographs (Investigation Committee for the Levee Breach by the 2019 Typhoon Hagibis in the Kanto Region (2020) with English translation).

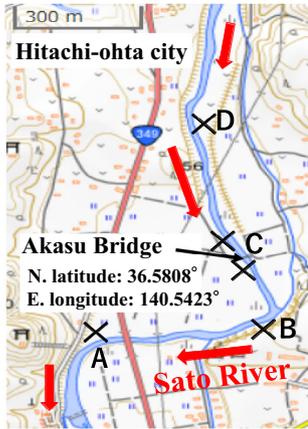
- (1) The overtopping occurred possibly due to the sharp curve of the river channel (Fig. 29).
- (2) The river water flowed back to the river channel after overtopping.
- (3) The backwater, whose water level on the protected side was higher than that in the river channel, caused the erosion of the river-side slope. The cross-section of the levee was gradually reduced, and finally, the breach occurred.

Fig. 29. Locations of levee breaches at Sato River. The standard map was obtained from the base map information of the Geospatial Information Authority of Japan. (<https://cyberjapandata.gsi.go.jp/xyz/std/15/29176/12801.png>, <https://cyberjapandata.gsi.go.jp/xyz/std/15/29176/12802.png>).

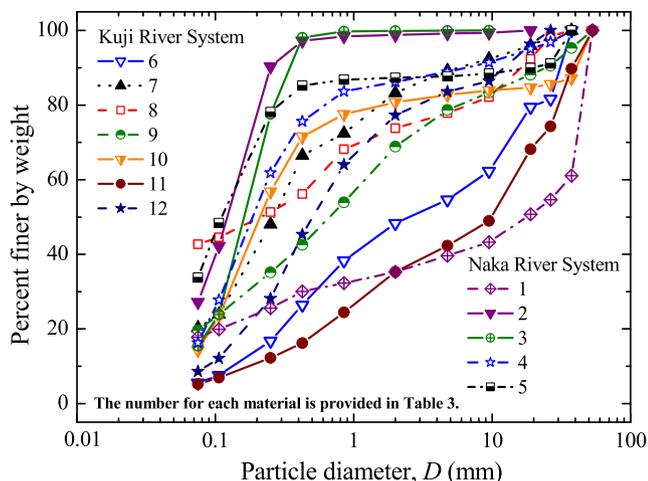
Fig. 36 shows the grain size distribution of the retrieved materials. The values for the maximum and mean particle diameters ( $D_{max}$  and  $D_{50}$ ), fines content ( $F_c$ ), uniformity coefficient ( $U_c$ ), and plasticity index ( $I_p$ ) of those materials are summarised in Table 3. These test results revealed that

Fig. 36. Grading curves of fill materials retrieved from breached levees reported in Sections 4 and 5.

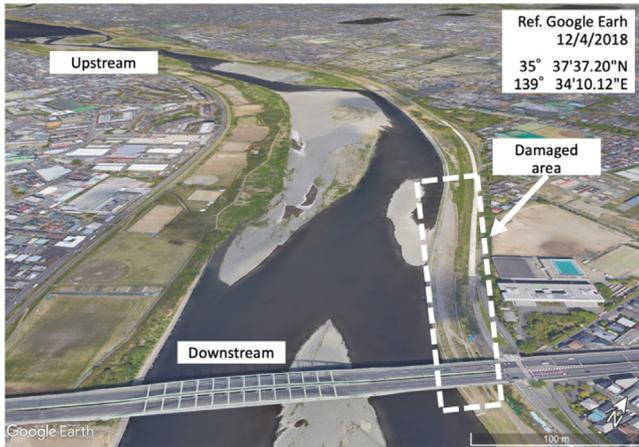
The erosion of the flood channel, i.e., enlarged stream channel occupied during periods of high water, occurred in the Motoizumi area of Komae City, Tokyo (around 35.627736N, 139.568626E). The length of the eroded section was about 340 m (Ministry of Land, Infrastructure, Transport and Tourism, 2020a). Fig. 37 provides a bird's eye view of the levee at 23.4 k on the Tamagawa River before the typhoon. In this section, there is the low-water revetment that consists of concrete blocks and gabions. Fig. 38 shows the state of the flood channel after the typhoon. A 1-m section of the surface of the flood channel, i.e., backfill soil of the low-water revetment, was eroded due to the flooding.

Fig. 37. Bird's eye view of levee at 23.4 k on Tamagawa River before typhoon.

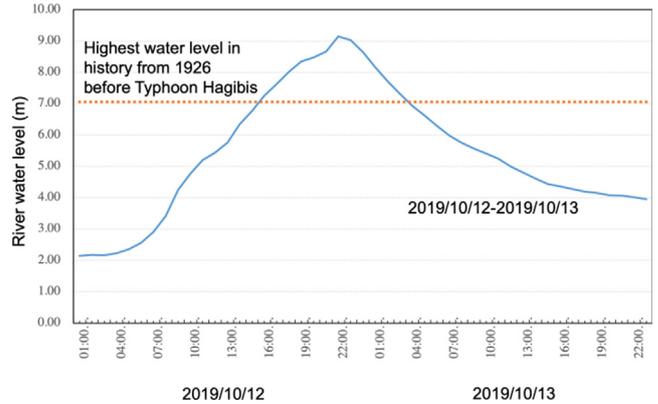
The Tamagawa River was partially flooded at Futako-tamagawa in Setagaya Ward, Tokyo. Overflow in the no-levee section (35.611955N, 139.625151E) occurred at the upstream of the Futako Bridge near Futako-tamagawa Station. The river water level exceeded the highest water level recorded in the past and the elevation at the no-levee section during the typhoon. Fig. 39 shows the time history of the water level observed at the Tamagawa Water Level Observation Station (Ministry of Land, Infrastructure, Transport and Tourism, 2020b). Tempo-

Fig. 39. Time history of river water level observed at Tamagawa Observation Station during typhoon. Data was obtained from the database maintained by the Ministry of Land, Infrastructure, Transport and Tourism, Japan (<http://www1.river.go.jp/>).

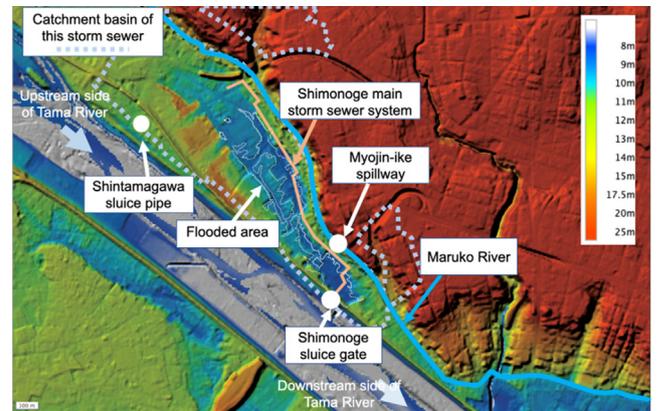
the Tamagawa River. In the Noge area of Setagaya Ward, Tokyo, 151 buildings, including a hospital, were damaged by inland flooding (Setagaya Ward, 2020). Noge is located between the Tamagawa River and the Maruko River, as shown in Fig. 40. In this area, the Shimonoge main storm sewer system was developed for topographical reasons. The dashed line in Fig. 40 indicates the area covered by this storm sewer system. At ordinary times, rainwater is drained via the Shimonoge sluice gate to the Tamagawa River through the storm sewer system. The Noge area also has two additional rainwater drainage facilities, Shintamagawa sluice pipe connected to the Tamagawa River and Myojin-ike spillway connected to the Maruko River.

Fig. 40. Elevation map of Noge area and area flooded by typhoon with information by [Setagaya Ward \(2020\)](#). The colour elevation map was obtained from the base map information of the Geospatial Information Authority of Japan (<https://cyberjapandata.gsi.go.jp/xyz/relief/13/7273/3227.png>, <https://cyberjapandata.gsi.go.jp/xyz/relief/13/7273/3228.png>).

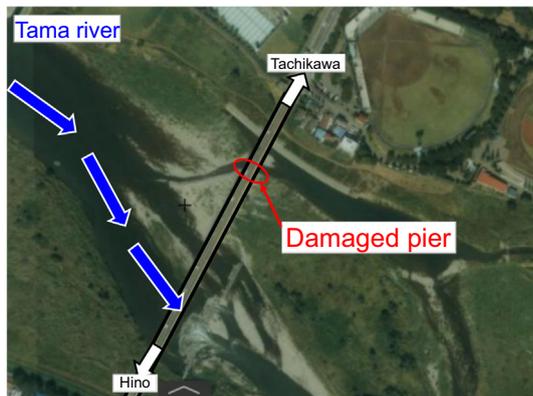
In the 1990s, the river flow of the Tamagawa River was on the opposite side (right side) of the damaged pier (Fig. 43), and countermeasures, such as riverbed protection works, were mainly taken on the right side, which was considered to be at high risk for scouring. However, around 2010, water began to flow on the left side of the river where the damaged pier exists. This was probably due to the slow movement of a sandbar. Maintenance (general inspections) of river bridge structures is conducted in accordance with the standards or technical guidelines, and measures and reinforcement are carried out as necessary. However, it is difficult for field engineers to predict the increase in scour risk due to changes in the river flow conditions, as seen in the case of the Hino Bridge.

Fig. 43. River flow of Tamagawa River around 1990. The picture was obtained from the map information of the Geospatial Information Library, Geospatial Information Authority of Japan (<http://geolib.gsi.go.jp/>)
