Title	Performance recovery of a repaired 4-storey reinforced concrete structure subjected to shake-table testing
Authors	Alex Shegay, Kota Miura, Akira Mikawa, Masaki Maeda, Matsutaro Seki
Citation	Earthquake Engineering & Structural Dynamics, Volume 52, Issue 5, pp. 1339-1359
Pub. date	2023, 1
DOI	https://doi.org/10.1002/eqe.3818
Creative Commons	Information is in the article.

Performance recovery of a repaired 4-storey reinforced concrete structure subjected to shake-table testing

Understanding the effects of repair on reinforced concrete (RC) structures is critical to evaluating their performance in future earthquakes. In this research, a system-level approach is taken by repairing a previously damaged ¼ scale 4-storey RC structure and subjecting it to a series of dynamic excitations via shake table testing. The repair was undertaken using common construction materials with the primary motivation of restoring original performance. The performance of the repaired structure was compared to that of the original structure prior to repairs. It was found that overall initial stiffness of the structure was recovered to 66% of the original initial stiffness and was generally higher in

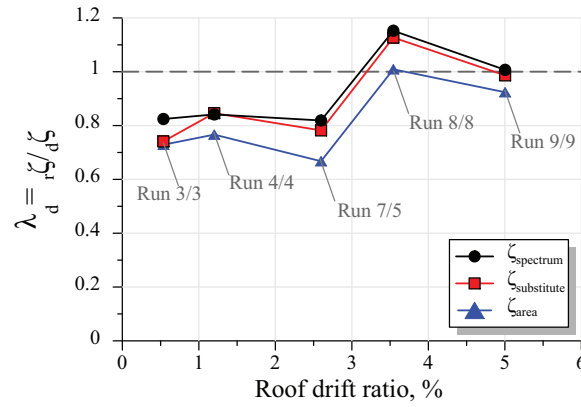
FIGURE 13 Recovery of damping ratio for each Run (Original/Repaired)

From Figure 12 it can be seen that the absolute value of the equivalent viscous damping ratio varies significantly between each calculation method. The level of variability tends to decrease with increasing roof drift ratio of the structure. The “substitute” method results in the highest damping ratios (above 20% for both Original and Repaired structures). The “spectrum” method produces higher damping ratios than the “area” method up until roof drifts of around 3%, after which the trend is reversed, such that the “area” method produces higher damping ratios. The large variability in the damping ratio between methods is not unexpected given the fundamentally different theoretical and empirical assumptions in the calculations. These differences have been previously shown to have a dependence on the structural period, ductility and hysteresis shape.³³ In this study, the focus is given on the level of recovery of damping ratio rather than the absolute magnitudes. To calculate the damping capacity recovery factor, λ_d , the damping ratios for the Repaired structure were normalized by that of the Original structure for comparable Runs. The results are shown in Figure 13 (Run 1 and 2 data are excluded as large scatter was obtained when executing the quotient operation in the elastic region of the response). The comparison shows that despite large differences in the absolute damping ratio values seen in Figure 12, the magnitude of the damping recovery factor is generally in agreement between all three calculation methods for the Runs shown. The damping capacity recovery factor is approximately $\lambda_d \approx 80\%$ up to 2.7% roof drift (i.e., Run 7/5 in Figure 13). This suggests that the damping capacity is only partially recovered at low-moderate seismic demands. The loss of damping capacity is attributed to imperfect restoration of the concrete performance (e.g., deficiencies in epoxy injection technique to reseal all cracks). On the other hand, at higher drifts (Run 8/8 and Run 9/9) corresponding to higher levels of damage, the damping capacity recovery factor is close to or slightly exceeding 1.0. At these high drift demands, concrete is generally fully cracked and so energy dissipation capacity is largely governed by the plastic deformation of reinforcement; thus, reduction in damping capacity is not expected provided there is no degradation in performance of reinforcement. Given these results, in simplified models of repaired structures that utilize some form of equivalent linearization of the beam-sway structural system, using a lower bound damping capacity recovery factor of 80% may be appropriate.

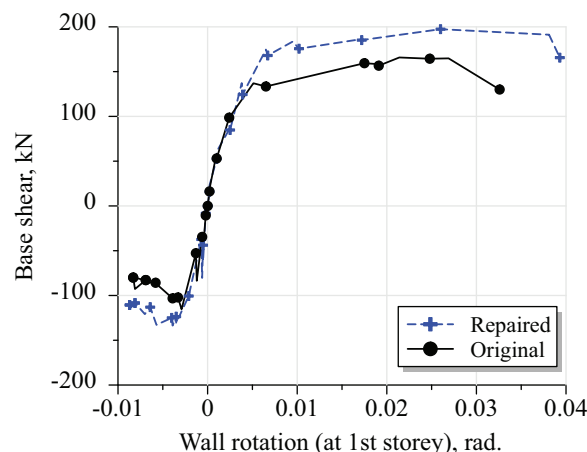
FIGURE 14 Plastic hinge rotation-base shear curve of the instrumented CW1 wall (Run 6 not shown)

Structural members in beam-sway structures must possess adequate deformation capacity to ensure sufficient earthquake energy absorption can occur. Structural members experiencing reduced deformation capacity due to repairs may no longer possess the necessary ductility to justify the shear force reduction factors assumed in the design. While neither the Original nor the Repaired structures were allowed to reach a level of total collapse during the experiments (due to safety concerns), some inferences can be made on deformation capacity based on the available data. The only X-direction members to have experienced failure in both testing programs were the CW1 walls (Figure 8D). The measured wall rotation-base shear backbones of the CW1 wall response in the Original and Repaired structures are shown in Figure 14. It can be observed from Figure 14 that both the Original and Repaired walls experienced significant strength degradation in the final run, which coincided with observation of concrete crushing and longitudinal reinforcement buckling in the corners of the wall (Figure 8D). The maximum rotation of the CW1 wall in the Repaired structure prior to the significant strength degradation (0.038 rad.) exceeded that of the Original structure wall (0.027 rad.), suggesting that deformation capacity was fully recovered. Higher deformation capacity of the CW1 walls in the Repaired structure is thought to be due to the replacement concrete being slightly softer than the original material (Table 3) combined with the softening of the beams that frame into the wall, allowing higher section curvatures to be attained in the wall. This data suggests a deformation capacity recovery factor $\lambda_{dc} = 1.0$ is appropriate for flexural walls, which is also in agreement with the value in the FEMA 306 guidelines. From the perspective of system-level performance, though the maximum deformation capacity at collapse is unknown, it can be seen in Figure 10 that inter-story drift ratio exceeded 5% in both structures. This is generally outside the typical range of drift demands expected on buildings, so it can be said that for a practical range of drift demands, deformation capacity was fully recovered following repairs.
