# Performance recovery of a repaired 4-storey reinforced concrete structure subjected to shake-table testing

Understanding the effects of repair on reinforced concrete (RC) structures is critical to evaluating their performance in future earthquakes. In this research, a system-level approach is taken by repairing a previously damaged ¼ scale 4-storey RC structure and subjecting it to a series of dynamic excitations via shake table testing. The repair was undertaken using common construction materials with the primary motivation of restoring original performance. The performance of the repaired structure was compared to that of the original structure prior to repairs. It was found that overall initial stiffness of the structure was recovered to 66% of the original initial stiffness and was generally higher in floors where more intensive repair works were undertaken. Damping capacity was quantified via equivalent viscous damping ratio using three different methods. Regardless of the calculation method, the damping capacity recovery was around 80% for low-moderate drifts and 100% for high drifts. While collapse was not induced in the structure, drift ratio demands of over 5% could be

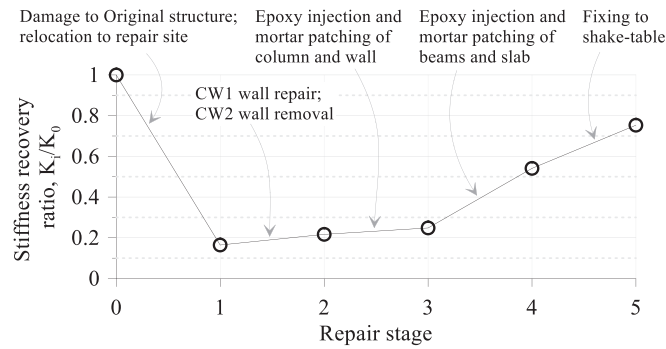
where  $K_0$  is the stiffness of the Original undamaged structure and  $K_i$  is the stiffness of the Repaired structure following the  $i$ th repair stage. The results of Equation (3) for each repair stage are plotted in Figure 7. From Figure 7 it can be observed that repairs to the wall (stage 2) and columns (stage 3) resulted in incremental increases in structural stiffness of 32% and 17% (relative to stage 1), respectively. Repair of the beams and slabs, (stage 4; corresponding to the largest volume of crack epoxy injection), resulted in the largest increase of stiffness relative to stage 1 of 151%. After re-attaching the structure to the shake-table (stage 5), the final Repaired structure's natural period was measured to have recovered to 87% of the Original structure's natural period (i.e., relative to stage 0), suggesting an overall stiffness recovery of 75%. This is considerably higher than the 70% recovery of natural period (50% stiffness recovery) achieved in a full-scale, 7-storey, repaired structure in a previous study.<sup>17</sup> It is thought that the comprehensive epoxy injection repair policy adopted in the

FIGURE 7 Estimated stiffness recovery factor from natural period measurements at each repair stage

present study (compared to<sup>17</sup> where only “major cracks” were injected) is the main reason for the higher stiffness recovery achieved.

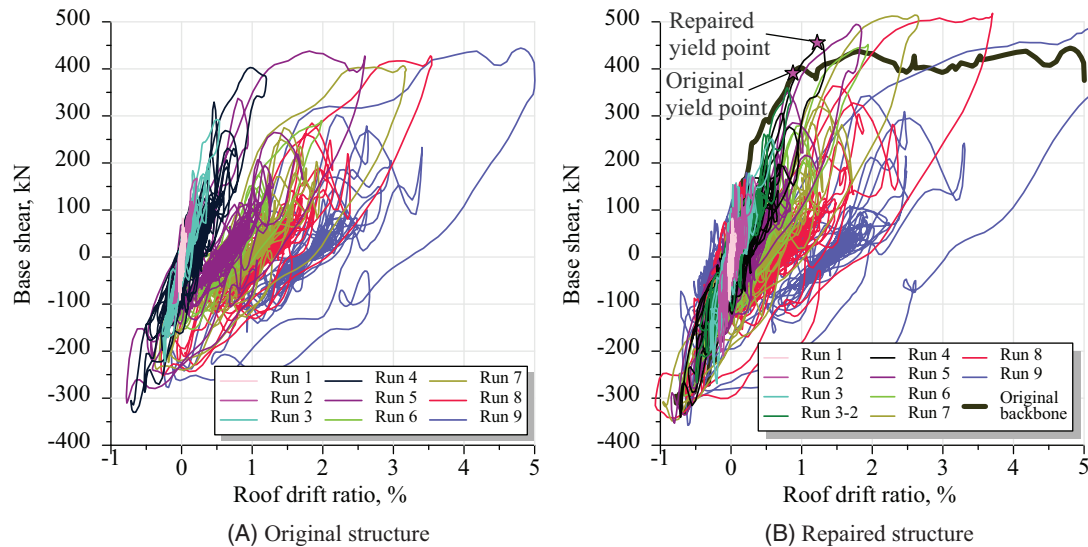
FIGURE 9 Base shear-roof drift ratio response of the (A) Original structure and (B) Repaired structure

The base shear-roof drift ratio relationship for the Original and Repaired structures are shown in Figure 9A and B, respectively. The envelope of the Original structure is traced as a grey line in Figure 9B for ease of comparison. Roof drift ratio was calculated as the cumulative sum of the inter-story drifts from each floor divided by the total height of the structure. The “yield points” of the Original and Repaired structures are also plotted in Figure 9B. The “yield point” corresponds to the formation of a full beam-sway mechanism in the structure. The full beam-sway mechanism was judged to have formed when strain in longitudinal reinforcement in all measured flexural hinges (beams, columns, and walls) exceeded the yield strain. From the comparison of Figure 9A and B the following observations can be readily made: (1) the stiffness of the Repaired structure leading up to the yield point is lower than that of the Original structure, (2) the apparent yield point of the Repaired structure has shifted to the right of the Original structure’s yield point, (3) the hysteresis loops in the Repaired structure do not exhibit any obvious increase in pinching characteristics compared to the Original structure (i.e., no significant reinforcement bond degradation, or shear sliding along cracks), and (4) the strength of the Repaired structure is considerably higher than that of the Original structure. These aspects will be discussed in detail in the next section.

From Figure 9B, the yield point has shifted from 0.97% in the Original structure to 1.3% in the Repaired structure. This shift is not thought to be due to a reduction in post-cracking stiffness (e.g., due to Bauschinger effect) because the Run 4 hysteretic curve of the Repaired structure passes directly through the Original structure's yield point, as can be seen in Figure 9B. Rather, this shift is thought to be due to member sections developing higher yield curvatures due to higher section yield strengths.<sup>29</sup> This observation suggests that the overall structural strength increase seen in Figure 9 is due to inherent strength increase of individual members rather than a change in modal vibration characteristics. Based on the yield point definition in Figure 9B, the “overall” yield secant stiffness of the Repaired structure recovered to 87% of the Original structure.

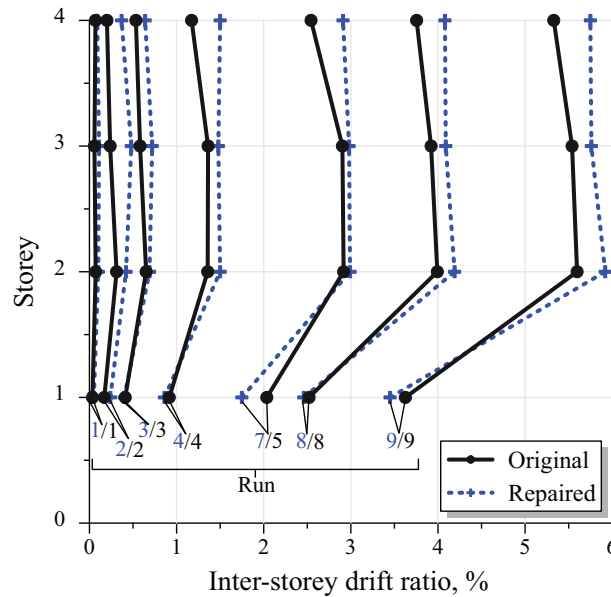
Maximum inter-story drift ratio distributions of the Original and Repaired structures are compared in Figure 10. Runs included in the comparison are those that achieve similar maximum roof drift ratios in both experimental programs (hereinafter “comparable Runs”). The purpose of this comparison is to make qualitative judgment on the shape of the drift ratio distribution rather than compare absolute magnitude. The maximum inter-story drift ratio distribution shape is very similar between the Original and Repaired structures suggesting no significant changes in the mode of vibration. Some minor difference is observed in the Repaired structure where the top inter-story drift ratio is slightly higher relative to the lower floors, when compared to the Original structure. This difference suggests that in the Repaired structure, upper stories are softer relative to the lower stories compared to the Original structure. Higher stiffness recovery in the lower floors is expected because of the higher intensity repair implemented (replacement of reinforcement and concrete) compared to the upper floors (epoxy injection only). Additionally, concrete cracks in the upper stories were generally narrower compared to that of the lower stories (particularly for columns and walls), resulting in likely reduced epoxy resin penetration depth.

FIGURE 10 Maximum inter-story drift ratio distribution for runs resulting in similar peak roof drift ratio

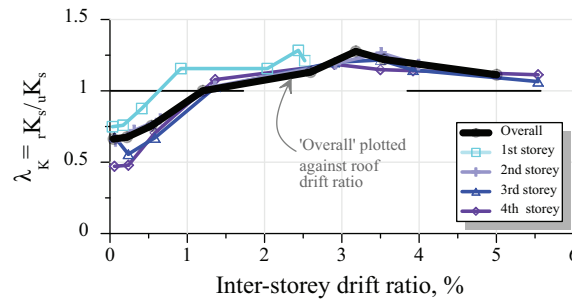
FIGURE 11 Recovery of secant stiffness,  $\lambda_K$ , for overall structure and for each storey

The recovery of structural stiffness is an important consideration in estimating potential future force and deformation demands on the structure. In this section, secant stiffness recovery is investigated over several excitations of the Repaired structure. As the response hysteresis loops are rounded due to inherent damping, in this paper secant stiffness of each Run is calculated as the average of the secant stiffness to maximum base shear and the secant stiffness to maximum deformation of that Run. Yield secant stiffness is calculated using the yield points in Figure 9B. The recovery factor,  $\lambda_K$ , of the secant stiffness of the Repaired structure,  ${}_rK_s$ , to that of the Original structure,  ${}_oK_s$  (where secant stiffness is calculated from the origin of the respective Run 1), is shown in Figure 11 for each comparable Run. The recovery factor is shown for both the “overall” response (i.e., using roof drift ratio) as well as that for each individual story, where accelerometer and inter-story drift data was used to get individual story stiffnesses. The “overall” initial stiffness of the Repaired structure (i.e., secant stiffness of Run 1) recovered to 66% of the Original structure. This number is similar to the 75% recovery ratio estimated from ambient vibration measurements, with the difference being due to the nature of the secant stiffness averaging method described above. These results show that despite a systematic and relatively extensive epoxy injection procedure the initial stiffness could not be fully recovered. This is likely due to a substantial number of cracks being too narrow or simply imperceptible to be effectively injected. Leading up to Run 4, secant stiffness recovery tends to be higher in the bottom stories (e.g.,  $\lambda_K = 0.75$  at first story for Run 1) compared to the top stories ( $\lambda_K = 0.47$  at top story for Run 1). This tendency is consistent with the data in Figure 10 where lower stories exhibited relatively lower peak inter-story

drifts, and again suggests that the repair was more effective in the lower stories. Following Run 4, the Repaired structure exceeded the strength of the Original structure, resulting in secant stiffness higher than unity thereafter.

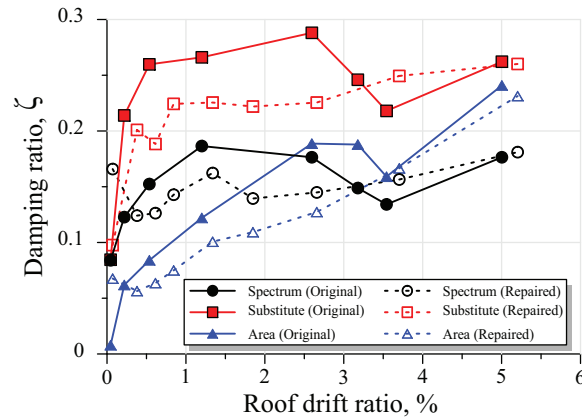
FIGURE 12 Equivalent viscous damping ratio of the Original and Repaired structures evaluated using three methods

From Figure 12 it can be seen that the absolute value of the equivalent viscous damping ratio varies significantly between each calculation method. The level of variability tends to decrease with increasing roof drift ratio of the structure. The “substitute” method results in the highest damping ratios (above 20% for both Original and Repaired structures). The “spectrum” method produces higher damping ratios than the “area” method up until roof drifts of around 3%, after which the trend is reversed, such that the “area” method produces higher damping ratios. The large variability in the damping ratio between methods is not unexpected given the fundamentally different theoretical and empirical assumptions in the calculations. These differences have been previously shown to have a dependence on the structural period, ductility and hysteresis shape.<sup>33</sup> In this study, the focus is given on the level of recovery of damping ratio rather than the absolute magnitudes. To calculate the damping capacity recovery factor,  $\lambda_d$ , the damping ratios for the Repaired structure were normalized by that of the Original structure for comparable Runs. The results are shown in Figure 13 (Run 1 and 2 data are excluded as large scatter was obtained when executing the quotient operation in the elastic region of the response). The comparison shows that despite large differences in the absolute damping ratio values seen in Figure 12, the magnitude of the damping recovery factor is generally in agreement between all three calculation methods for the Runs shown. The damping capacity recovery factor is approximately  $\lambda_d \approx 80\%$  up to 2.7% roof drift (i.e., Run 7/5 in Figure 13). This suggests that the damping capacity is only partially recovered at low-moderate seismic demands. The loss of damping capacity is attributed to imperfect restoration of the concrete performance (e.g., deficiencies in epoxy injection technique to reseal all cracks). On the other hand, at higher drifts (Run 8/8 and Run 9/9) corresponding to higher levels of damage, the damping capacity recovery factor is close to or slightly exceeding 1.0. At these high drift demands, concrete is generally fully cracked and so energy dissipation capacity is largely governed by the plastic deformation of reinforcement; thus, reduction in damping capacity is not expected provided there is no degradation in performance of reinforcement. Given these results, in simplified models of repaired structures that utilize some form of equivalent linearization of the beam-sway structural system, using a lower bound damping capacity recovery factor of 80% may be appropriate.

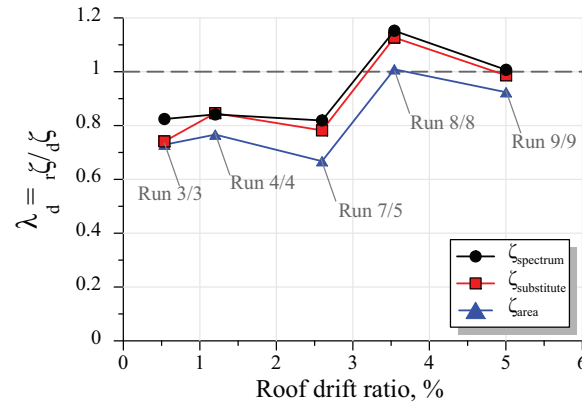
FIGURE 13 Recovery of damping ratio for each Run (Original/Repaired)

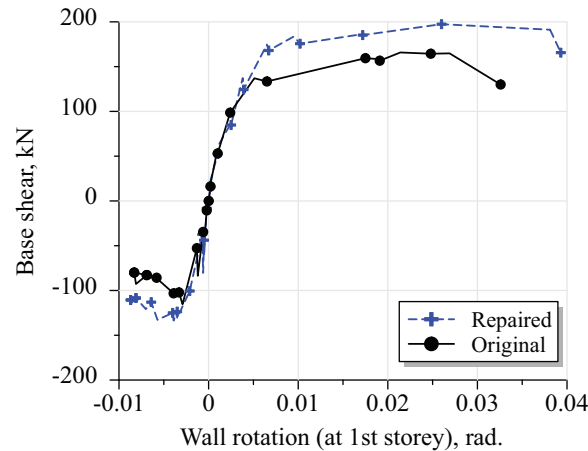
FIGURE 14 Plastic hinge rotation-base shear curve of the instrumented CW1 wall (Run 6 not shown)

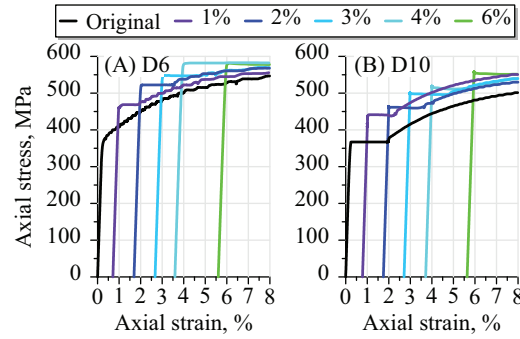
FIGURE 15 Stress-strain relationship of D6 and D10 reinforcement before and after strain aging

Therefore, a combination of reinforcement strain hardening and strain aging are thought to be the principal causes for the observed strength increase. The presence of strain aging also helps explain the absence of Bauschinger effect in Figure 9, as previous studies have demonstrated that the Bauschinger effect is “reset” by strain aging.<sup>35</sup> Previous studies on strain aged reinforcement have indicated that a strength increase of 10%–20% of the original yield stress can be expected, and that this value is somewhat independent of the maximum previously exerted strain.<sup>34–37</sup> To confirm whether strain aging was a cause of the observed strength increase in the present study, longitudinal reinforcement used in the beams (D6 bars), columns and walls (D10 bars) were tested. The test procedure involved subjecting the reinforcement to an initial tensile strain ranging from 1%–6% (strain ranges recorded in members of the Original structure); unloading and allowing the bars to age; and finally reloading the bars until tensile fracture. The aging process was accelerated by heat treating the bars at 100°C for 4 h, to simulated 1-year of strain aging<sup>38</sup> (the period between testing of the Original and Repaired structures). The stress-strain curves for the “original” non-aged reinforcement and strain-aged reinforcement are shown in Figure 15. It can be seen that after the strain aging process the yield stress of both the D6 and D10 reinforcement exceeded the envelope of the “original” reinforcement. The strain aged reinforcement curves also exhibit reemergence of the yield-plateau, which would otherwise not be present had reloading occurred immediately after unloading from the initial strain. This provides evidence for the disappearance of the Bauschinger effect and an explanation of why the backbone of the Repaired structure in Figure 9B passes through the yield point of the Original structure. The increase in stress directly attributed to strain aging (i.e., excluding the effect of strain hardening) for each bar diameter is shown in Figure 16. It can be seen that while the magnitude of the stress increase is different for the D6 and D10 reinforcement, it is essentially independent of the initially applied peak strain level, provided yielding has occurred. On average, the increase in stress is 57 MPa for D6 reinforcement and 81 MPa for D10 reinforcement. Expressed as a percentage relative to the expected stress at the corresponding strain level for a non-aged bar, this becomes 12% and 19% for D6 and D10 reinforcement, respectively.

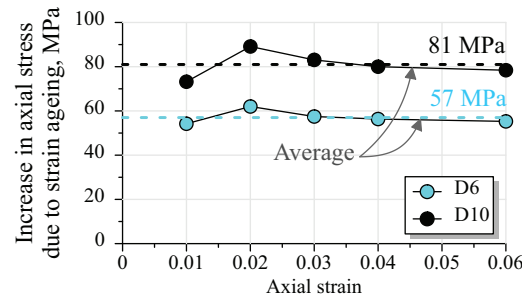
FIGURE 16 Increase in strength attributed to strain aging for D6 and D10 reinforcement
