### Article Community-Based Portable Reefs to Promote Mangrove Vegetation Growth: Bridging between Ecological and Engineering Principles

Citation: Sreeranga, S.; Takagi, H.; Shirai, R. Community-Based Portable Reefs to Promote Mangrove Vegetation Growth: Bridging between Ecological and Engineering Principles. *Int. J. Environ. Res. Public Health* **2021**, *18*, 590. https://doi.org/10.3390/ ijerph18020590

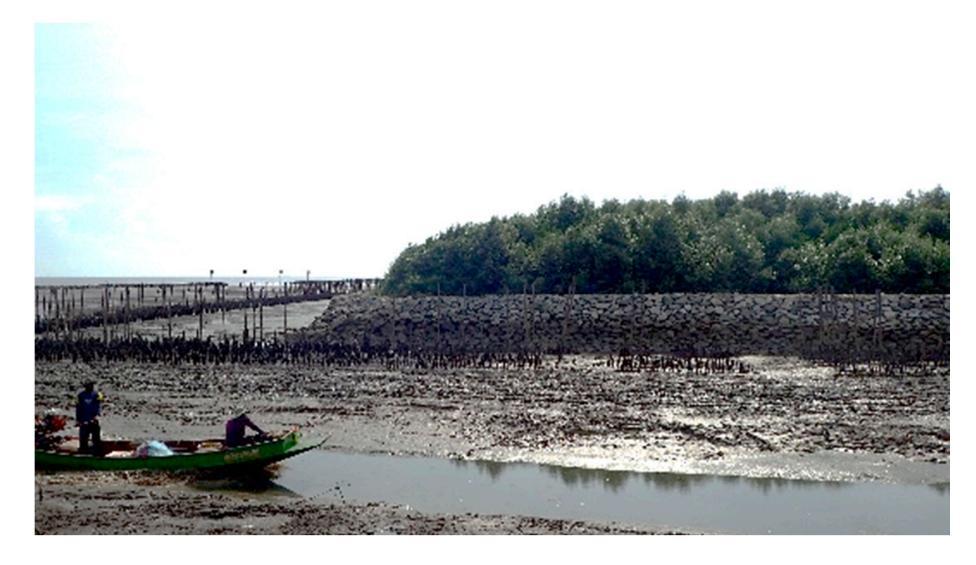
**Figure 1.** Successful mangrove plantation in Chonburi, Thailand—however, the rubble dike stopped the expansion of the forest [photo taken by one of the authors].

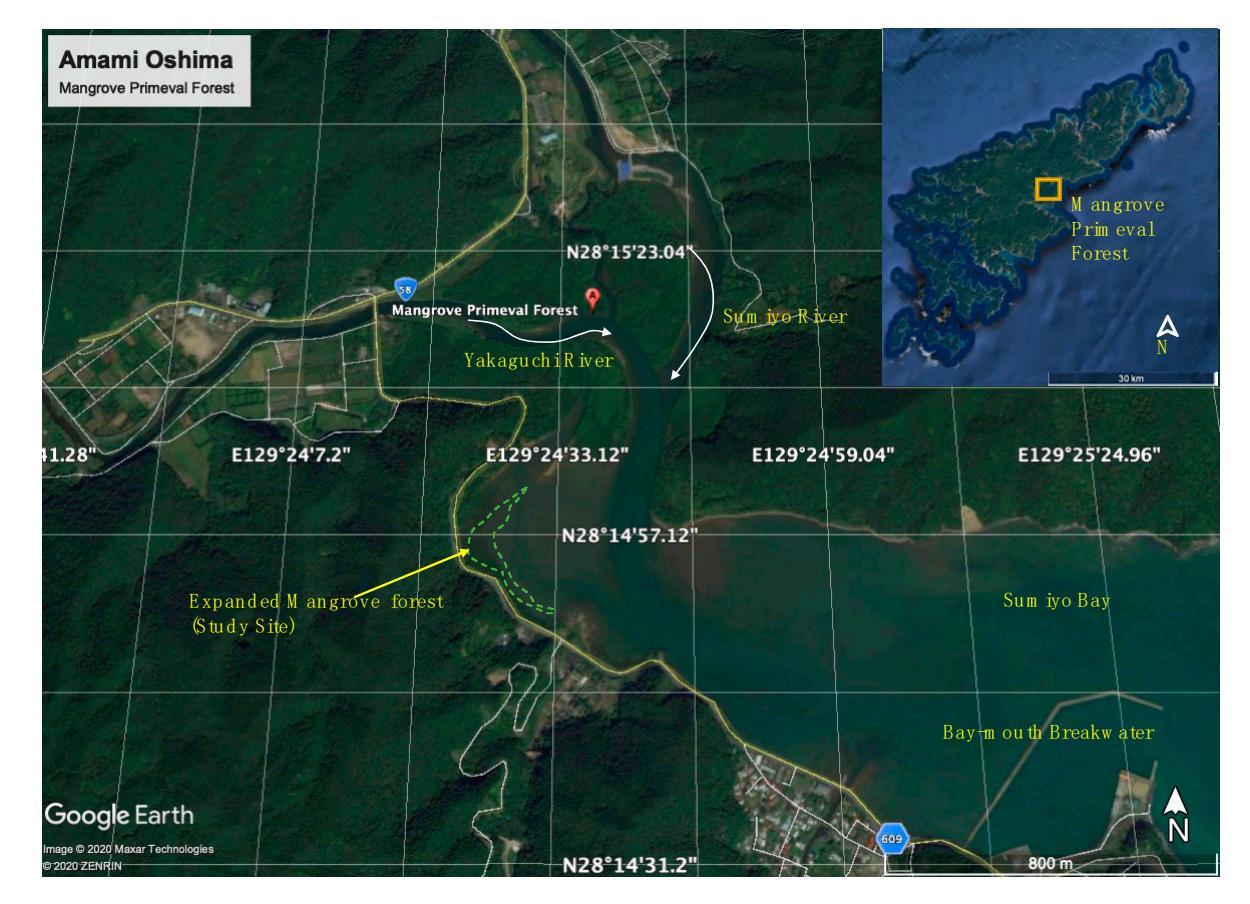
**Figure 2.** Mangrove study site, which is located at the inner-most part of Sumiyo Bay in Amami (study site location: 28°14′57.3″ N 129°24′24.8″ E).

Field surveys were conducted in May 2019 and December 2019, and seaward expansion of young mangrove shrubs was found on sediment deposition in the tidal inlets of Amami Oshima Island (hereinafter "Amami"), Japan. The month of May is the postpollination period, in which the species *Kandelia obovata* in the primeval mangrove forest produces enormous seeds, whereas December is cold, and mangrove growth is not vibrant [43]. A large colony of natural mangroves (*K. obovata*) was identified in Sumiyo Bay of Amami near the inlets of the Yakugachi River and Sumiyo River (Figure 2). As observed in the field survey, mangrove seedlings were transported from the mainstream of the primeval forest and settled on the shallow mudflat with the fast-developing root system. While many mangrove forests are facing degradation in Japan, the primeval mangrove forest of Amami has been expanding for several decades [44]. This mangrove forest is located in areas where the flow of rivers is mild, and the coast is shallow and calm. When the tide recedes, the tidal flat becomes a place where organic matter from the river and the ocean is deposited, providing a habitat for a variety of animals. In addition to the favorable environmental conditions, the expansion of the area may also partially be attributed to the breakwater constructed at the bay mouth, protecting the inner bay area from offshore high waves (Figure 2).

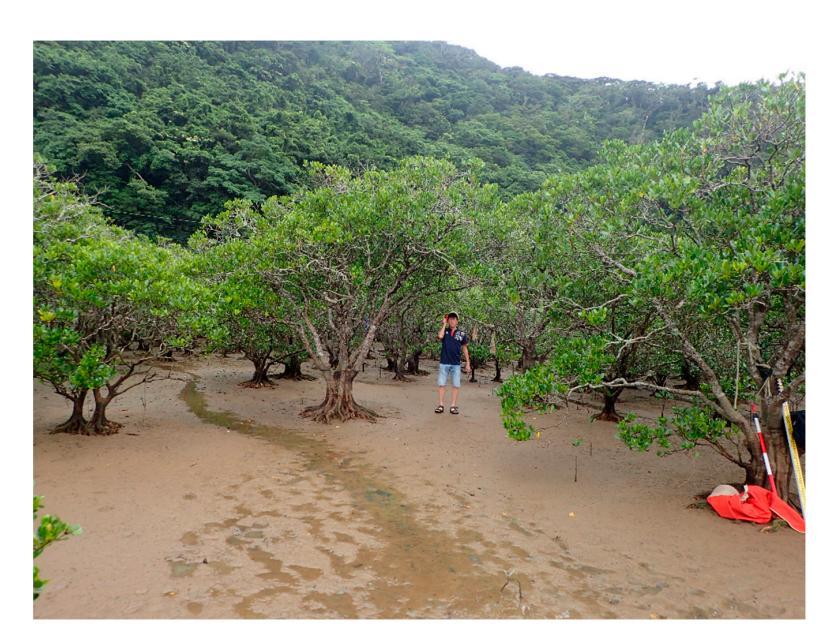
Figure 4. Measurement of the topography in the mangrove forest.

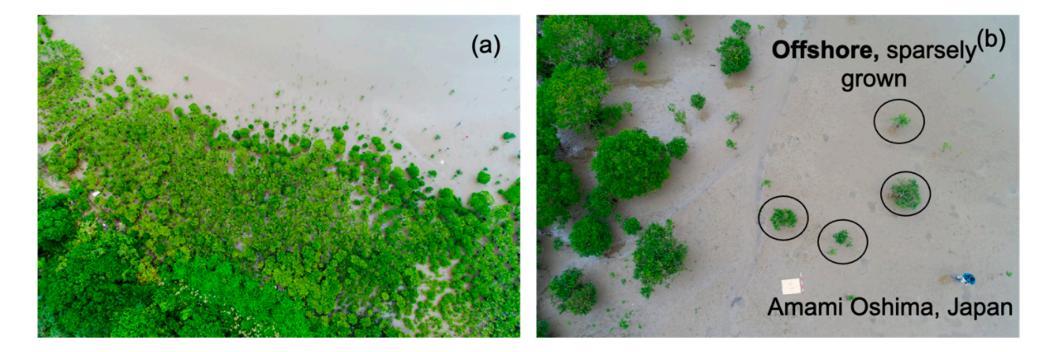
Figure 5. (a,b) Observed mangrove density at the study site in Amami (photos were taken by a drone).

The land slope of a mangrove forest approximately 80 m wide was measured to be as mild as 1/100 on average. This can be considered as a gentle slope but not extremely flat. The density of mangrove plants varied extensively depending on location, i.e., offshore, midshore, and near-shore regions. When approaching the offshore area, it was observed that the number of plants tended to decrease. The lowest mangrove densities were found offshore, where water depths reached half a meter at high tide. Mangrove density was very sparse offshore, whereas 2–4 plants/m<sup>2</sup> in the midshore and 10–20 small mangrove plants/m<sup>2</sup> around two matured shrubs onshore were observed, as shown in Figure 5a,b.

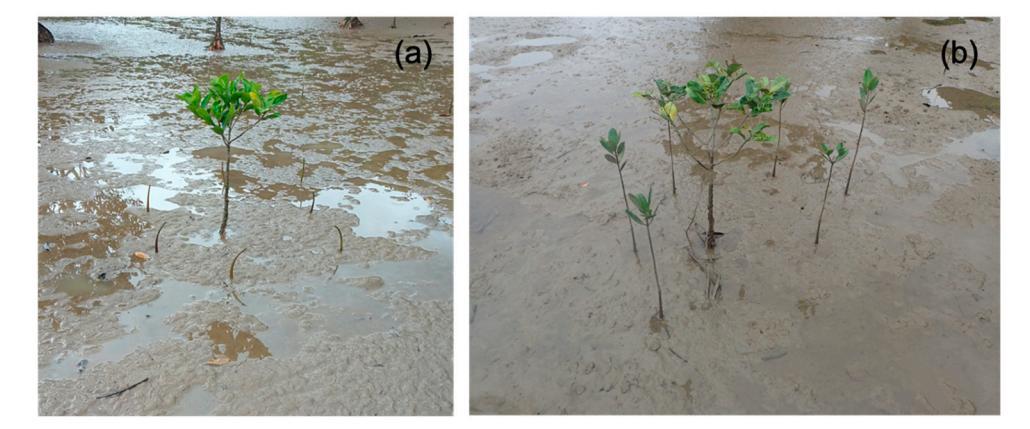
**Figure 6.** (a) Mangrove seeds planted around a prominent existing mangrove in May 2019 and (b) mangrove plant growth in December 2019.

Figure 6a,b illustrate the plantation of mangroves and their growth from May 2019 to December 2019. Twenty seeds with an initial seedling length of 18.5 cm on average (standard deviation of 3.5 cm) were planted in the offshore zone. The diameter of the seeds varied among the seedlings, with the widest part being 5–10 mm. As shown in Figure 3, some seedlings were completely straight, whereas the others were significantly curved, as observed during the plantation. The color of the seeds varied from green to brownish-green. Of the many plantations, one was made around an existing mangrove plant to clearly identify it during a future survey, as in Figure 6a,b, and the remaining seedlings were planted in nearby locations. In the December 2019 visit, it was found that the survival rate of planted seedlings was 75% (15 out of 20 seeds). Hydrological disturbances, such as high waves, unusual tides, and currents, especially during the typhoon season (July to October), can result in the uprooting of seedlings in soft sediments. Fortunately, however, no strong typhoon approached Amami during the half-year of this survey. Nevertheless, the five seedlings died or washed away for some reason. Various microbial organisms, such as bacteria, fungi, viruses, nematodes, and insects [47], and abiotic factors, such as high salinity levels and low and extremely high temperatures, could have adversely affected the growth of the mangrove plants [2]. The loss may also have been caused by sapling damage by animals, e.g., sea crabs, which selectively eat young seedlings. The water temperature and salinity level in May 2019 were 28.3 °C and 8‰, respectively, while the temperature reduced to 26.1 °C and the salinity increased to 19‰ in December 2019. The rise in salinity may have been because the water discharge from the two rivers is higher in spring than in winter. The precipitation chart is shown in Figure 7, which also supports the observation that salinity levels might have varied because of the difference in precipitation, which is higher in the rainy season (around June) and lower in the winter season (around December).

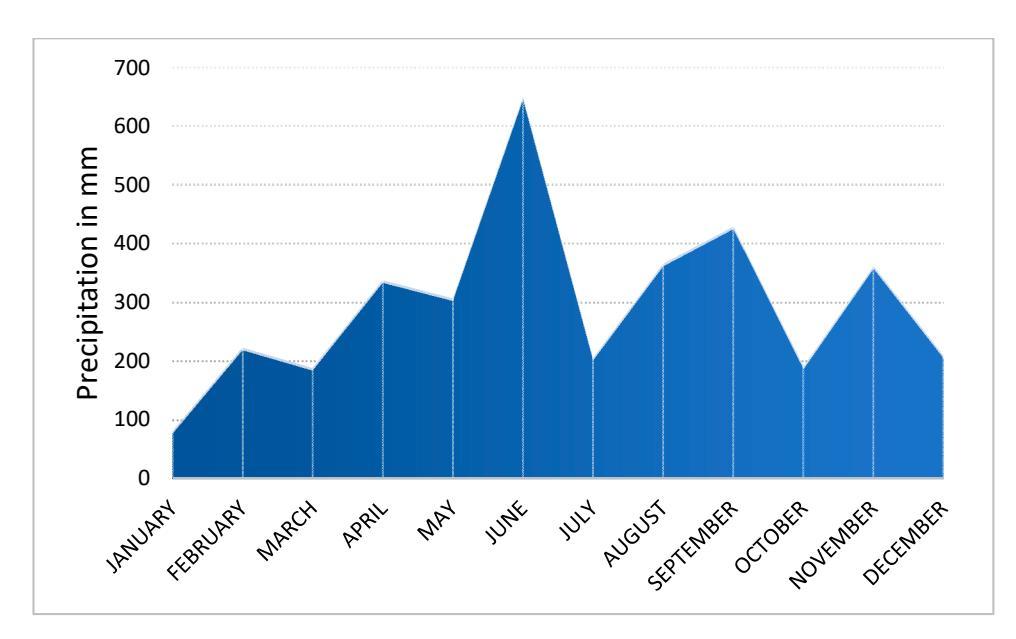
**Figure 7.** Monthly precipitation in 2019, recorded at Naze WMO Station in Amami (Lat 28°22.7′ N Lon 129°29.7′ E)—source: Japan Meteorological Agency.

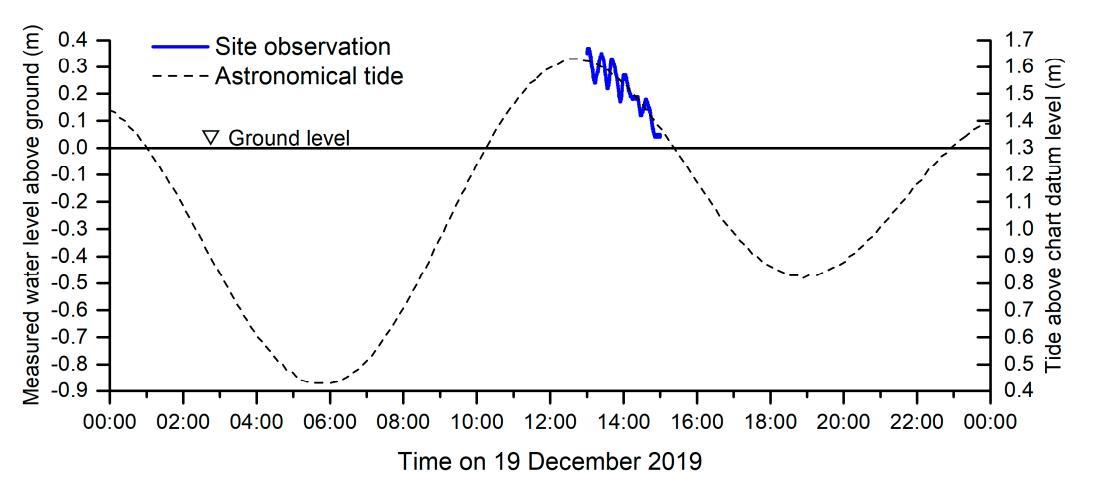
**Figure 8.** Water levels recorded at 1-s intervals for approximately 2 h (19 December 2019) presented in coordination with local astronomical tide data of the day.

Figure 8 depicts water levels and their fluctuations in the study site, recorded using the pressure sensor, on the one-day cycle of the predicted astronomical tide of the bay. The water level fluctuates in correspondence with astronomical tides. It dropped from nearly 0.4 to 0.05 m above the ground level in 2 h, between high to medium tidal ranges. This observation was conducted on a half-moon day during a medium tidal phase. However, the actual water level oscillated with a short period of approximately 20 min on top of the tidal curve. Although it has not been confirmed, this seems to be a sort of seiche that occurs in the bay. As a result, actual currents in mangrove forests may be faster than those induced by pure astronomical tidal forcing. However, the maximum velocity measured in the field was approximately 10 cm/s. This is significantly slower than the velocity generated in a tidal-dominant river mouth where a tidal current of more than 1 m/s often occurs [48].

Because the water depth is very shallow in the study site, frictional effects are believed to be responsible for a significant reduction in flow speed. This level of tidal currents is considered to be less impactful to young mangroves.

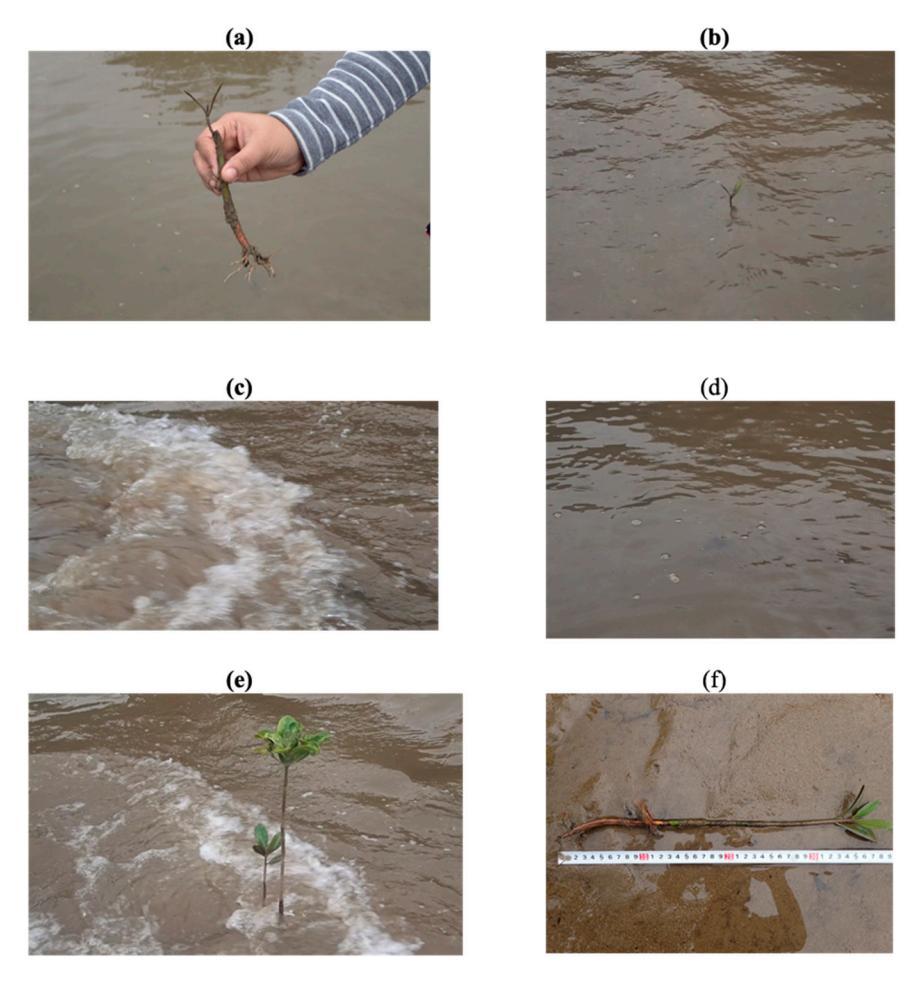
Figure 9. On-site manual wave generating test: (a) one-month mangrove, (b) before the wave test, (c) during the wave test, (d) after the wave test, (e) half-year-old and one-year-old mangroves during the wave test, and (f) half-year-old mangrove pulled out.

In the December survey, an in situ wave experiment was conducted to observe the strength of plants against waves. Waves were manually generated with a paper board for approximately 2 min, which impacted different age groups of plants, such as a month, a half year, and one year. The purpose of this test was to verify the differences in response to waves and critical wave height among the three young mangroves in different growth stages. The maximum wave height during manual wave generation was estimated to be approximately 10 cm through visual analysis with a video image. Figure 9a shows a 17-cm-long one-month-old mangrove that had two leaves, a short main root of approximately 2 cm, and thin subroots. The plant was mostly submerged during the test (Figure 9b). The one-month-old plant was broken entirely and submerged by a 2-min continuous-wave impact, as in Figure 9c,d, whereas a half-year-old and one-year-old mangrove 39 and

80 cm in height, respectively, survived without visible damage, as shown in Figure 9e. The six-month-old mangrove plant shown in Figure 9f developed a stiff root system with a length of one third the total plant length. Hence, it was firmly rooted in the sediment and could withstand the waves. The field investigation revealed that mangroves in the very early stage of growth (a few months) were particularly weak, whereas a half-year-old or older mangrove can sufficiently withstand moderate waves. Thus, special protection is required to protect mangrove seedlings from high waves in the initial two to three months. As a rough estimate, the failure limit of mangroves is considered to be a wave height of 0.1 m, which was used as a basis for the structural design of a portable reef.

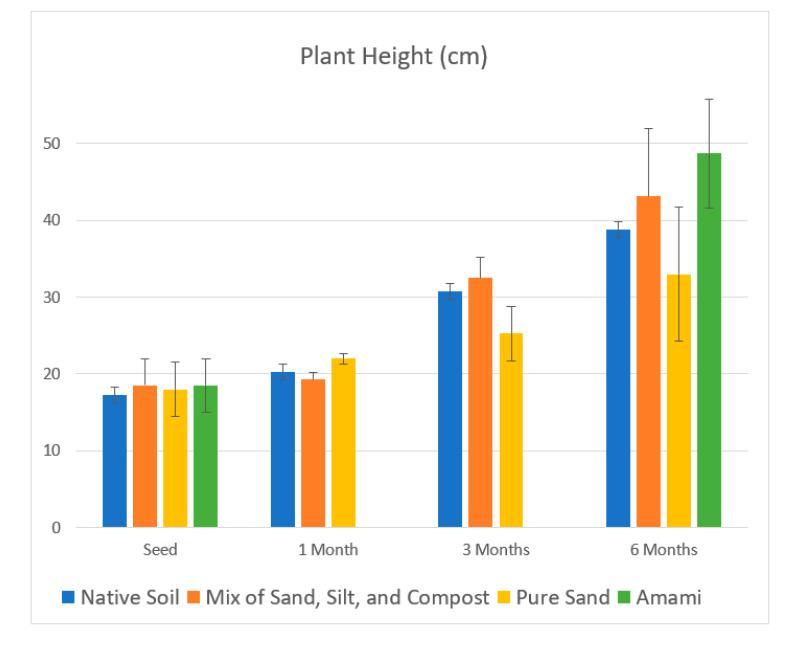
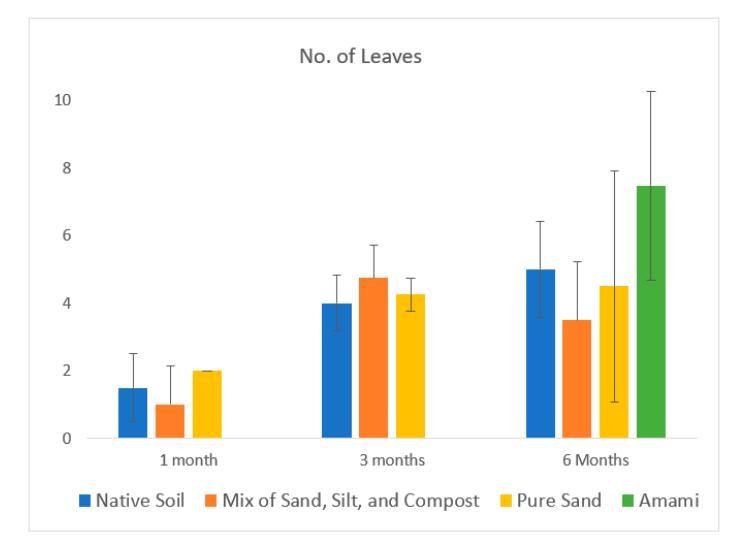
**Figure 10.** (**a**,**b**) Average mangrove growth in terms of height above the soil and the number of leaves recorded during six months in the laboratory: error bars indicate the range of minimum to maximum.

Figure 10a,b illustrate the mangrove evolution in terms of plant height and number of leaves in the laboratory. Mangrove growth was also measured six months after plantation at the Amami research site, as shown in Figure 6b, and compared with the sixth-month growth of plants in the laboratory. In the laboratory in Tokyo, the growth of the mangrove plant was observed for six months, and measurements were taken for the first, third, and sixth months. Pregerminated mangrove seeds (propagules) brought from the site were planted to observe their growth in different soil states: native soil, a mixture of sand, silt, and compost, and pure sand. The growth of mangroves was observed and measured in terms of the average height and the average number of leaves with standard deviations, as shown in Figure 10a,b. Pictures of propagule growth were taken at zero, one, three, and six months of laboratory plantation, as shown in Figure 11a–d. Although the initial

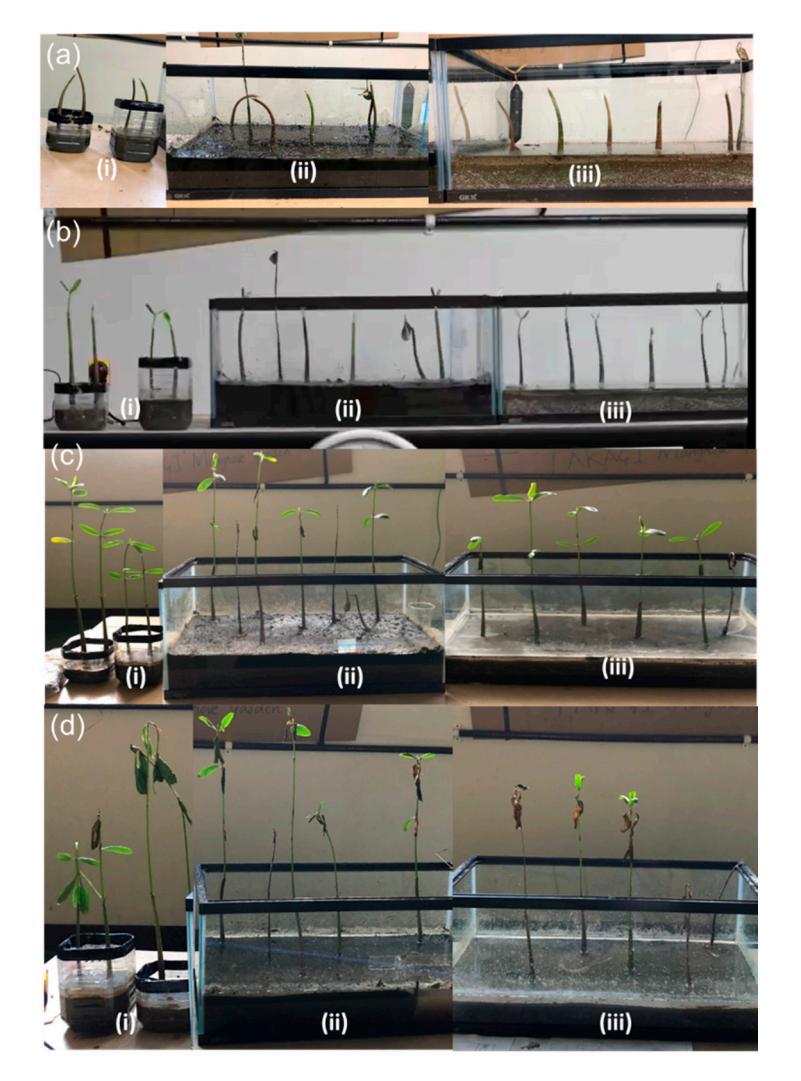
**Figure 11.** Growth of laboratory mangroves in (i) native soil, (ii) mix of sand, silt, and compost, and (iii) pure sand (**a**) on day of the plantation (5 June 2019), (**b**) after one month (10 July 2019), (**c**) after three months (9 September 2019), and (**d**) after sixth months (10 December 2019): an example of the growth record has been uploaded as a time-lapse video at http://www.ide.titech.ac.jp/~takagi/Labmangrove.html.

growth was similar among the three soil types, the fastest plant growth was observed in the mixture of sand, silt, and compost after six months. Two plants in the mixture soil had withered at the end of the sixth month, despite showing good growth until three months. The average height of mangrove plants in Amami was 49 cm, with an average of 7.3 leaves per plant, as in Figure 10a,b, while indoor plants demonstrated growth of a height of 38.5 cm with the number of leaves up to 4.3 on average. The laboratory-grown plants were 21% lower in height than the plants grown in Amami. Similarly, the average number of leaves after six months was 41% lower than that of the plants at the Amami research site. The laboratory-grown plants appeared weak, and the stems turned and bent downward, as shown in Figure 11d. The plants grown in native soil looked healthiest among the three soils.

The germination of seedlings began with the development of the stem with a pair of leaves in the first month in all soil media, as shown in Figure 11b. After the third month, the

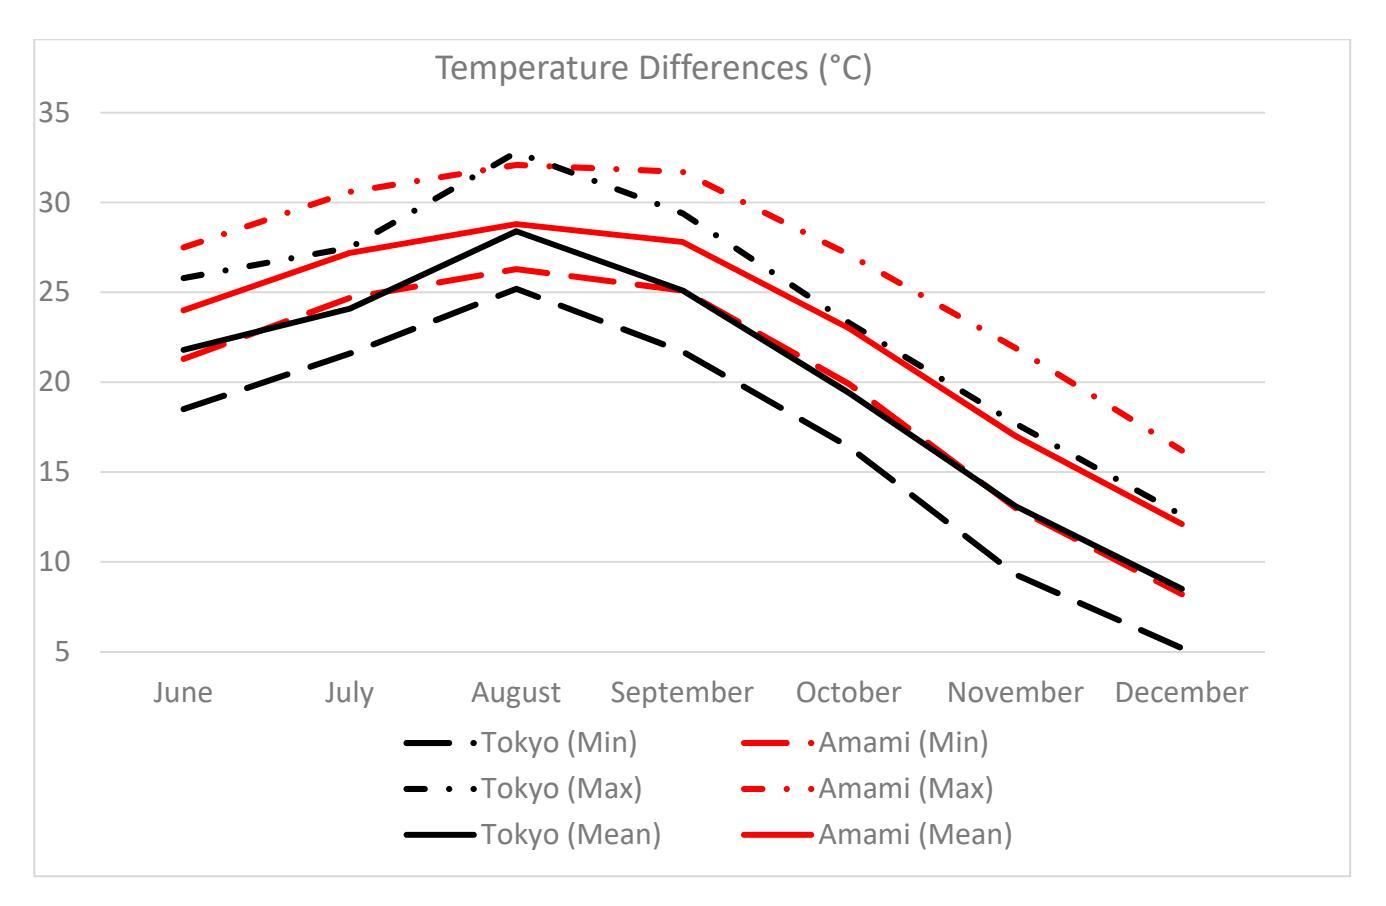
**Figure 12.** Comparison of average minimum, mean, and maximum temperatures between Tokyo and Amami (Kagoshima Prefecture)—source: Japan Meteorological Agency.

The air temperature differences in Tokyo and Amami for the period of six months from June to December 2019 are shown in Figure 12. On average, the temperature in Amami was 2.8 °C higher than in Tokyo. However, the maximum temperature in Tokyo (28.8 °C) was 0.4 °C higher than that in Amami (28.4 °C) in August. In December, the average temperature dropped to 8.5 °C in Tokyo, while that in Amami was 12.1 °C. The cold weather during the early winter season probably retarded the growth of mangrove plants and resulted in the withering of the leaves. The diameter of the laboratory mangroves remained almost unchanged and was less than 4 mm on average, while the average stem diameter of Amami mangroves was 5.4 mm, which is 35% thicker than that of the laboratory mangroves. The Amami mangrove stems appeared tougher and had a deeper green color than those in the laboratory. The leaf surface of the Amami plants was also slightly thicker, whereas that of the laboratory mangroves was thinner and lighter in color.

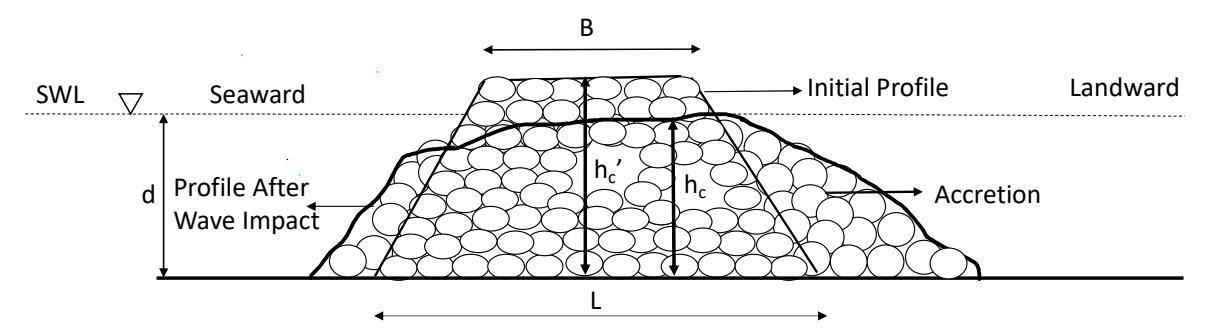
Figure 13. Typical reef profile before and after damage, adapted from Ahrens (1989) [58].

However, it is essential to allow deformation of the system to some extent, particularly in the case of smaller stones. Hence, the formula obtained by Ahrens [59], which designs a low-crested rubble-mound, reef-type breakwater without a multilayer cross section, was applied. Figure 13 illustrates the concept of the low-crested breakwater. Here,  $h_c'$  is the initial crest height, and  $h_c$  is the crest height at the end of the wave impacts, based on an empirical equation from the experiment. In addition, B is the crest width (three median stones wide:  $3D_{n50}$ ). The stability can be examined by considering the crest height that sunk as a result of continuous wave impacts.

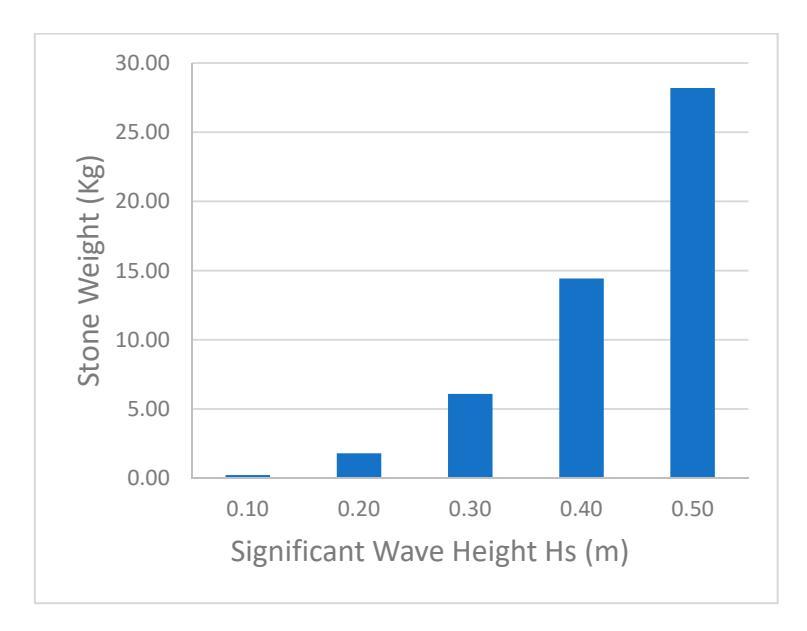
Figure 14. Required weight of single stone against a given wave height.

Equation (1) is analyzed for the range of significant wave heights ( $H_s$ ), with  $K_D$  being 1.2 for quarry stone, smoothly rounded for breaking waves [57]. Here,  $\gamma_s$  is taken as 2800 kg/m<sup>3</sup>, and the slope of the structure is considered to be 1V:2.5H, leading to a slope angle  $\alpha$  of 21.6°. The relationship between  $H_s$  and the armor unit weight is plotted in

Figure 14. When 0.3 m is used as the design wave height, the lowest stone weight is calculated to be approximately 6 kg.

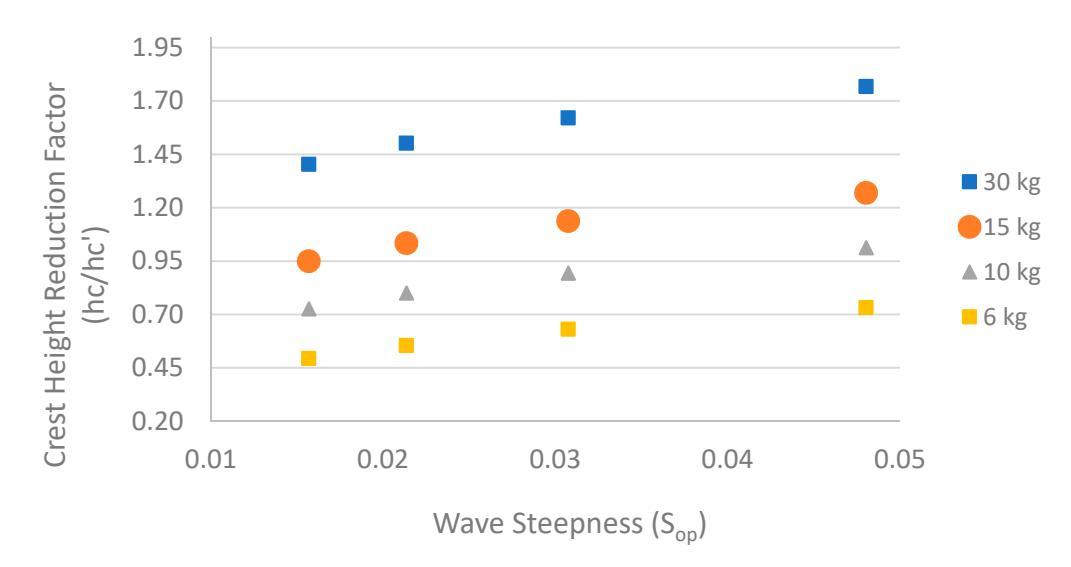
**Figure 15.** Crest height reduction factor  $(h_c/h_c')$  versus wave steepness  $(S_{op})$ .

Here,  $A_t$  is the structural cross-sectional area  $(Bh_c'+C'h_c'^2)$ , C' is the average structural slope,  $N_s$  is the spectral stability number,  $B_n$  is the bulk number, and d is still water depth. Short wave periods in the range between T = 2 and 3.5 s are assumed to calculate the wavelength  $L = \sqrt{gd}T$  and wave steepness  $S_{op} = 2\pi H_s/gT^2$ . The deformation in crest height  $(h_c)$  can be estimated using Equations (3) and (4). Figure 15 shows a graph of the crest

height reduction factor  $(h_c/h_c')$  versus wave steepness. If  $h_c/h_c'$  exceeds 1, the structure is fully stable, whereas, when  $h_c/h_c'$  drops below 1, the structure is less stable [57]. The structural stability increases with the increase in wave steepness. A stone weight more than 15 kg showed  $h_c/h_c' > 1$ , indicating a stable condition for the design wave. Hence, for the design considerations of stone, a weight of 15 kg can be used as an optimal weight, rather than 6 kg.

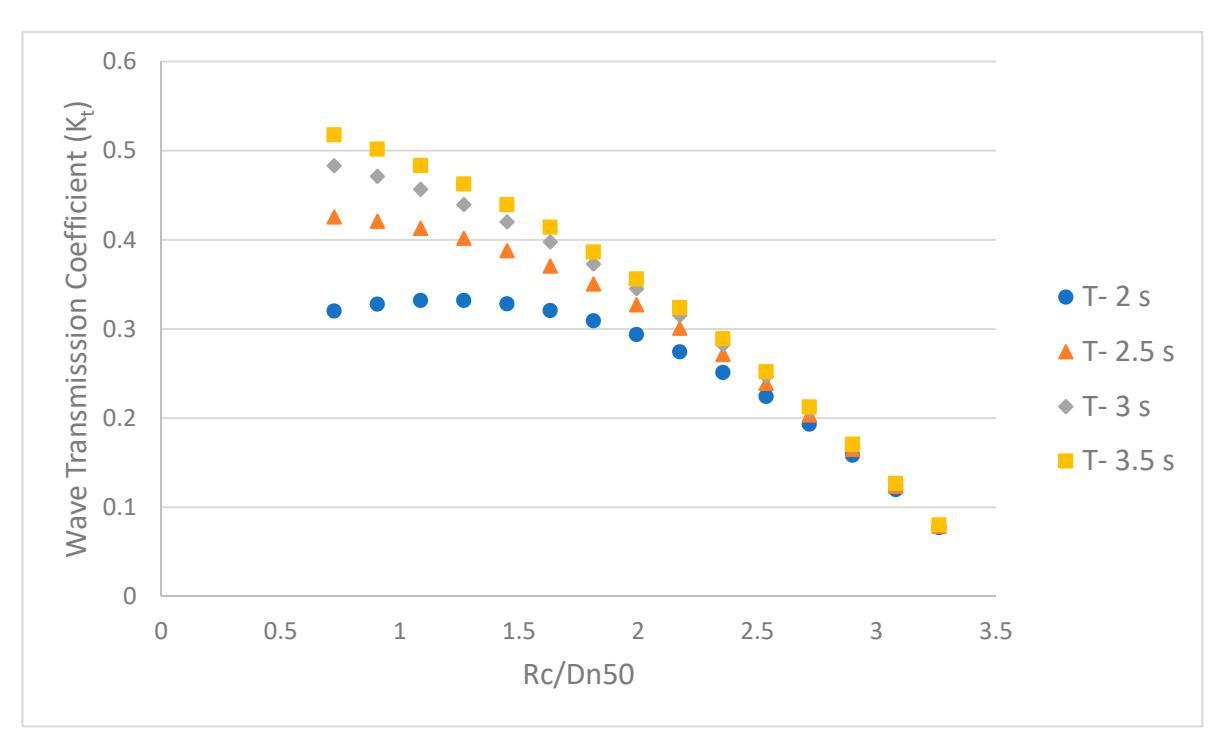
Figure 16. Wave transmission versus relative crest height.

Here,  $K_t$  is derived for the proposed portable reef design (Figure 16. The  $K_t$  value markedly varies with the change in the relative crest height ( $R_c/D_{n50}$ ). The minimum  $K_t$  and maximum  $K_t$  expected of a portable reef breakwater fall between 0.07 and 0.51 for wave periods of 2 to 3.5 s. The lower the relative crest height, the higher the transmission. The lower the height of the breakwater, the smaller the stone volume required. However, a reduction in the freeboard increases the transmission of the waves and adversely affects the growth of mangroves. In the field experiments in Amami, it was found that mangroves of approximately one- or two-month-old plants were washed away by waves, even at a wave height of approximately 10 cm. Hence,  $K_t$  needs to be set below 0.3 in the case of a wave height of 30 cm at the portable reef.

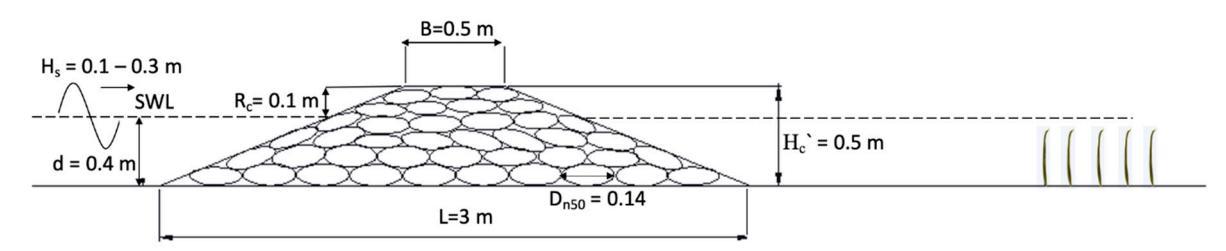
Figure 17. Example of a portable reef and mangrove planting.

As a result of these considerations, the breakwater cross section shown in Figure 17 was selected as one of the candidates to form the entire reef system as simply and feasibly as possible for the local community. The total number of stones needed to form a trapezoid per cubic meter was estimated as 145 (average of 15 kg each). Because of the low weight of the stone, construction can be accomplished without the use of heavy machinery if several workers collaborate. This is an advantage in areas where the ground is loose, such as where mangroves grow. There is a possibility that the reef top may sink a little bit owing to settlement, but it will be easy to replenish. A mangrove plantation is implemented after the reef is installed. However, plants may be washed away because of the disturbance caused by wave overtopping if planted immediately behind the reef. Therefore, it is recommended to maintain a certain distance between the reef and the plantation. It is necessary in future research to investigate how much distance is needed.
