Wind-induced Response Characteristic Evaluation of High-rise Seismic Isolated Building Based on Observed Records

KEY WORDS: High-rise Seismic Isolated Building; Wind-induced Response; Observation Records; Residual Deformation.

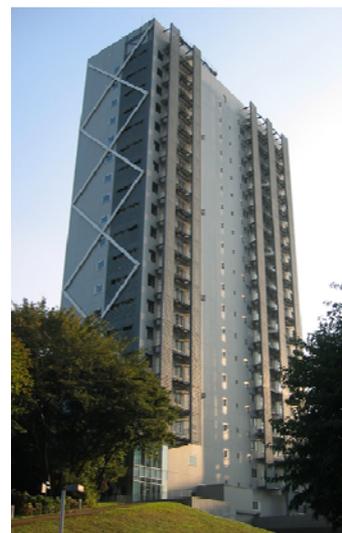
Figure 1. External appearance of 20-story high-rise seismic isolated steel building (J2-building)

20-story high-rise seismic isolated steel building (91.4 m) as shown as in Figure 1 was constructed at Tokyo Institute of Technology Suzukake-dai campus located in Yokohama Japan in 2005, and a long-term monitoring to the wind velocity and the response of building has been executed. This paper presents about a long-term dense monitoring system of this high-rise seismic isolated building, and discusses about the wind-induced response characteristics of this high-rise seismic isolated building based on observed records.

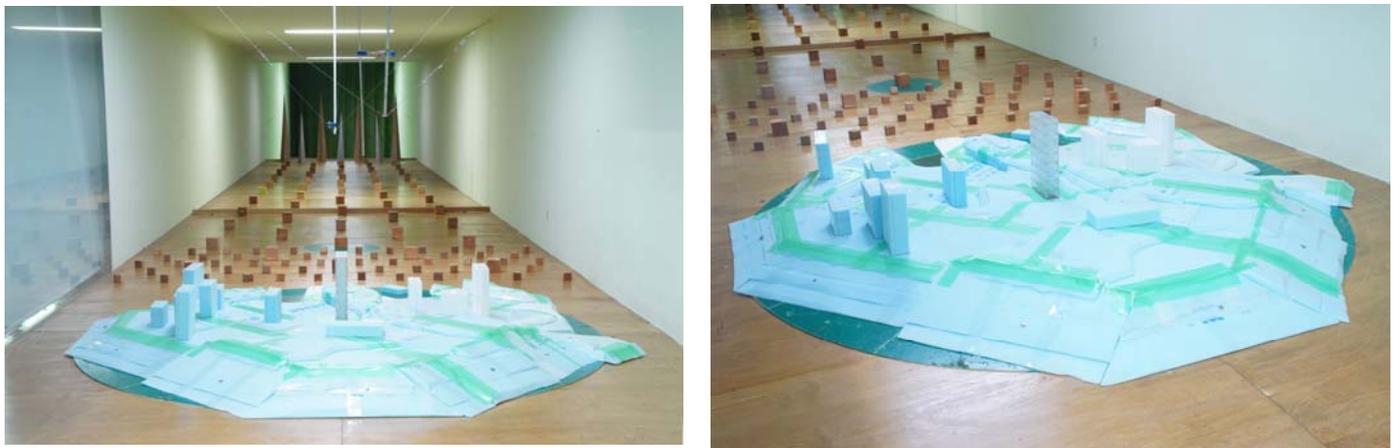
Figure 22. Situation of wind tunnel experiment

where, j : step number every ten minutes, ρ : the air density, $A^{(j)}$: projected area of building at step j , $C_{DX}^{(j)}$: X direction's wind force coefficients at j step's wind direction which are obtained from the wind tunnel experiment. The wind tunnel experiment are carried out by using the exposure category III flow, and the building surroundings are reproduced as shown in Figure 22. Figure 23 illustrates the relation between the X direction deformation of isolation layer obtained from the observer records δ_{MX} and the X direction static shearing force $Q_{MX}^{(j)}$ calculated by Eq. (2). In addition, the designed stiffness of the isolation layer [1]
