Doctoral Dissertation

**Development of Performance Improvement Method
of Existing Steel Railway Bridges
by Installing Concrete Decks**

Masamichi SAITO

Department of Civil Engineering,
Graduate School of Science and Engineering,
Tokyo Institute of Technology

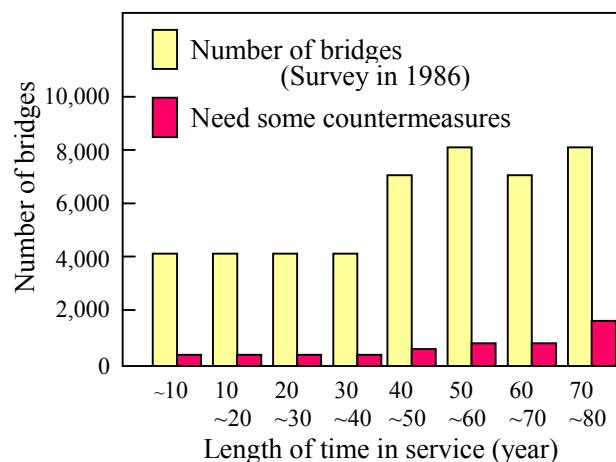
Fig. 1-1 Number of steel railway bridges in Japan Railways¹⁾

There are about 50,000 steel railway bridges in Japan. **Fig. 1-1** shows the number of steel railway bridges and the number of bridges in need of attention, with respect to age of bridges¹⁾. Although the data is a result of an old survey in 1986, the data shows the number of bridges in whole Japan National Railways. According to **Fig. 1-1**, more than half of existing railway steel bridges has been still in service beyond their designed lifetime, *i.e.* 60 years. **Fig. 1-2** shows the number of bridges in the area of JR East²⁾. Until 70 years ago, steel bridges had been mainly constructed as railway bridges. On the other hand, concrete structures, *i.e.*, reinforced concrete (RC) and prestressed concrete (PC), have been constructed as railway bridges. As a result, there is a difference in its composition between older bridges (60 years ~) and younger bridges (~ 60 years). Most of these bridges are maintained appropriately in a systematized maintenance method³⁾. However, still a large number of these bridges are in need of repair or replacement. These bridges have problems such as corrosion, fatigue, large noise and maintenance.

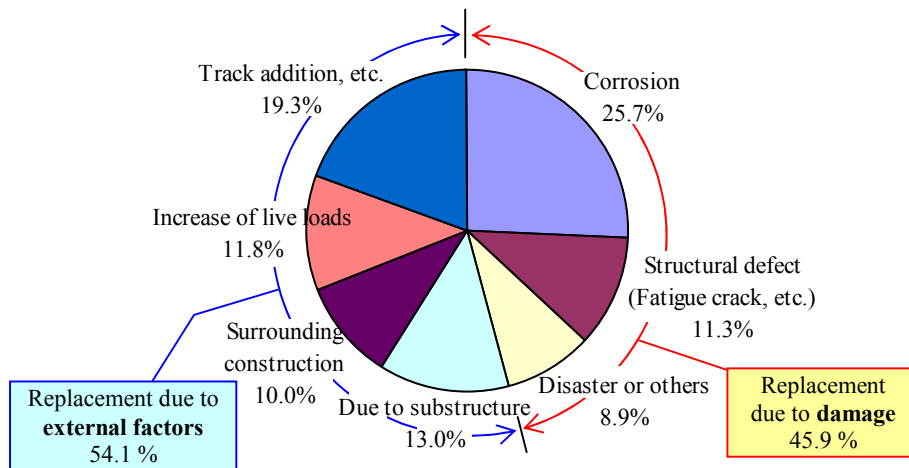
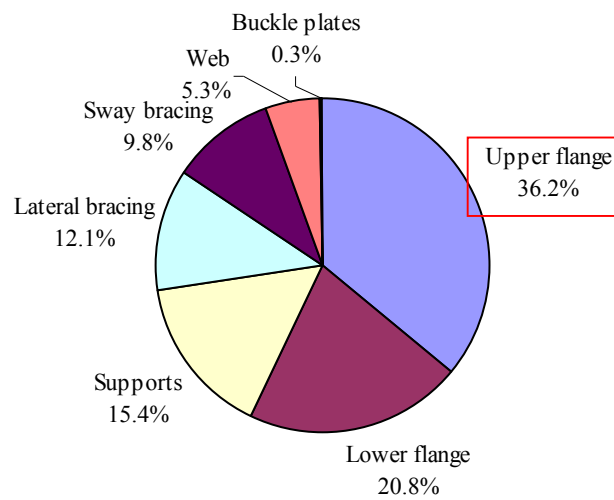
Fig. 1-3 Reason of replacement and corroded member of steel railway bridges⁴⁾

According to the result of the past investigations⁴⁾, about half of the bridges were replaced due to their damage and another half of them were replaced due to external factors, as shown in **Fig. 1-3(a)**. Among these reasons, corrosion accounts for 25.7 % and it is the maximum number. Furthermore, corrosion of the upper flange accounts for 36.2 % among the corroded members of deck girder bridges. Although these data are the result of old survey (in 1969), more than half of the existing steel railway bridges were constructed before this survey as mentioned in 1.1.1. Furthermore, the current situation of them is not totally different from the time of the survey, *i.e.* there are many cases of the upper flange corrosion⁵⁾.

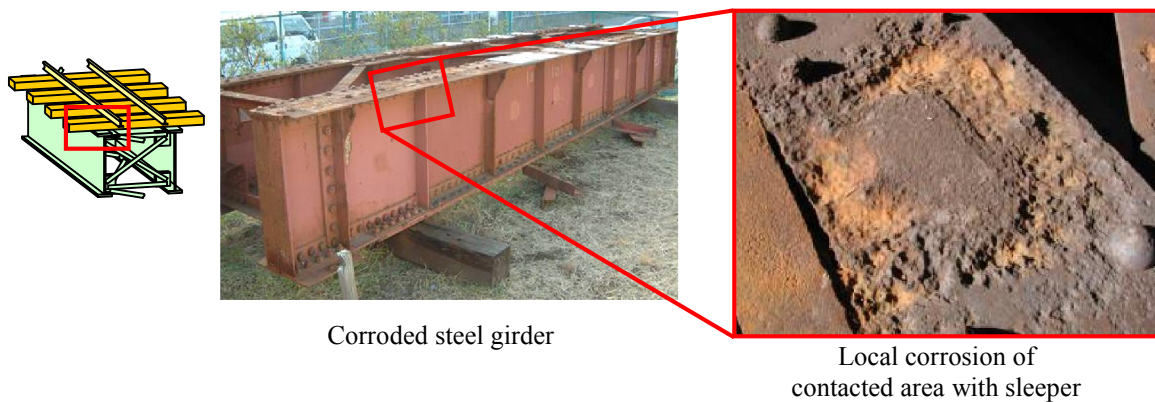
Fig. 1-4 Corrosion of upper flange⁵⁾

Many of existing railway steel bridges has sleepers directly set on the girders. Corrosion of upper flanges often occurs at the contacted areas with the sleepers⁵⁾, as shown in **Fig. 1-4**. This is because ordinary paintings of the upper flanges under sleepers easily degrade by cyclic train load⁶⁾⁷⁾⁸⁾. In addition, the situation, that the re-painting of the upper flange is difficult because of the sleepers, also furthers the corrosion of the upper flange⁹⁾¹⁰⁾. **Fig. 1-5** shows the cross section of the corroded upper flange¹¹⁾. In this case, most of the thickness of the cover-plate was decreased by corrosion.

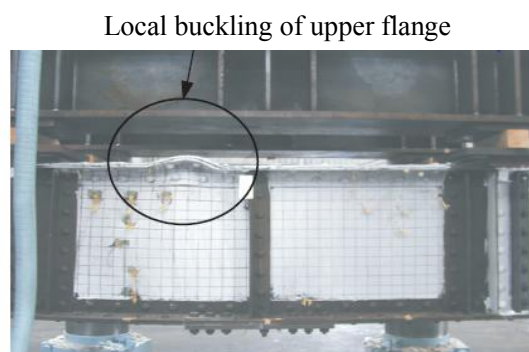
Fig. 1-6 Local buckling of upper flange¹²⁾

The thickness reduction of the upper flanges due to corrosion leads to decrease of load-carrying capacity of the girders. Especially, the local buckling of the corroded section of the upper flange decreases the load-carrying capacity of the girder significantly comparing with the corrosion of the tensile members, such as the lower flange, as shown in **Fig. 1-6**¹²⁾. Many researches have been carried out on predicting the remaining load-carrying capacity in Japan⁹⁾¹⁰⁾¹²⁾¹³⁾¹⁴⁾ and abroad¹⁵⁾¹⁶⁾¹⁷⁾.

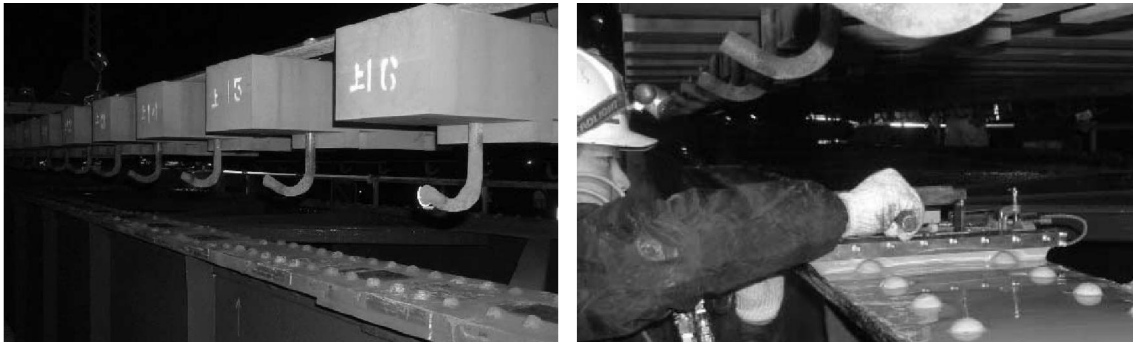
General procedure of re-paintings consists of “removal of existing paintings and rust” and “painting”¹¹⁾²¹⁾. However, the re-painting of the upper surface of the upper flange is different from that of the other members. In order to re-paint the upper flange, it is necessary to remove the track members by lifting-up prior to the re-painting works²³⁾, as shown in **Fig. 1-7**.

(a) Lift-up of track members
prior to re-painting

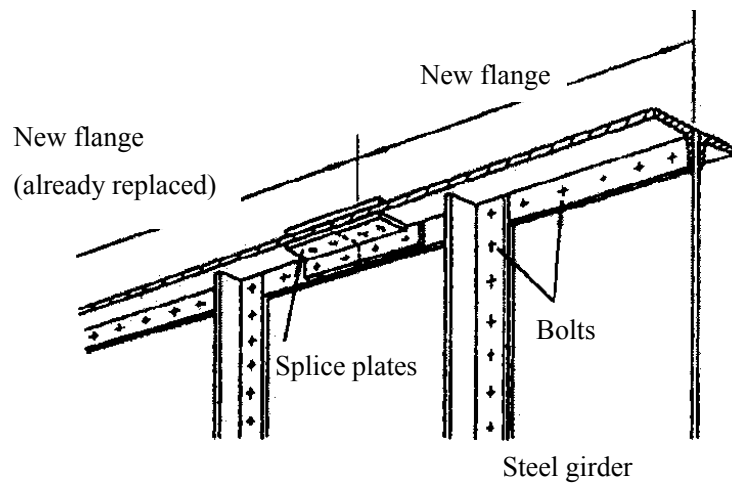
Fig. 1-8 Method of upper-flange replacement¹¹⁾

If the thickness decrease of the upper flange due to corrosion is significant, replacement of upper flange can be carried out, as shown in Fig. 1-8¹¹⁾³⁰⁾³¹⁾. Fig. 1-9 shows an example of the flange replacement. Prior to the night-work, it needs to remove existing rivets. At the beginning of the night-work, the track members, such as rails and sleepers, are removed out. Then, the upper flange can be removed and the new upper flange is installed. As shown in these photographs, the replacement work is not easy and it must be finished within the tight time schedule.

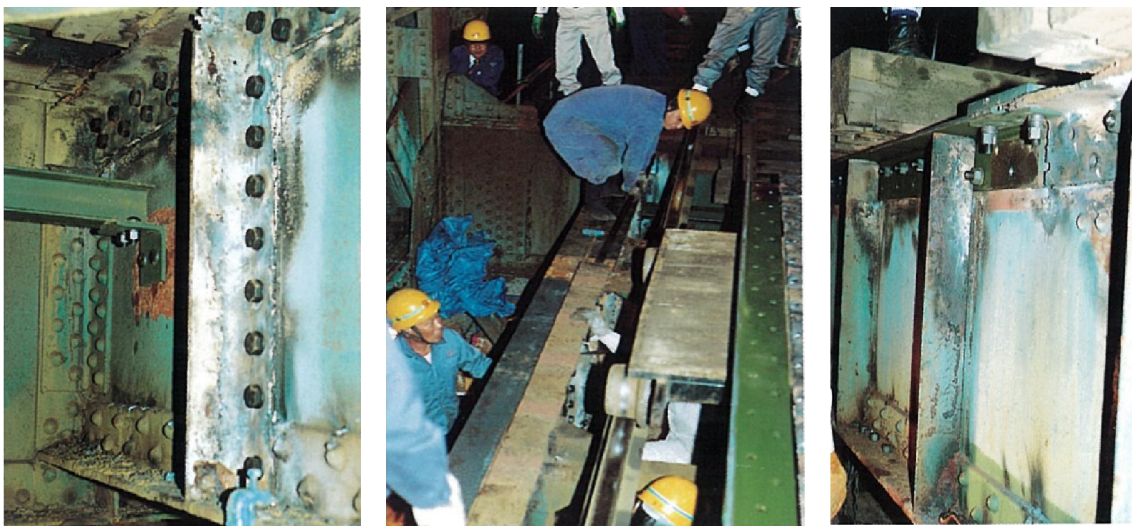
Fig. 1-9 Example of replacement of upper flange¹¹⁾

(a) Replacement of rivets to high-strength bolts

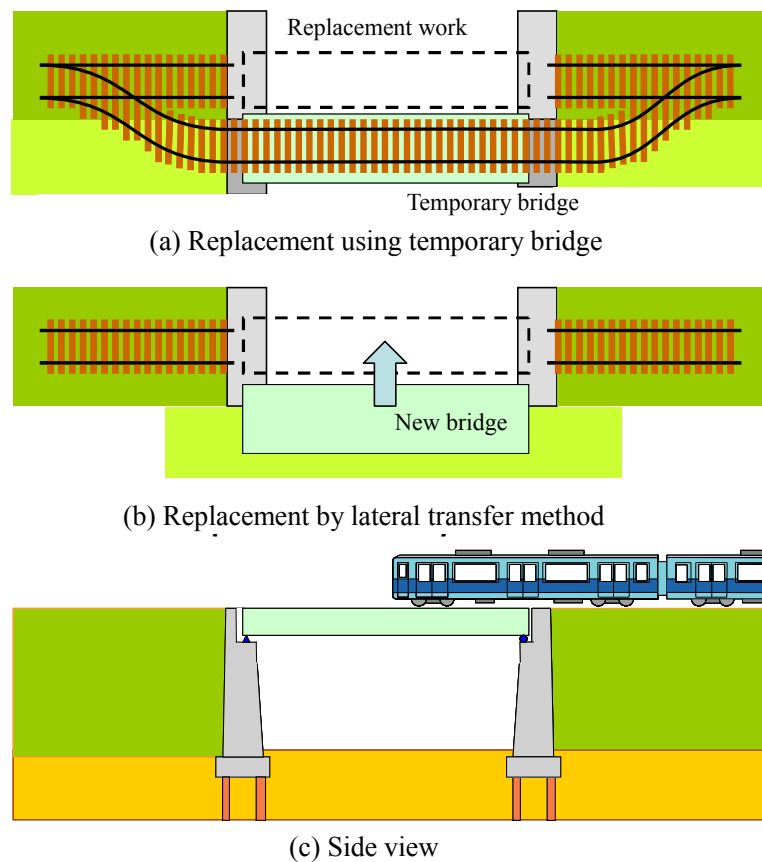
Fig. 1-10 Methods for replacement of existing bridges

In previous times, severely damaged bridges were generally replaced with new bridges. However, the replacement requires high cost and much time during which the train operation has to be stopped. In railway system, train operation should not be stopped, especially in urban areas. To avoid the stop of the train operation, special methods are applied, such as replacement using temporary bridge and replacement by lateral transfer method, as shown in **Fig. 1-10**. In both methods, it takes much more costs for construction and removal of temporary equipment rather than the cost for new bridge.

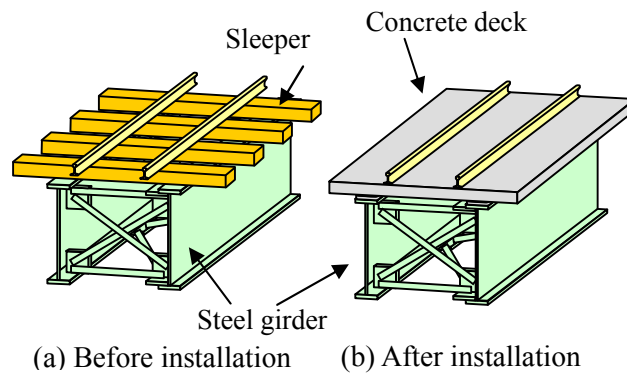
Fig. 1-11 Installation of concrete deck

To avoid the replacement of existing steel railway bridges and to make it possible to keep the bridges in service in effective way, it is important to improve the performance of the bridges, such as load-carrying capacity, fatigue life and noise emission. In this research, an idea to install concrete decks on the steel girders instead of sleepers, as shown in **Fig. 1-11**, is proposed as a method to improve the performance.

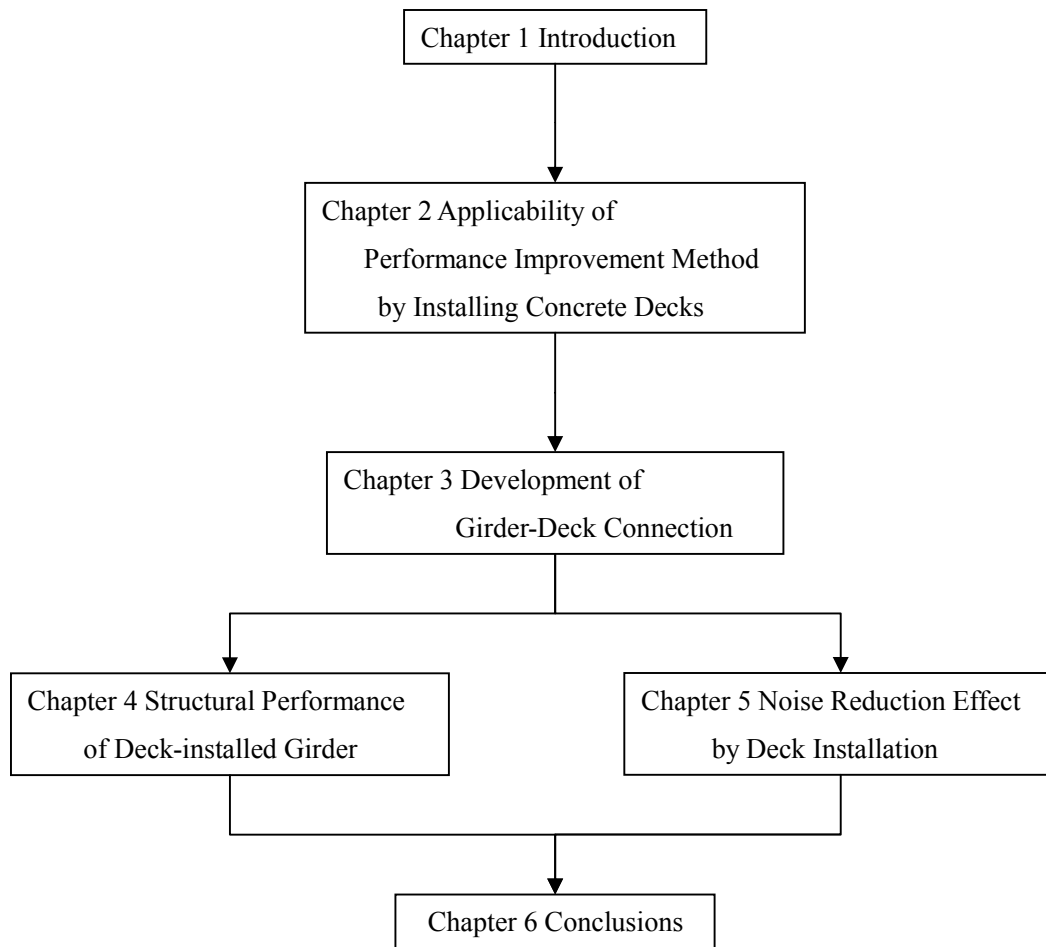
Fig. 1-12 Flow and contents of research

This thesis consists of six chapters. Flow of this research is shown in **Fig. 1-12**. The contents of Chapter 2 to Chapter 6 are described as follows.

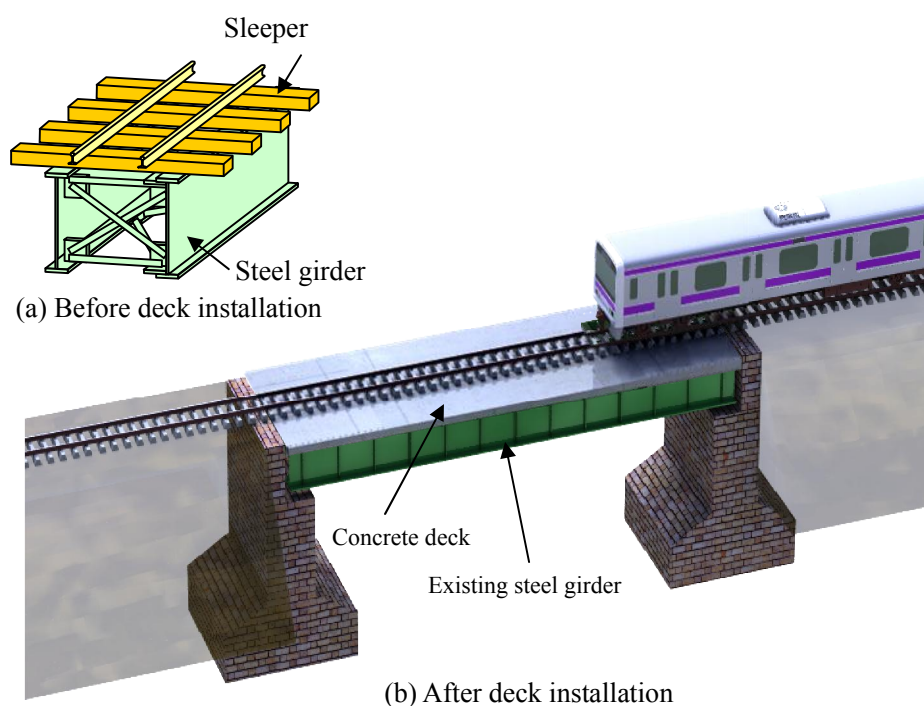
Fig. 2-1 Image of performance improvement method by installing concrete deck

By installing the concrete deck, the structural system of a steel girder can be changed into a composite girder and increases its load carrying capacity. In addition, this method is also possible to mitigate accumulation of fatigue damage by reducing stress at the steel girders and to reduce noise due to vibration of the bridge members. Furthermore, the concrete deck prevents corrosion on the upper flange and thus the maintenance work of the steel girders can be reduced. The purpose of this research is to develop the performance improvement method of existing steel railway bridges by installing concrete decks.

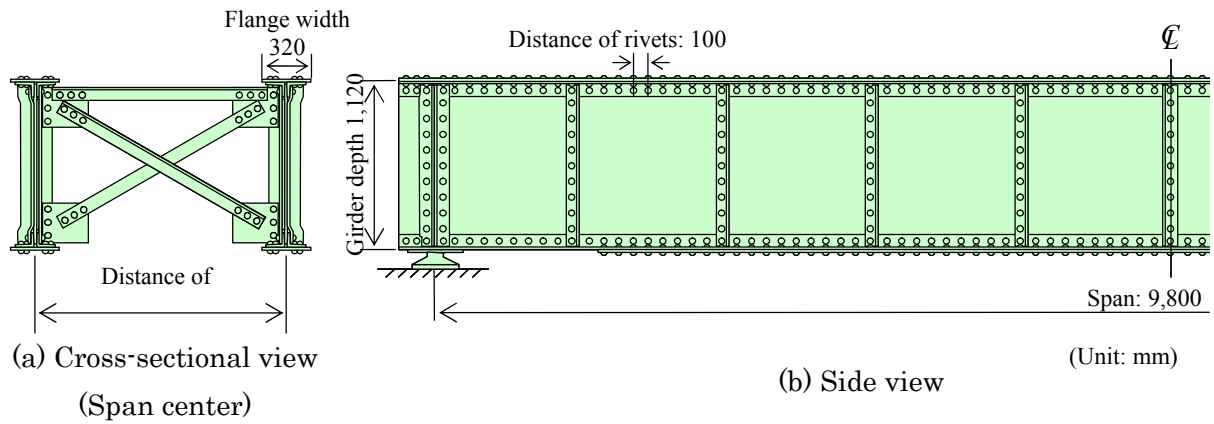
Fig. 2-2 Steel girder of example bridge

Through design calculation, the stress of the girder was estimated under the condition before and after the deck installation. The models for the calculation are typical existing railway bridges, which has simple girders with span of about 10 ~ 40 m. **Fig. 2-2** shows an example of the deck girder bridge with about 10 m span. The stress after the installation of concrete deck was calculated considering composite action of the deck and the steel girder. Here the thickness reduction of the girder is not taken into account. Depth of the deck must be less than 200 mm, conforming to that of the sleepers. The stress is calculated for 'live load', *i.e.* the train load and the impact load. For the train load, "E-17" load, shown in **Fig. 2-3**, was applied.

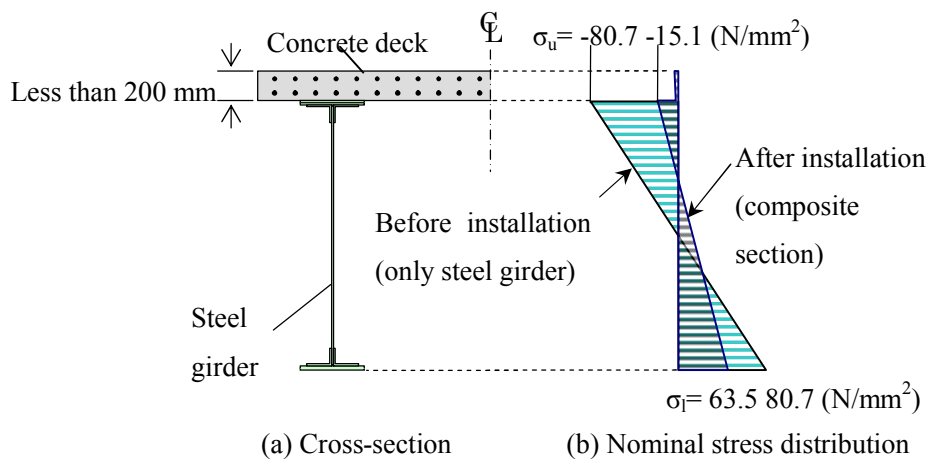
Fig. 2-4 Stress reduction by deck installation (9.8 m span girder)

reduction effect is relatively large in shorter span bridges.

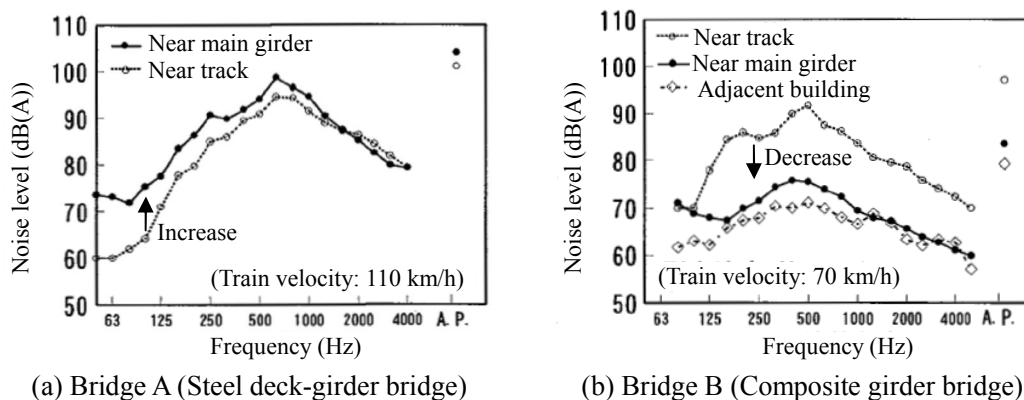
**Fig. 2-5 Measured noise level in steel bridge and composite girder bridge³⁵⁾**

Steel railway bridges tend to generate larger structure-borne noise than other structures, such as reinforced concrete structures³⁴⁾. According to the previous measurement result³⁵⁾, the noise near the main girder is larger than the noise near the track, as shown in **Fig. 2-5(a)**. This is because the noise is amplified by the vibration of the steel girder members. On the other hand, in the composite girder bridge, the noise near the main girder is smaller than that near the track, as shown in **Fig. 2-5(b)**. It means that the noise from the steel girder in the composite girder bridge is comparatively small. From this fact, it is expected that the installation of concrete deck on the steel girder is effective to reduce the noise. This will be discussed in Chap. 5.

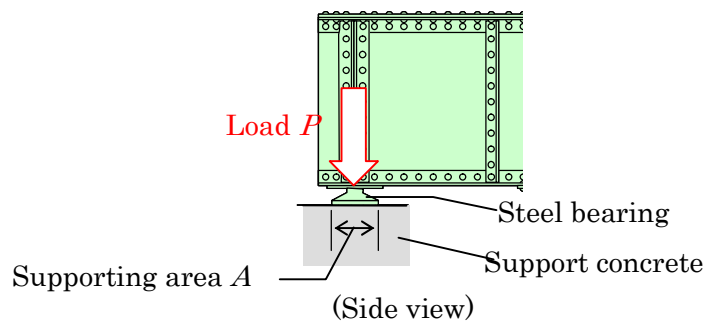
Fig. 2-6 Bridge support of existing steel bridge

When the concrete deck is installed onto the existing bridge, increased dead load acts directly on the supports of the bridge, such as steel bearings and support concrete shown in **Fig. 2-6**. Through the design calculation, the bearing stress of the support concrete was estimated as Load P divided by the supporting area A , under the condition before and after the deck installation. The

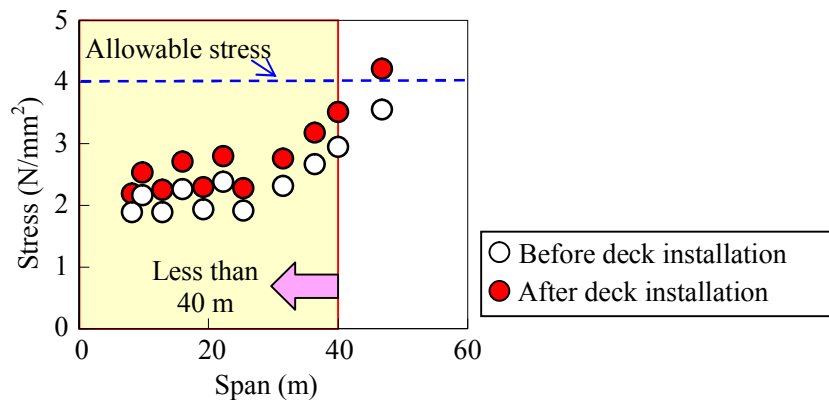
Fig. 2-7 Bearing stress at support concrete and applicable range of span

models of calculation are typical existing railway bridges with structural type of deck girder bridges, simple-span and single-track. Here it was assumed applying the concrete deck with at most 200 mm depth, conforming to the depth of the existing sleepers, in order not to change the rail level. **Fig. 2-7** shows the results of the calculation. In the bridges with span of more than 40 m, bearing stress of the concrete of the supports exceeds the allowable stress for general existing structures³⁶⁾. From the results, it was found that the proposed method is applicable to the bridges shorter than 40 m. For the bridges exceeding 40 m span, the actual strength of the support concrete should be obtained to judge the applicability.

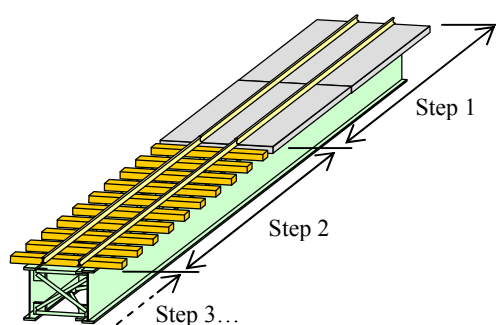
**Fig. 2-8 Separation of deck installation work into several night works**

In the “pre-cast deck method”, multiple pre-cast concrete decks are installed on the girders and the precast decks can be installed in a short-time work at a site. Furthermore, the installation work for longer bridges can be carried out by separating the long work into several short time night works for each pre-cast deck, as shown in **Fig. 2-8**. For this reason, the pre-cast deck method is the most applicable to existing railway bridges on the view point of installation work. However, it is necessary to consider how to connect the girders and the pre-cast concrete decks.

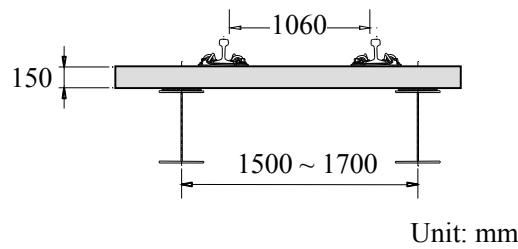
Fig. 2-9 Distance between girders

To confirm the applicability of 150 mm deck depth, the capacities and stress of the concrete deck were examined through design calculation. The standard distance between the main girders of existing steel bridges is 1500 to 1700 mm and it is longer than the distance between the rails, as shown in **Fig. 2-9**. Accordingly, the bending moment by the train loads acts on the concrete deck. Here, three types of concrete deck were examined, as shown in **Fig. 2-10**. The concrete deck was

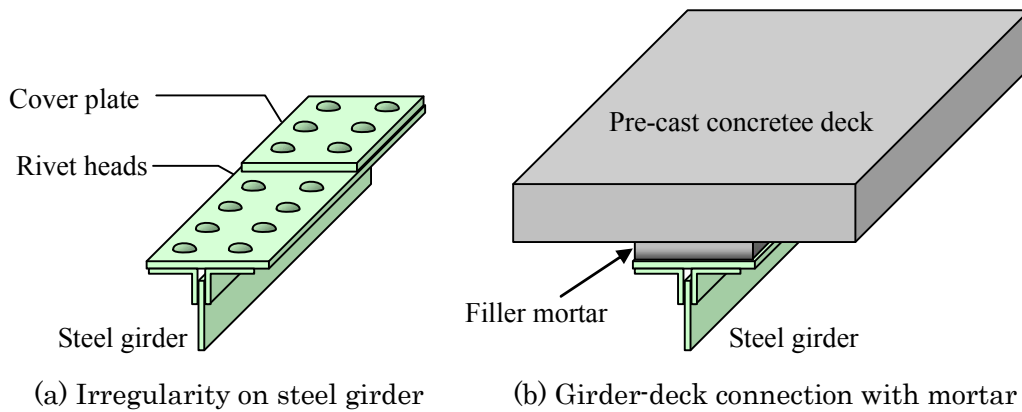
Fig. 2-11 Irregularity on steel girder and connection using filler mortar

As mentioned before, the use of pre-cast concrete decks is applicable to deck installation in a tight time schedule. However, most of the existing steel bridges are riveted girders, which were constructed before adopting welded girders. On the upper flange of the riveted girders, there are irregularities due to existence of rivet heads and cover plates, as shown in **Fig. 2-11(a)**. In such situation, it is difficult to connect the pre-cast decks directly to the steel girders in a simple way.

To enable the connection, a method of connection using filler mortar and steel fasteners was proposed, as shown in **Fig. 2-11(b)**. Filler mortar smoothes the irregularities on the surface of the steel girders and enables setting of the pre-cast concrete decks easily.

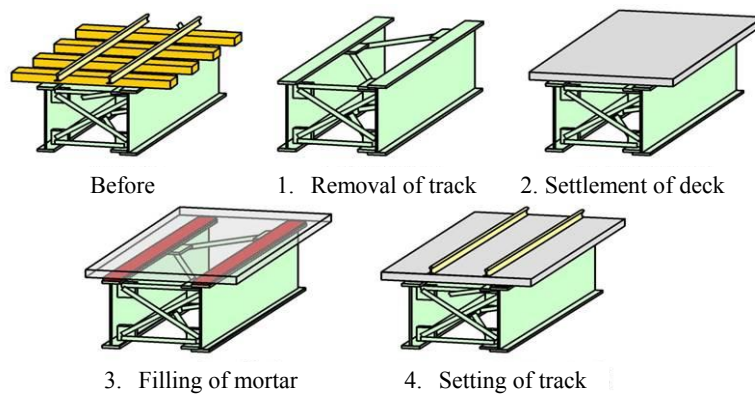
Fig. 2-12 Basic procedure of deck installation

By applying the concrete deck and girder-deck connection proposed above, the deck installation procedure shown in **Fig. 2-12** is thought to be applicable to actual bridges in short time works. For the detail of girder-deck connection and the detailed installation procedure are discussed in the following chapters (Chap. 3 and Chap. 4).

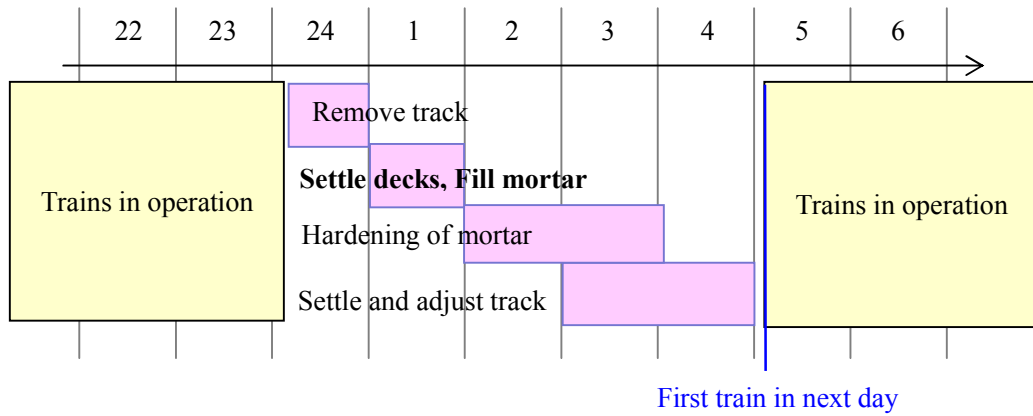
Fig. 2-13 Time constraint in night work

At the stage of the deck installation work, it is necessary to finish the work in required time schedule. **Fig. 2-13** shows an example of time schedule of night work. From the last train to the first train in the next day, time frame available for the installation work is limited to 4~5 hours. Considering removing track before the installation and time for hardening of mortar and placement and adjustment of track after the installation, time for the settlement of pre-cast decks and mortar filling work should be less than 1 hour. To obtain work time for deck installation and setting error of the decks, a test construction of concrete deck was carried out. The specimen for the test, shown in **Fig. 2-14**, is the specimen Type 2 used in the loading test in Chapter 3. It has 8 m span and is the length for five pre-cast concrete decks.

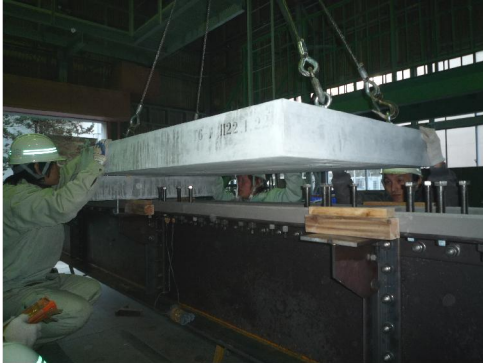
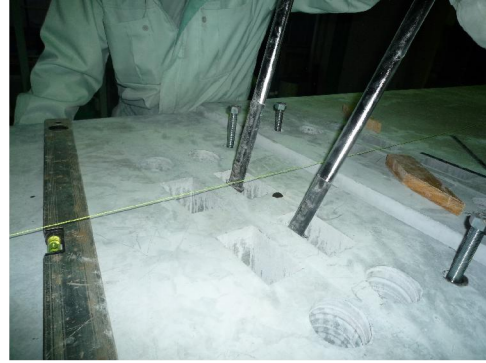
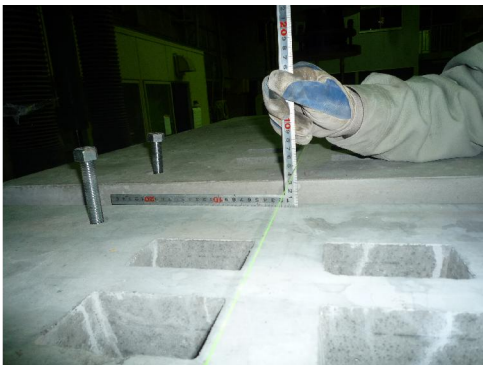
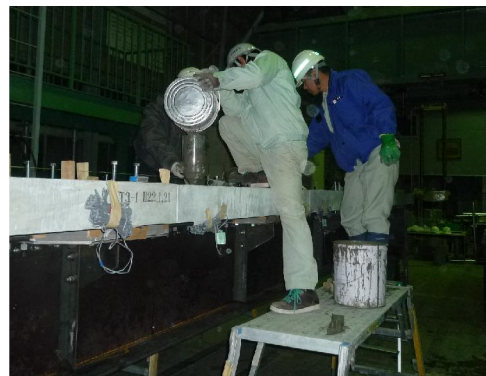
Fig. 2-15 Test construction of concrete deck

The pre-cast deck was lifted by crane and settled on the steel girder, as shown in **Fig. 2-15**. After the crane work, the level error and the lateral error were adjusted by operating crowbars by hand. After the adjustment, the mortar was filled between the steel girder and the concrete deck.

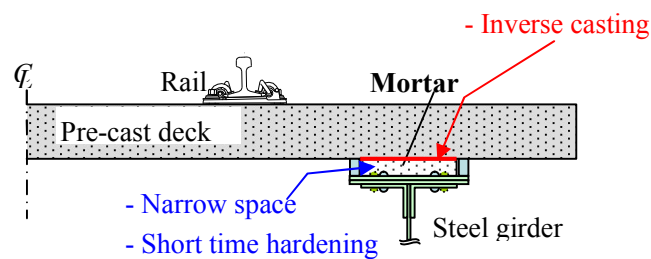
Fig. 2-16 Conditions at the filler mortar

At the girder-deck connection, the mortar is filled into the gap between the steel girder and the pre-cast concrete decks. In the proposed method, the deck installation should be finished within the night work. In addition, the space for filling mortar should be as small as possible, so that the thickness of the pre-cast concrete deck can be maximized. In addition, the interface of the pre-cast decks and the mortar is inversely casted section and bleeding is concerned at the section. In this study, the property of the mortar was verified and the applicability was discussed, focusing on bleeding property, flowability and bonding strength of the mortar-concrete interface.

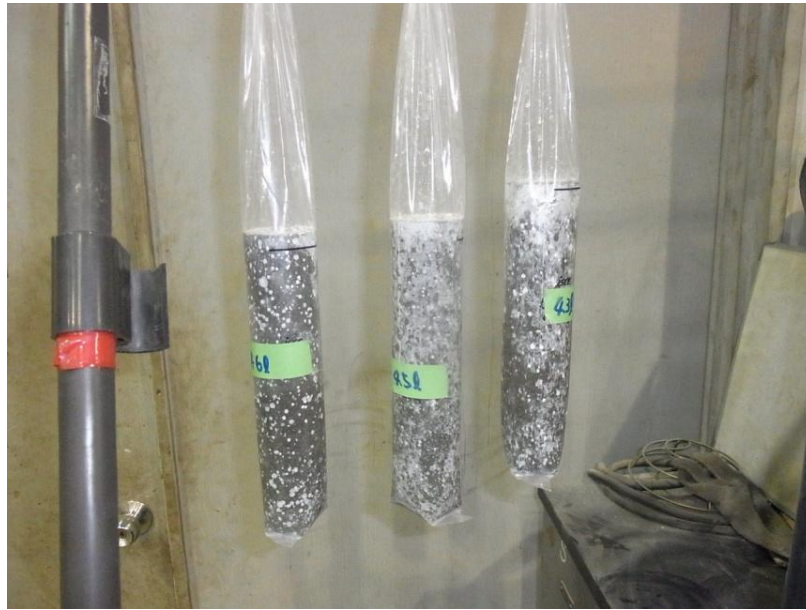
Fig. 2-17 Bleeding test of mortar

The bleeding property may depend on water ratio. For this reason, the mortar with three different water ratios, *i.e.* 'Specimen A' with 4.3ℓ, 'Specimen B' with 4.5ℓ and 'Specimen C' with 4.6ℓ per 25 kg pre-packed mortar material, were prepared. The test was carried out according to the standard test method by JSCE (JSCE-F 522-2007). Each specimen was prepared by pouring the fresh mortar into a polyethylene bag, as shown in **Fig. 2-17**.

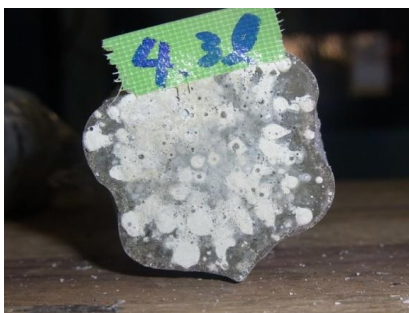
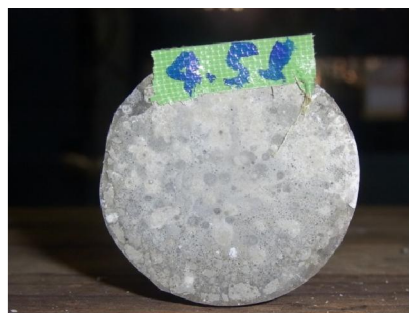
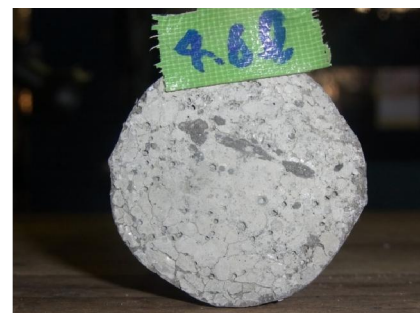
Fig. 2-18 White powdery layer at the top of specimens

As a result of the bleeding test, no bleeding water was seen in each specimen. However, at the top of the specimens, white powdery layer was seen, as shown in **Fig. 2-18**. In the specimen with higher water ratio, more powdery layer was produced. Considering this result, the water ratio of 17.2 % (4.3ℓ per 25 kg) is more desirable than the other water ratio.

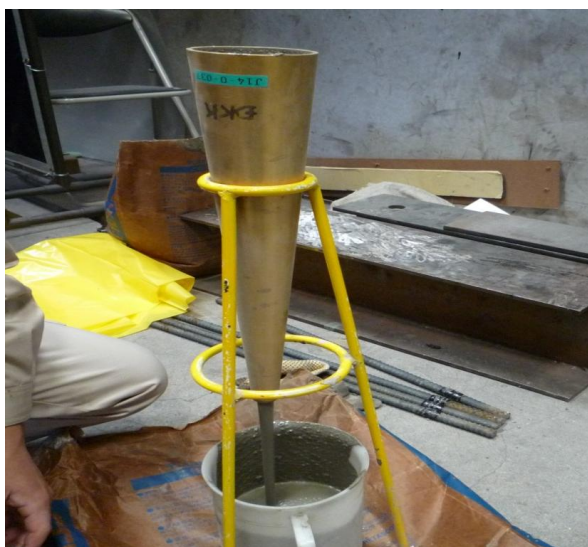
Fig. 2-19 Wrought for flowability test

The test was carried out according to the standard test method called 'J-14 wrought test' (JSCE-F 541-1999). Test material is identical to Specimen A in the bleeding test, *i.e.* the pre-packed mortar with 17.2 % water ratio (4.3 l/25 kg). Considering influence of temperature, the material in two different water temperatures of 11 °C and 25 °C were prepared.

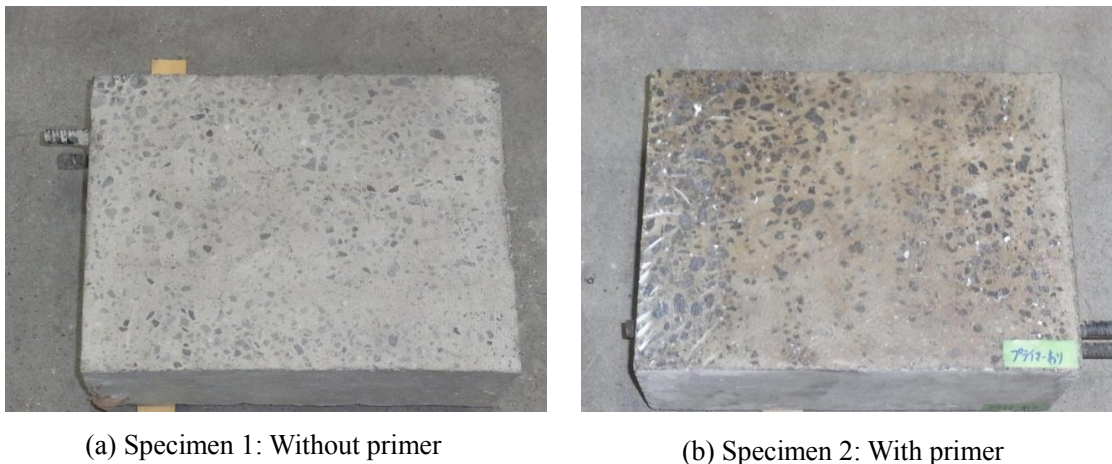
Fig. 2-20 Surface of concrete deck

To obtain appropriate surface condition of the concrete deck, a bonding test of mortar-concrete interface was carried out. Focusing on the influence of surface treatment, specimens with two different surface treatment of the concrete deck was prepared, as shown in **Fig. 2-20**. Both of the specimens' surfaces were polished and cleaned in order to enable comparison of both specimens. Only Specimen 1 was painted by primer with acrylic polymer.

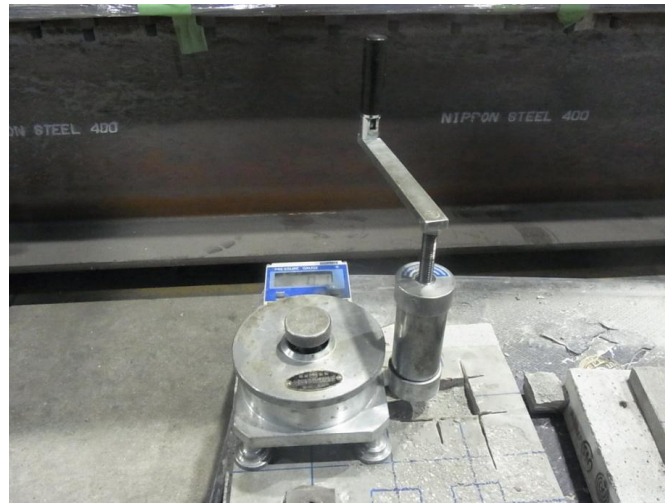
Fig. 2-21 Test equipment for bonding test

To evaluate the bonding strength quantitatively, the test was carried out according to JIS A 1171:2000. The test equipment of the bonding test is shown in **Fig. 2-21**. The mortar, with the flowability of 8.4 sec by J-14 wrought and average compressive strength 47.7 N/mm^2 , was poured in inversely casted state. Thickness of the mortar was 10 mm. After the hardening of the mortar (nine days after the casting), the mortar layer was cut out in $40 \times 40 \text{ mm}$ square. The pulling out tests were carried out to five different cut squares, in 1500~2000 N per minute.

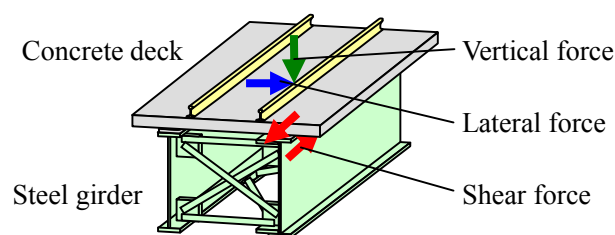
Fig. 3-1 Forces acting on girder-deck connection

While the train load acts on the bridge, the girder-deck connection is under vertical force, lateral force and shear force, as shown in **Fig. 3-1**. The vertical force is acted by the axle load of passing train. The lateral force is mainly acted by the horizontal load of train. The shear force is mainly acted by the bending behaviour of the composite girder. Considering these forces, two types of girder-deck connection were proposed, as shown in **Fig. 3-2**.

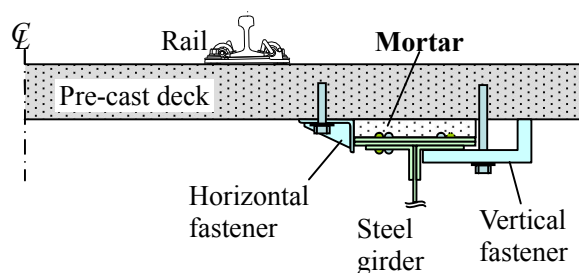
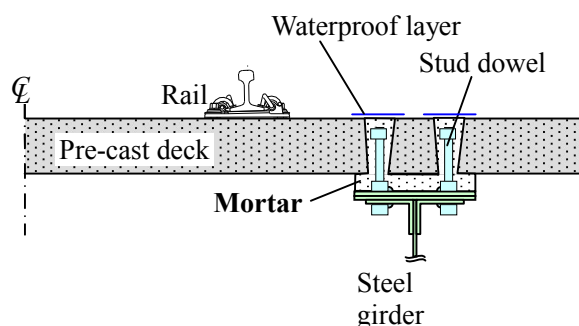
Fig. 3-2 Detail of girder-deck connection

In type 1 connection, the horizontal fasteners resist against the lateral force. The vertical fasteners resist against the up-lifting force by the vertical force. The filler mortar smoothes the irregularities on the surface of the steel girders and enables setting of the pre-cast concrete decks easily. Furthermore, the filler mortar is expected to transmit the shear force between girders and decks by the irregularities by rivet heads on the steel surface.

In type 2 connection, the stud dowels are expected to resist against the lateral force, the up-lifting vertical force and the longitudinal shear force. For newly constructed composite bridges with pre-cast concrete decks, the decks are generally connected to girders with shear connectors. However, the filler mortar is also expected to resist against the longitudinal shear force.

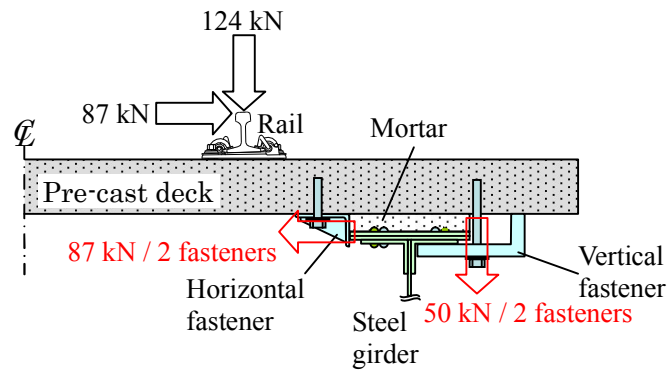
Fig. 3-3 External forces and design loads on steel fasteners

For the loading condition, design loads to each specimen for two cycles were applied. The design loads were calculated considering external forces by a train axle shown in **Fig. 3-3**, according to the design standard³⁸⁾. At the third cycle, increased load until the maximum loads of the specimens was applied.

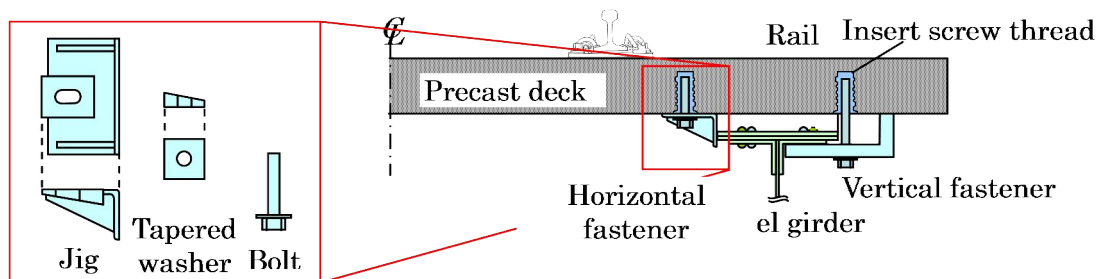
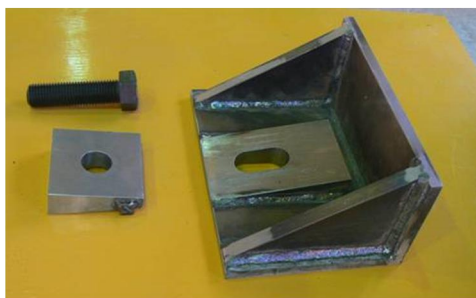
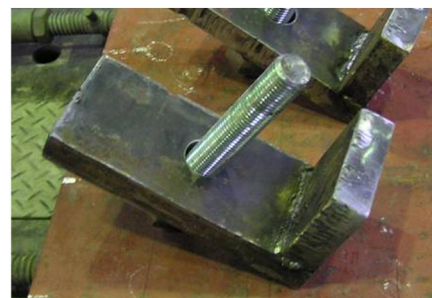
Fig. 3-4 Steel fasteners for pre-cast concrete decks

Fig. 3-4 shows the steel fasteners used in the loading test. Horizontal fasteners were installed at the inside of the steel girders and resist against the transverse force. It has a tapered washer in it and it is effective for adjustment of setting errors and it makes connection tighter when a transverse force is applied. Vertical fasteners were installed at the outside of the girder and resist against uplifting force. At each location of the fasteners, a steel insert screw thread was installed to the lower surface of the pre-cast concrete deck.

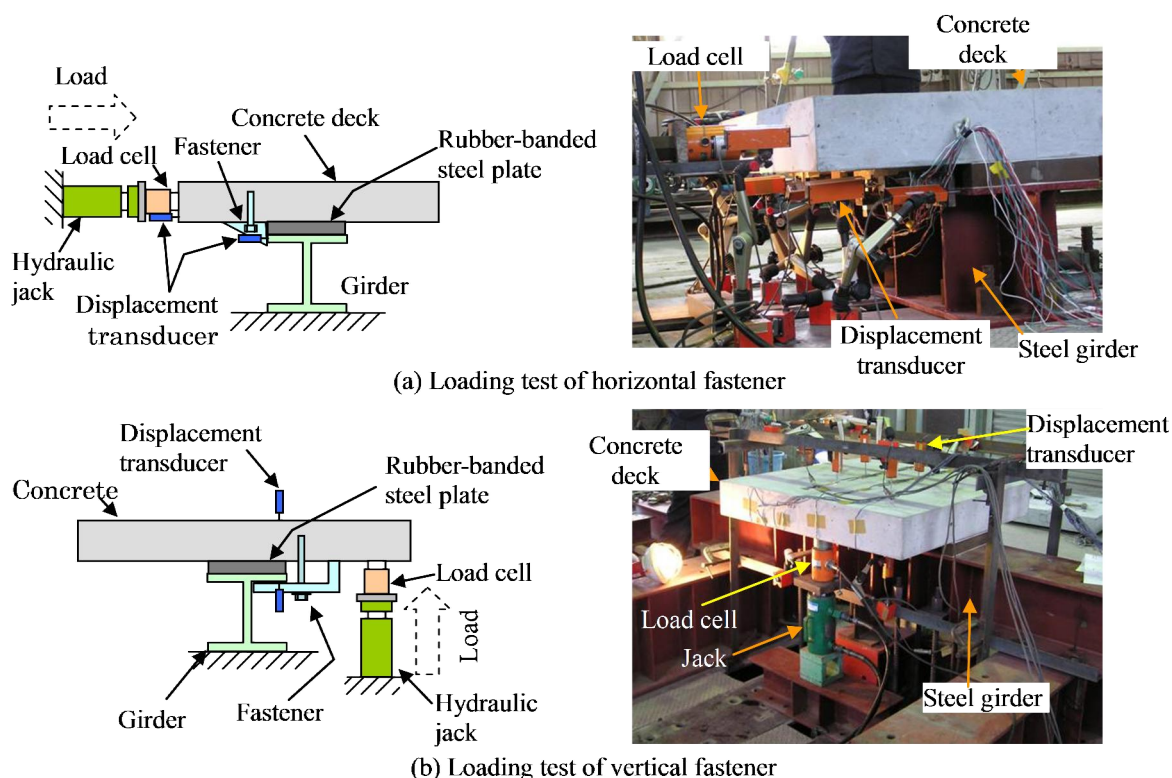
Fig. 3-5 Loading tests of steel fasteners

Fig. 3-5 shows the condition of loading of the tests. Length of the specimen was set at 1 m considering a length of the area where one axle load is applied. Two fasteners were installed for

each specimen. Here the filler mortar was not filled between the girder and the deck in order to evaluate the capacity of the fasteners. In order to evaluate the strength of the connection only by fasteners, rubber-banded steel plates were put between girder and deck instead of filling the mortar.

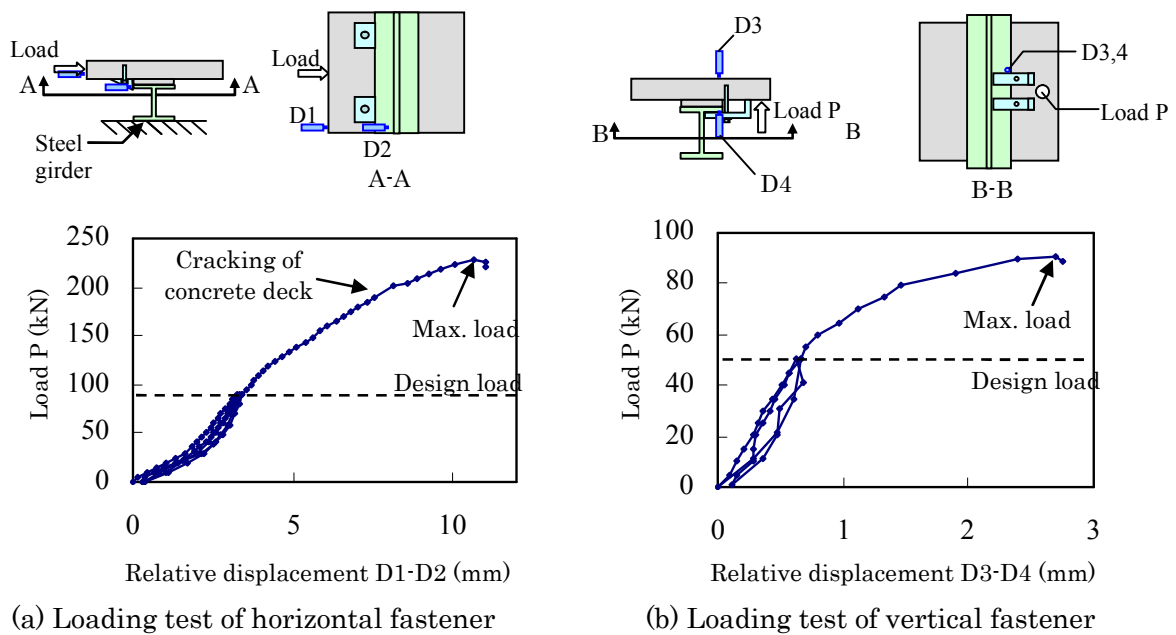
Fig. 3-6 Load-displacement relationship

Type	Capacity of specimen	Capacity per fastener
Vertical	90.3	45.2
Horizontal	229.0	114.5

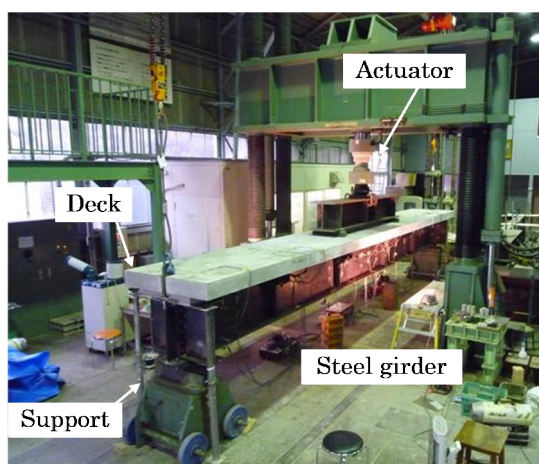
Fig. 3-8 Specimen under loading test

The tests were carried out as static four-point bending tests. The load was gradually increased up to 200 kN, considering maximum train axle load is 180 kN. **Fig. 3-8** shows the specimen under loading test.

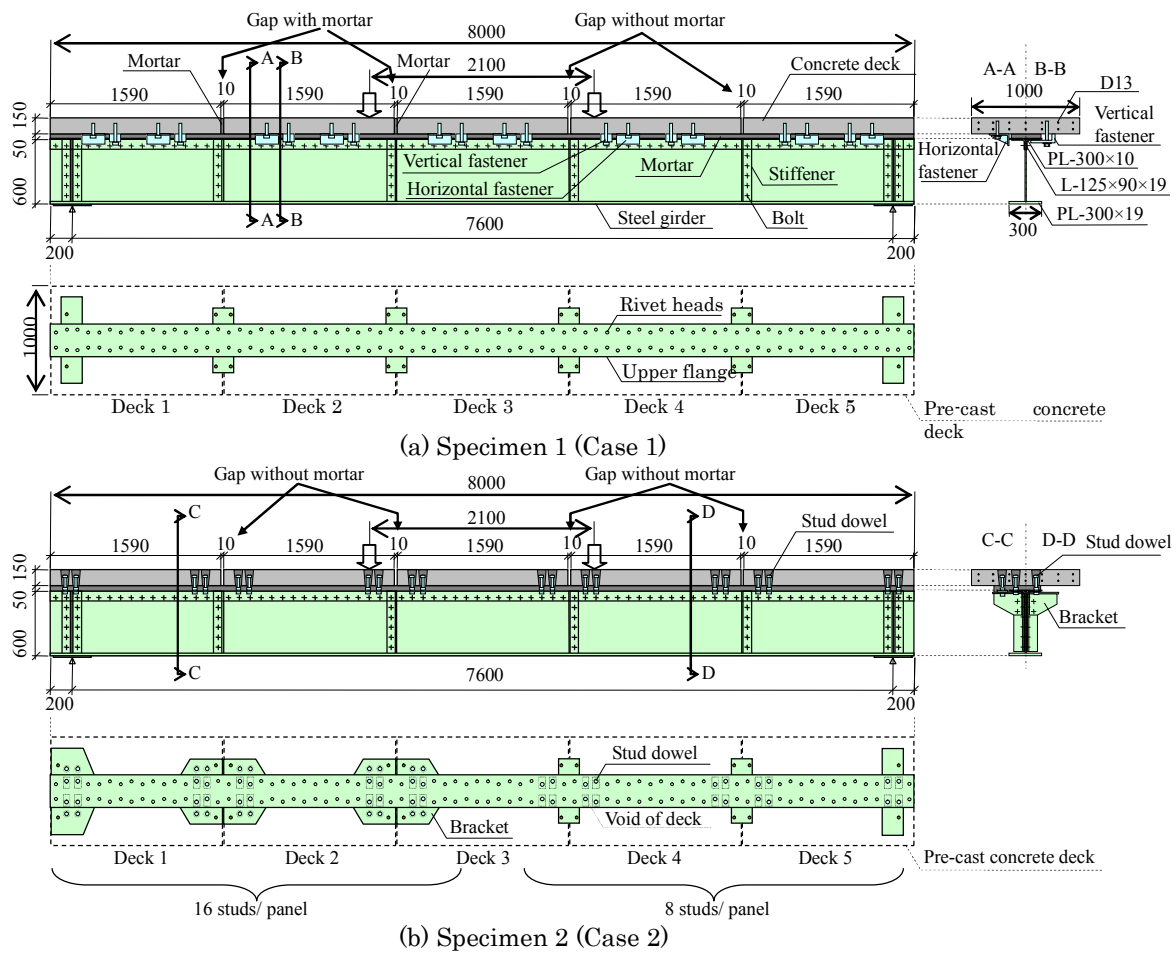
Fig. 3-9 Test specimens for loading test and dimensions

There are gaps between the pre-cast panels. On the left side of Specimen 1, the gap between Decks 1-2 and the gap between Decks 2-3 are filled with mortar (Type 1A). On the other gap has no filler mortar (Deck 3-4, 4-5 in Specimen 1 (Type 1B) and all gaps in Specimen 2 (Type 2A and 2B)).
