Doctoral Dissertation

**Development of Performance Improvement Method
of Existing Steel Railway Bridges
by Installing Concrete Decks**

Masamichi SAITO

Department of Civil Engineering,
Graduate School of Science and Engineering,
Tokyo Institute of Technology

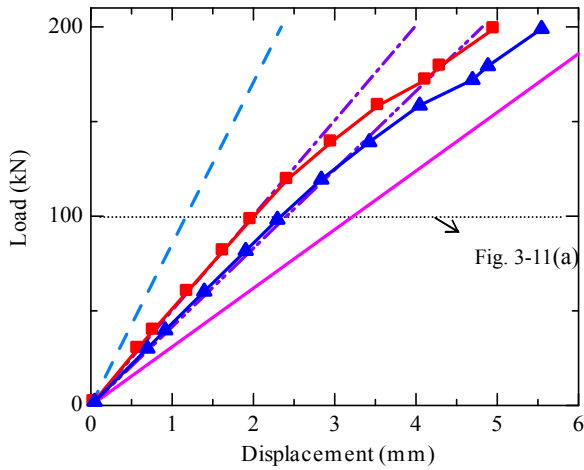
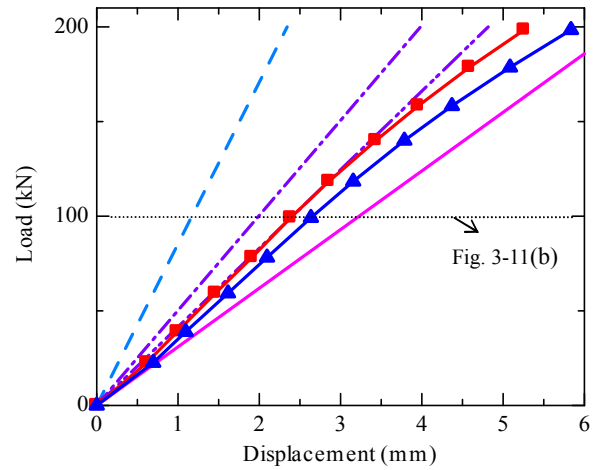
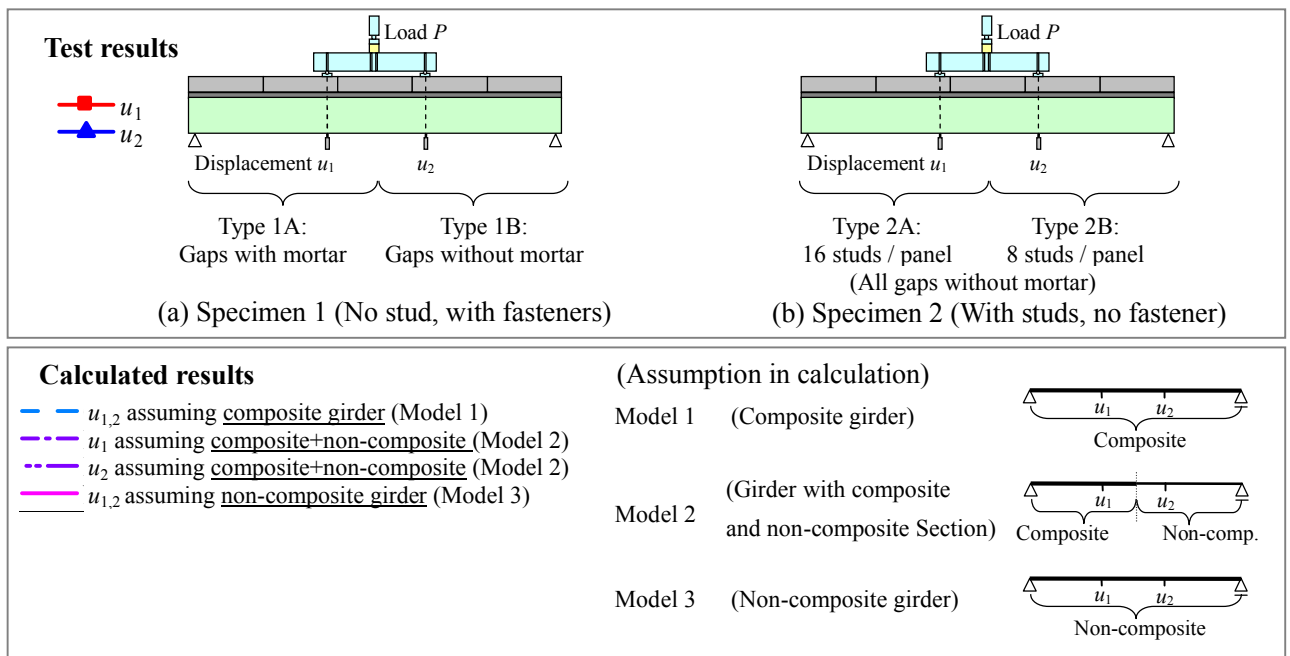
Fig. 3-10 Load-displacement relationship

From these results, it is considered that the left side of Specimen 1 has composite section and the right side has non-composite section. However, the state was changed around 120 kN loading. On the other hand, neither of the sides of Specimen 2 has composite section.

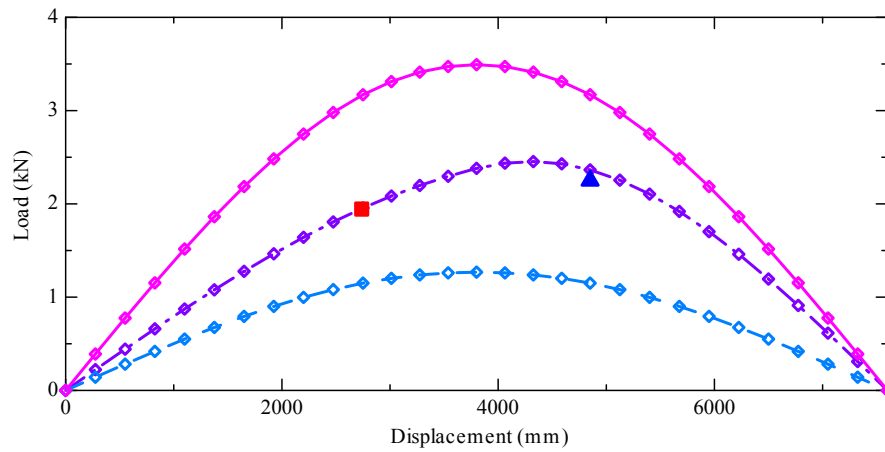
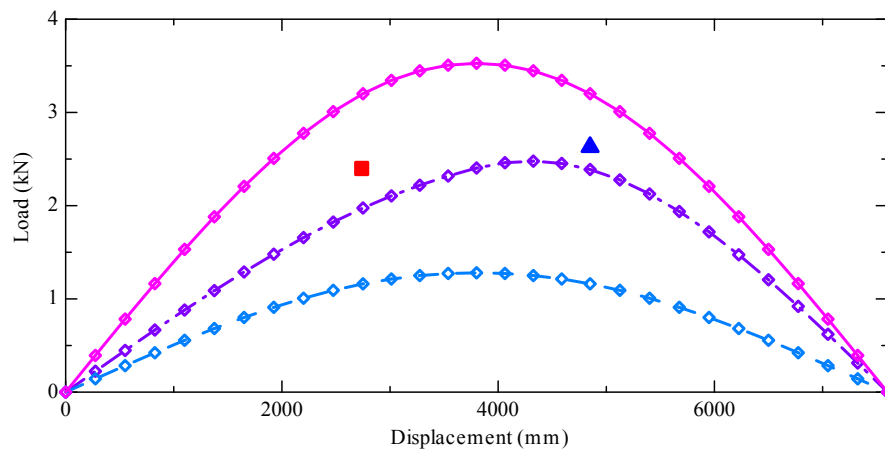
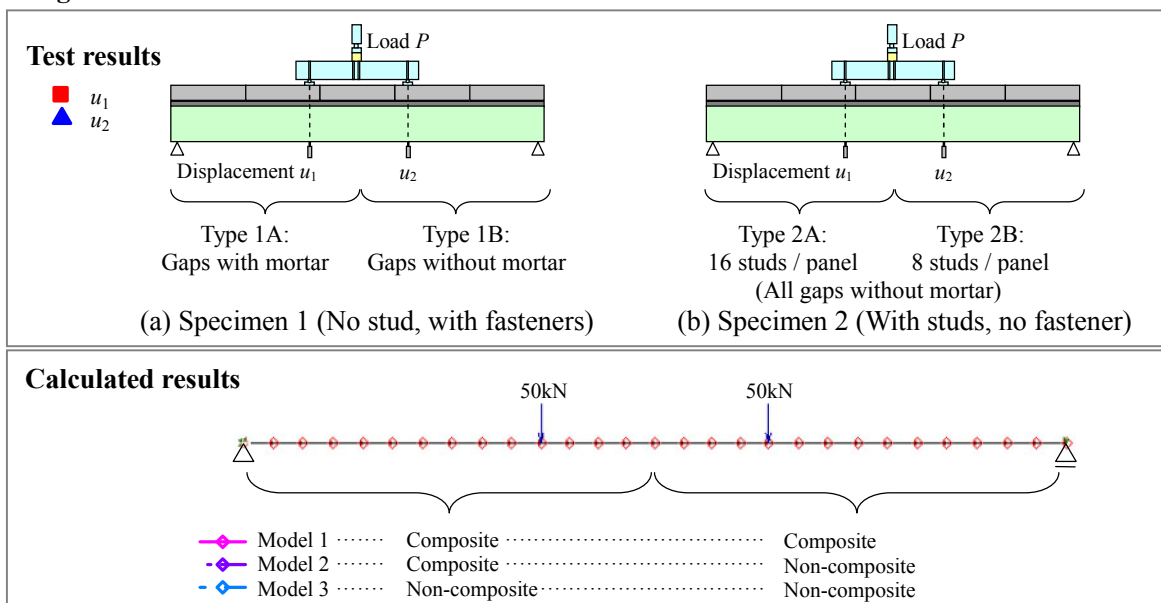
Fig. 3-11 Displacement of girder at 100 kN loading

(a) Specimen 1 (No stud, with fasteners, 100kN loading)

(b) Specimen 2 (With studs, no fastener, 100kN loading)

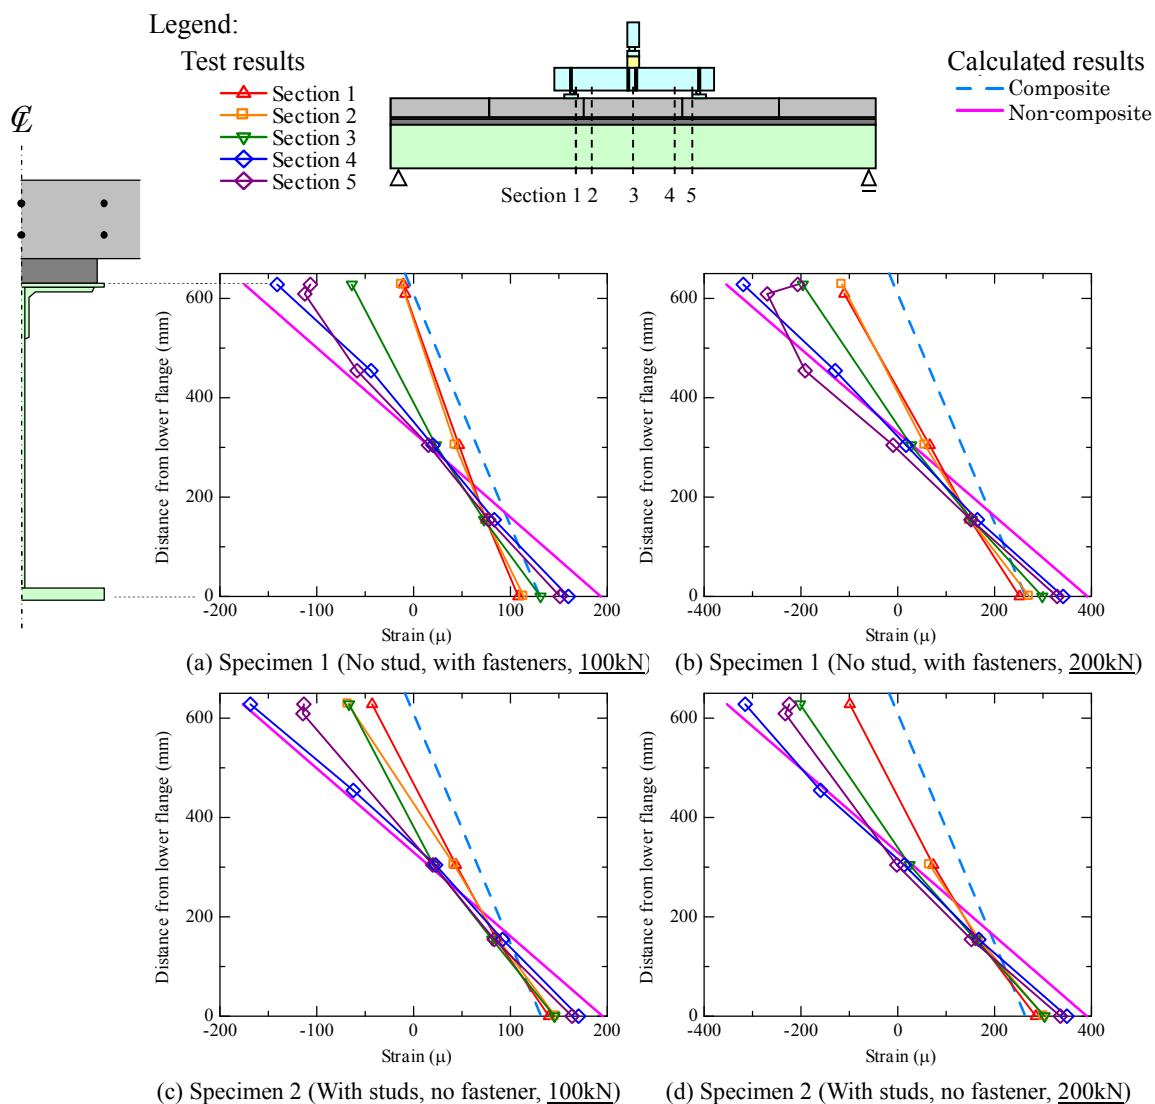
Fig. 3-12 Distribution of nominal strain in each section

To clarify the cause of state change in load-displacement relationship, strain distribution before and after the state change were compared, focusing in strain distribution of the steel girders. **Fig. 3-12** shows vertical distribution of the strain in the longitudinal direction at the sections in each specimen. The graphs also show the calculated results in composite and non-composite state, obtained through the beam theory calculation. The results of Case 1 at 100 kN loading are shown in **Fig. 3-12 (a)**, as a state before the change. At Section 1 and 2 in the left side of the specimen, the strain is similar to that of composite girder state. At Section 3, the strain state showed that the section has a middle state between composite and non-composite. At Section 4 and 5 in the right side, the strain is similar to that of non-composite girder state. The results at 200 kN loading are shown in **Fig. 3-12 (b)**, as a state after the change. The strain at Section 1 and 2 changed its state to the middle state. The test results of Case 2 at 100 kN loading are shown in **Fig. 3-12 (c)**. Section 1, 2 and 3 showed middle state and Section 4 and 5 showed non-composite state. At the 200 kN loading (**Fig. 3-12 (d)**), the sections did not show much difference from those at 100 kN loading. These states of each specimen are summarized in **Table 3-3**.

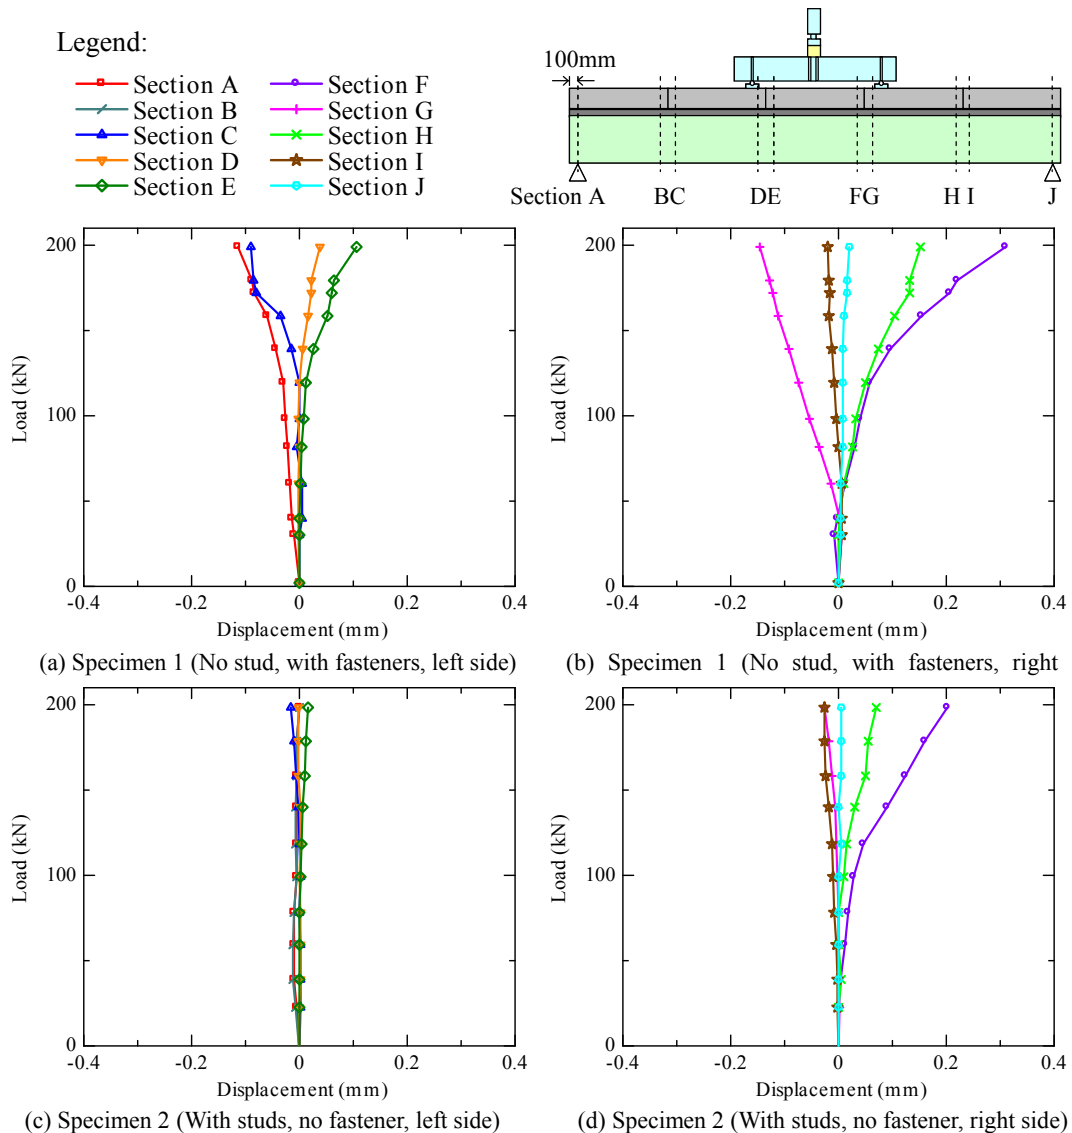
Fig. 3-13 Relative displacement between steel girder and concrete deck

Fig. 3-13 shows relative displacement between the upper flange of the steel girder and the lower surface of the concrete decks in longitudinal direction. At Section A~F of Case 1, the relative displacement started to increase from 140 kN loading. On the other hand, at Section F~J of Case 1, the displacement started to increase from 60~80 kN. At Section A~F of Case 2, the displacement did not increase. On the other hand, at the section F~J, the displacement increased from 120 kN. Table 3-4 shows the load when the slip displacement of each section started to increase.

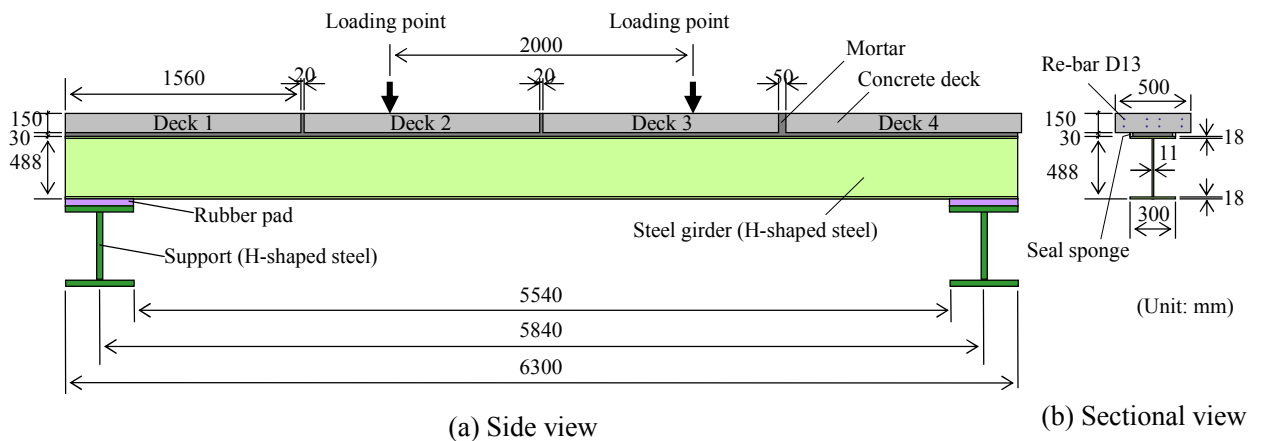
Fig. 4-1 Dimensions of specimen (Specimen 1)

To investigate the influence of mortar thickness on workability and structural performance, different mortar thickness at the girder-deck connection and the gap between pre-cast panels were set in each specimen. The mortar thickness at the girder-deck connection was set to 30 mm in Specimen 1 and 20 mm in Specimen 2. The thickness of the gap between the pre-cast panels was set to 20 mm at the gap between Deck 1 and Deck 2 (hereinafter called ‘left gap’) and 50 mm at the gap between Deck 3 and Deck 4 (hereinafter called ‘right gap’).

The loading test was carried out in 4-point bending test. The loading points are shown in **Fig. 4-1**. The load was acted to each loading points through the loading beam as shown in **Fig. 4-3 (a)**. **Fig. 4-3 (b)** shows the loading steps. The load was increased gradually up to 200 kN at Step 1~3, considering train load. In the next step (Step 4), the load was increased up to about 1,000 kN to confirm the limit state of the girder. In addition, wooden stiffeners were installed at the girder end and the loading points for safety during the test. The girder was supported by H-shape steels, through rubber pads between them.

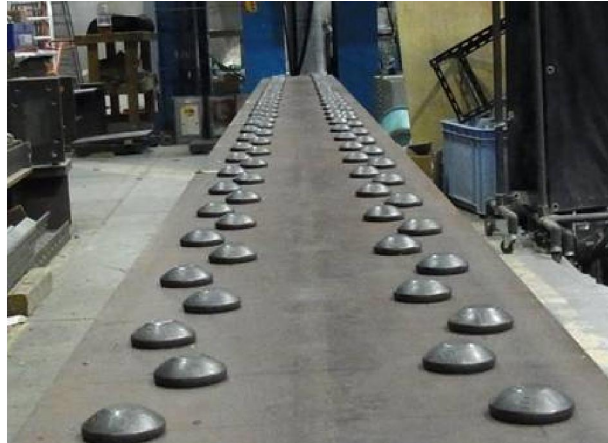
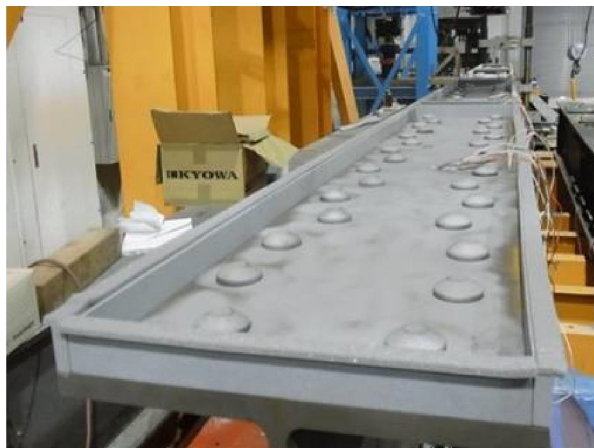
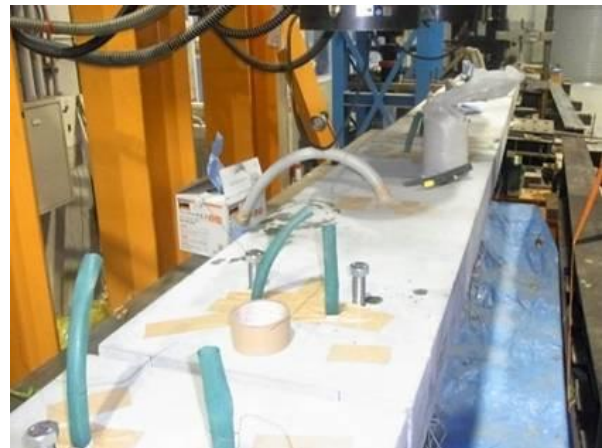
Fig. 4-2 Fabrication of specimens

used. To extract the air out of the girder-deck connection and ensure contact of mortar-concrete interface, the mortar was poured using compressor.

Applying above-mentioned method for mortar filling, the mortar layer with good quality was obtained in both of the specimens. From these results, it was found that there is no problem in filling mortar in the range of the thickness of the girder-deck connection in 20~30 mm and the range of the thickness of the gap between pre-cast panels in 20~50 mm.

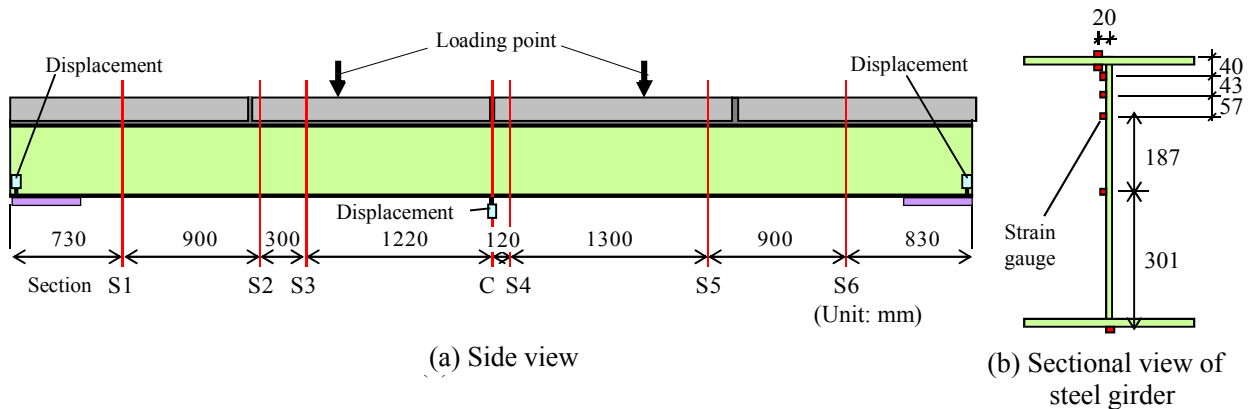
Fig. 4-4 Measurement location of displacement and strain

Fig. 4-4 shows the points of measurement of displacement and strain. In order to obtain stiffness and bending capacity of the girder, displacements were measured at the span center. In order to confirm stress reduction effect by concrete deck, the strain of the steel girder was measured at each point in each section S1~S6.

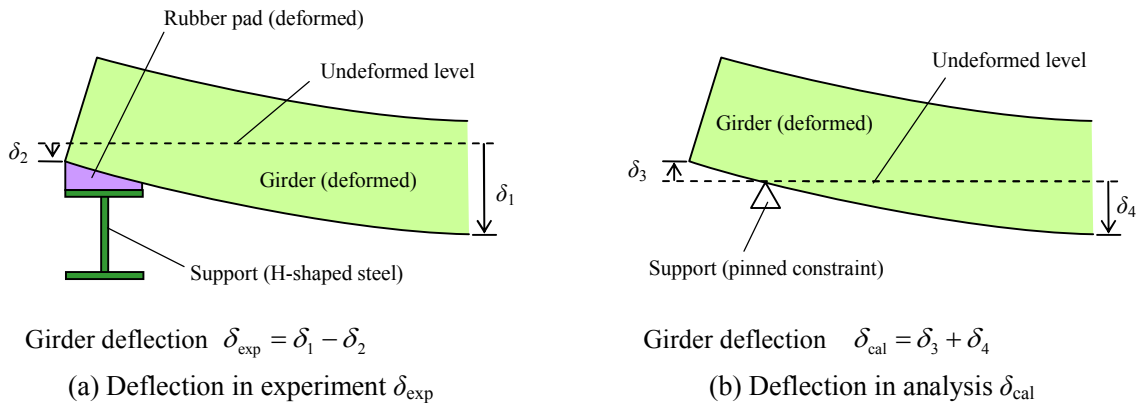
Fig. 4-5 Calculation of girder deflection

As mentioned before, the girder was supported by the H-shape steel through the rubber pads. The deflection, *i.e.* bending displacement of girder, should be calculated considering the deformation of the rubber pads. In the test, the displacement of the girder end was measured as shown in **Fig. 4-4**. The deflection of the girder is calculated using the measured displacement data, as shown in **Fig. 4-5** (a). For the calculated values of the deflection, displacement of the girder was calculated using the finite element analysis shown in **Fig. 4-6**. The analysis code is ABAQUS and the linear elastic solid elements were applied.

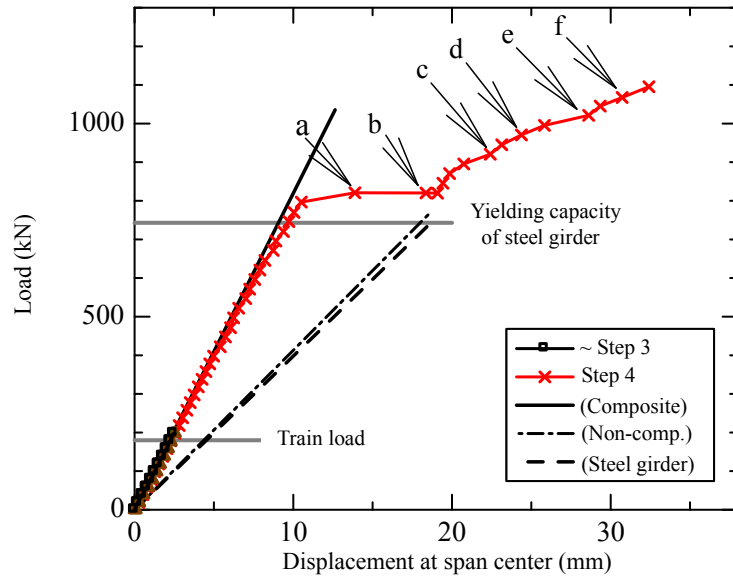
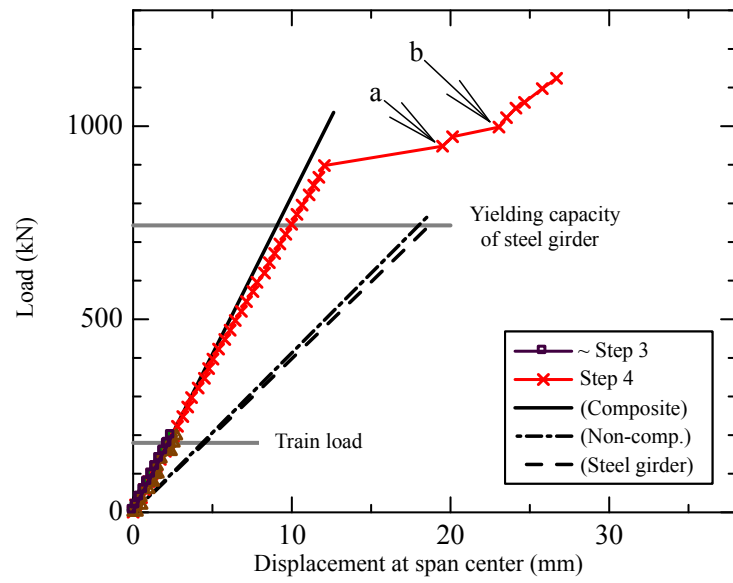
In Specimen 2 (mortar thickness 20 mm), at 948 kN loading, the girder-deck connection failed at the right-hand-side girder end. At the same time, the lower flange of the steel girder started to yield. (phase a). After increasing the load, the girder-deck connection at the left-hand-side girder end at the loading of 998 kN (phase b).

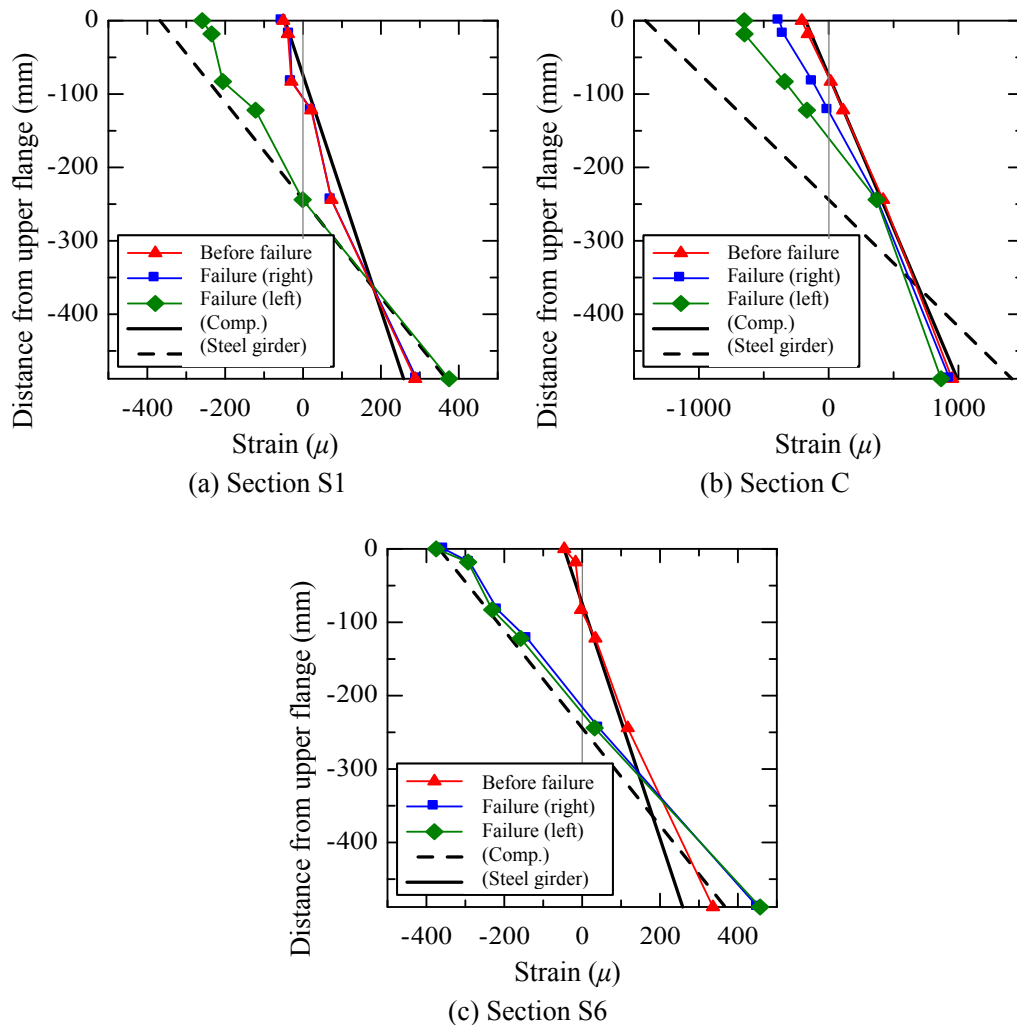
Fig. 4-8 Longitudinal Strain distribution in steel girder (Specimen 1)

After the failure of the girder-deck connection at the right-hand-side girder end (blue line, phase a), the strain did not change at Section S1 near the left-hand-side girder end while the strain showed the non-composite state at Section S6 near the right-hand-side girder end. After the failure of the girder-deck connection in the left-hand-side girder end (green line, phase b), the strain moved to non-composite state at Section S1. From these results, it can be said that the specimen kept composite state until the girder-deck connection failed and the state suddenly changed to non-composite state at the time of the failure. In addition, at Section C (span center), change of the strain distribution was comparatively small. This is because the girder-deck connection remained after the failure at the girder ends.

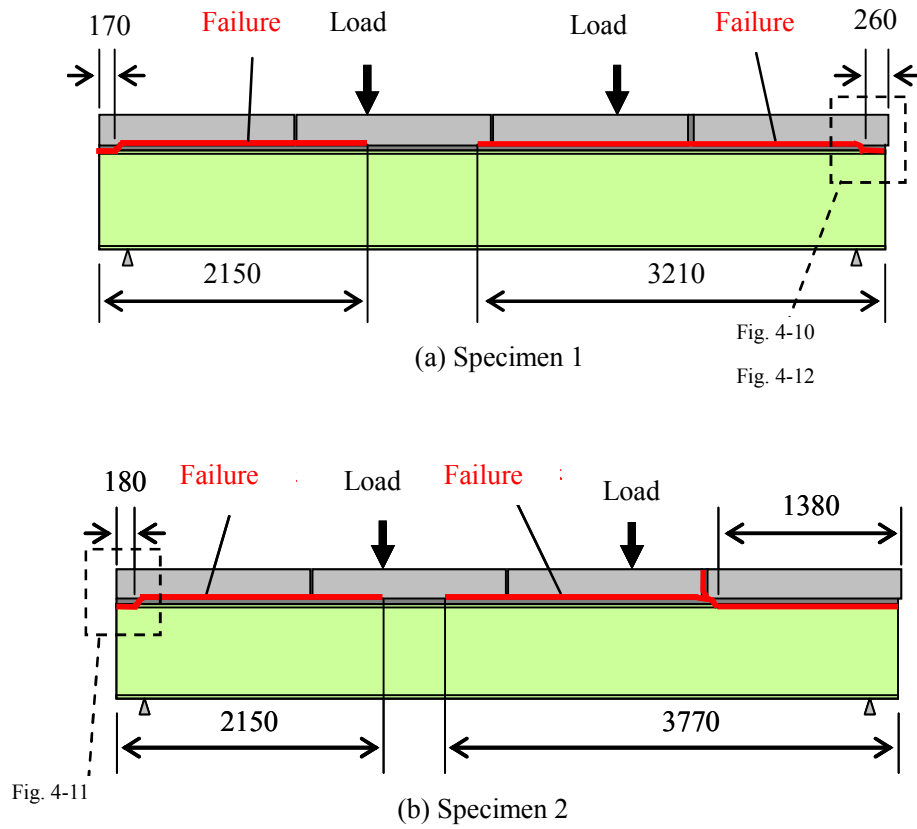
Fig. 4-9 Failure of girder-deck connection

Mode iii): Debonding of mortar-concrete interface at the area at inner side from the location of failure ii)

Fig. 4-10 shows the example of failure at the right-hand-side girder end in Specimen 1. These failure modes i)~iii) seemed to occur at the same time. Furthermore, these failed surfaces of i)~iii) were continuous each other. From these results, it is considered that a failure, occurred at one point, propagated and lead to the other failure modes.

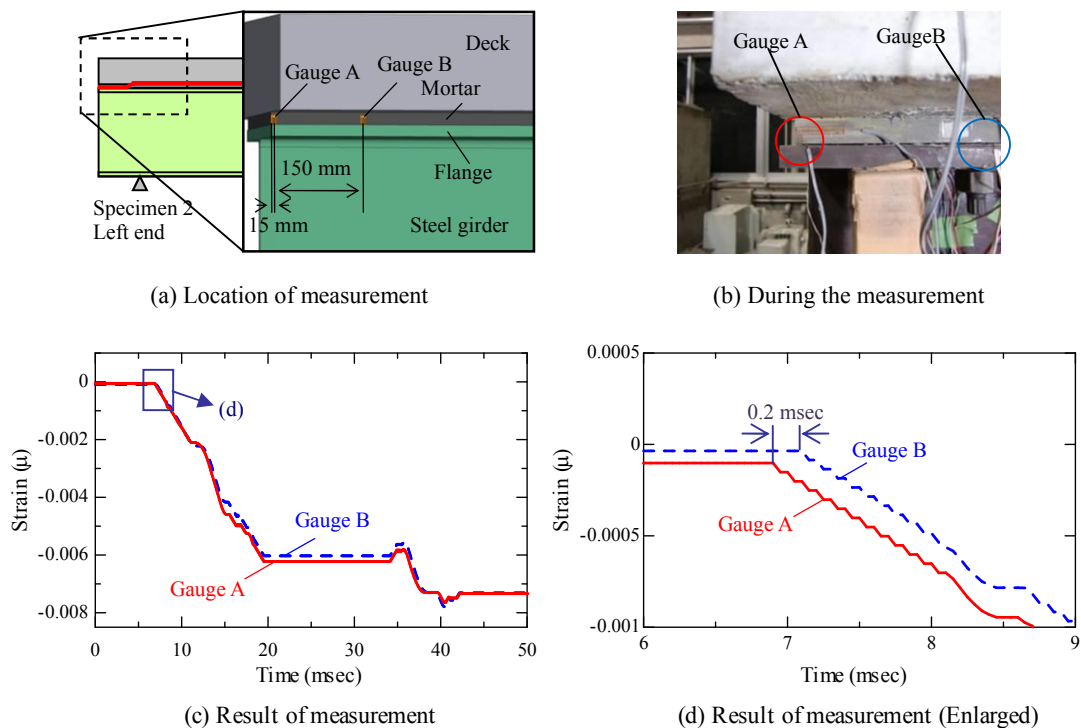
Fig. 4-11 Measurement of steel-mortar interface (Specimen2, left end of girder)

Fig. 4-11 (a) shows the left-hand-side girder end of Specimen 2. Dynamic strain at the steel-mortar interface was measured at the time of the failure of the girder-deck connection. The measurement points were set at the point 15 mm from the girder end (Gauge A) and the point 165 mm from the girder end (Gauge B). The strain gauges were placed between the steel and mortar, as shown in **Fig. 4-11** (b). The interval of the measurement was set to 0.04 msec.

Fig. 4-11 (c) shows the result of the measurement. The strain showed a change at the time of the failure. The strain change at Gauge A occurred 0.2 msec earlier than that of Gauge B. From this result, it is considered that the initiation of the failure occurred from the girder end and propagated in the direction of the span center. Thus, among the failure modes, Mode i) occurred prior to Mode ii). Although Mode iii) was not measured directly, it is thought to occur after Mode i) and ii).

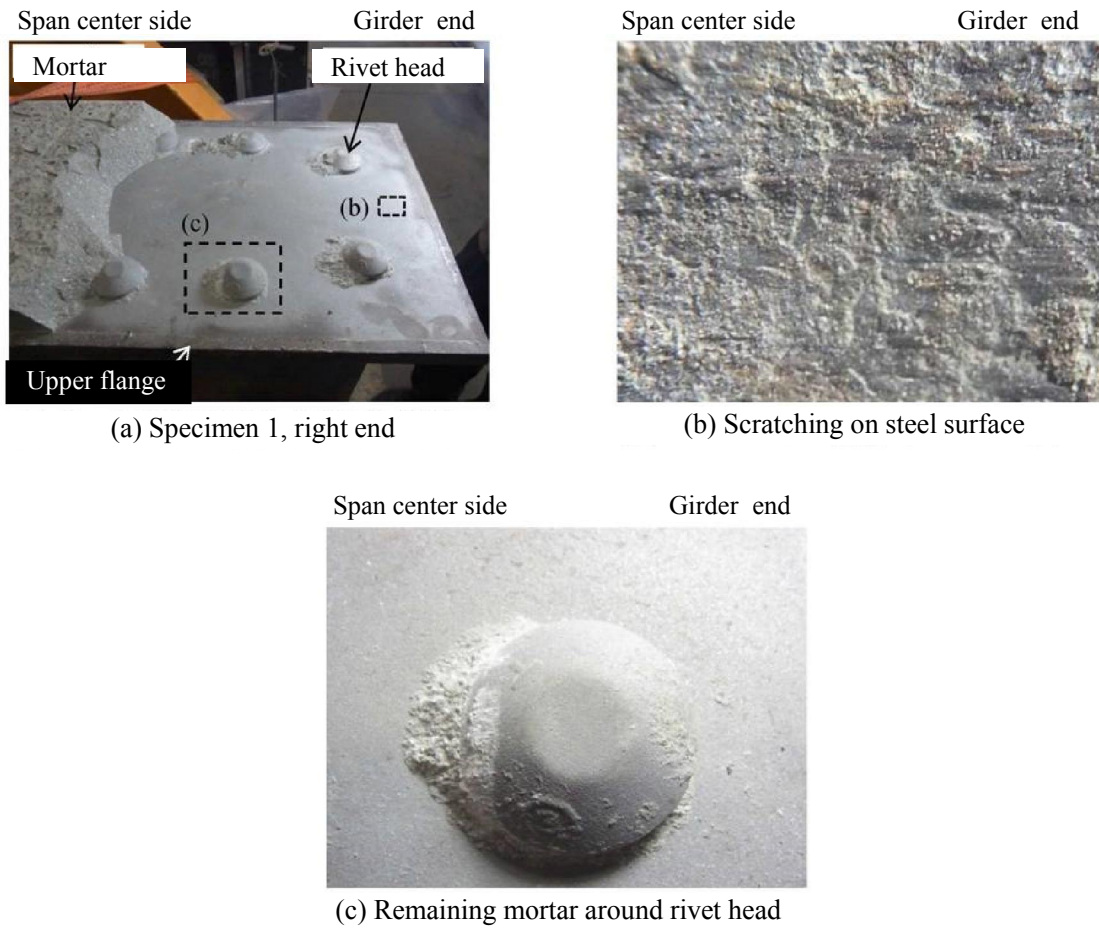
Fig. 4-12 Upper surface of steel girder after failure

In addition, at the place of Mode ii), starting point of mortar failure is different in the area around the rivet heads and area there is no rivet heads, as shown in **Fig. 4-12(a)**. This is thought because the shear resistance was higher near the rivet heads. At the other girder ends, the same thing can be said.

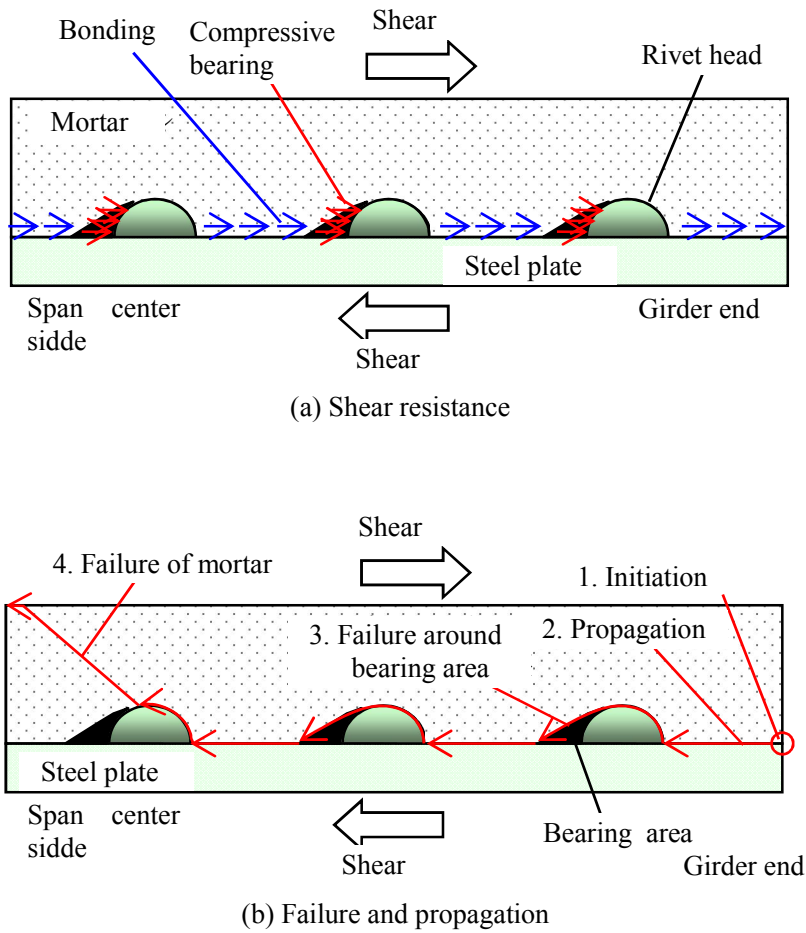
Fig. 4-13 Presumed of shear resistance and failure at steel-mortar interface

From these results, it is considered that the failure occurred and propagated as shown in **Fig. 4-13** (b). The failure initiated from the debonding of steel-mortar interface at the girder end. The failure then propagated into the direction of span center. After that, at the place of rivet head, mortar layer started to fail and the failure propagated further.

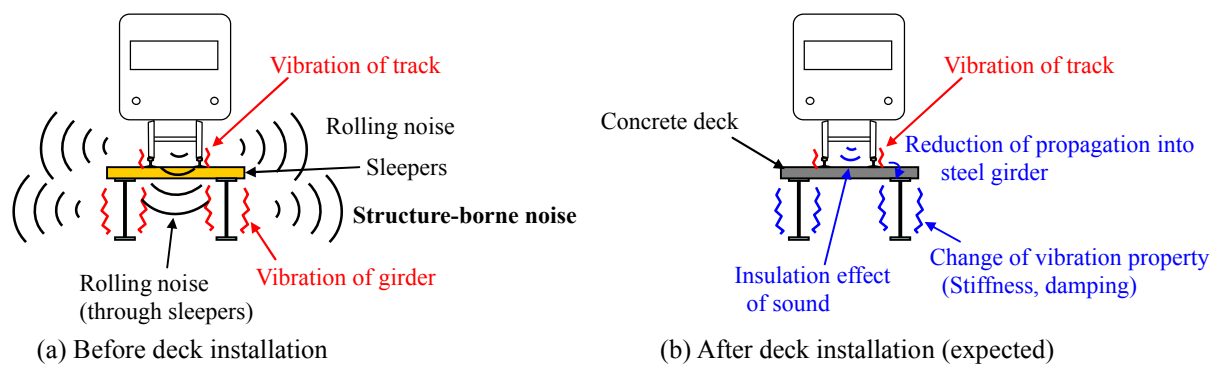
Fig. 5-1 Noise and vibration of steel railway bridge

Noise of railway structures consists of vehicle noise and structure-borne noise⁴⁶⁾. As shown in **Fig. 5-1**, the structure-borne noise is caused by vibration of the steel members. The vibration of the steel members is caused by rolling vibration of rail-wheel contacted area (hereinafter called ‘on-girder vibration’) and the on-girder vibration propagates into the steel girders.

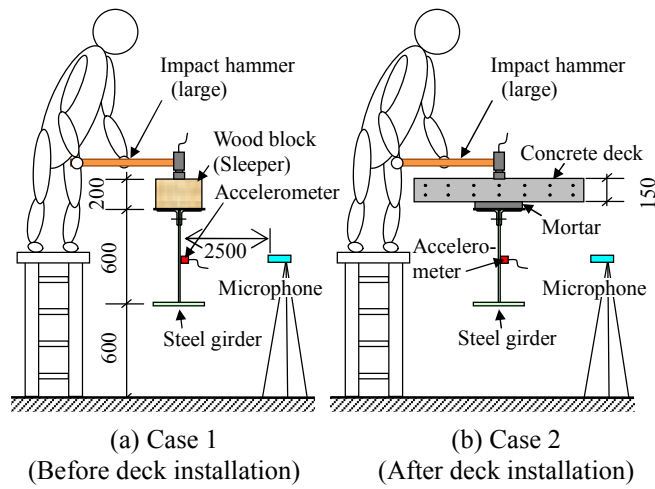
Fig. 5-2 Method of on-girder impact test

In order to grasp the effect of propagation reduction (above mentioned Effect (i)), the on-girder impact test was carried out. In this test, an impact was induced on the girder by a large sledge impact hammer with the hammer mass of 5.5 kg, which has a force sensor with sensitivity of 0.24 mV/N (hereinafter called ‘large hammer’), as shown in **Fig. 5-1**. By this large hammer, impact force was measured in time domain. The web acceleration was measured by an accelerometer with sensitivity of 6.42 pC/(m/s²) and response frequency of 1~7,000 Hz. The accelerometer was placed at the center of the web. The sound level was measured by the microphone at the distance of 2.5 m from the web. The sound level was measured with the time weighting ‘Fast’, the frequency weighting ‘A’ and the measurement time of 5 sec (hereinafter called ‘Noise level’).

To compare the vibration property and the noise property, the test was carried out in two conditions: “before the deck installation (Case 1)” and “after the deck installation (Case 2)”. In Case 1, the specimen has no concrete deck (only a steel girder) and a wooden piece with 200 mm depth was settled on the steel girder considering a wooden sleeper. The impact was induced on the wooden piece, as shown in **Fig. 5-1(a)**. In Case 2, the impact was induced directly on the concrete

deck, as shown in Fig. 5-1(b). Fig. 5-3 shows the photograph during Case 2 test.

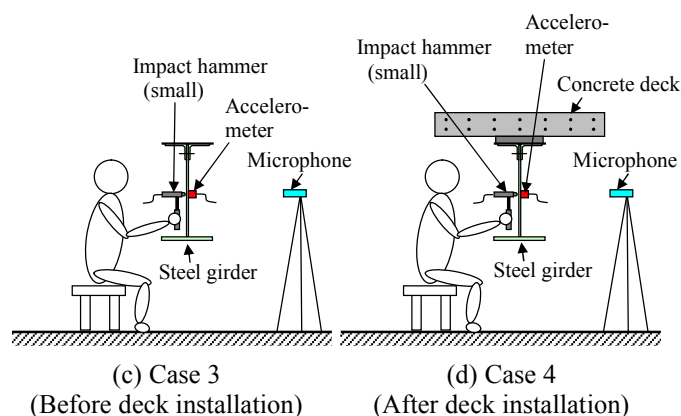
Fig. 5-4 Method of web impact test

In order to grasp the effect of the stiffness increase (Effect (ii)) and the damping increase (Effect (iii)), the web impact test by a small hammer was carried out. To compare the response of the web against the impacts under the same condition, the impact was induced on the center of the web directly, as shown in **Fig. 5-4**. As well as the on-girder impact test, the web impact test was carried out in two cases: “before the deck installation (Case 3)” and “after the deck installation (Case 4)”. The web acceleration and the sound level were measured during the test in the same location as the on-girder impact test. **Fig. 5-5** shows the photograph during the test (Case 4). For the web impact test, an impulse hammer with hammer mass of 0.32 kg, which has a force sensor with the sensitivity of 0.23 mV/N (hereinafter called ‘small hammer’) was applied.

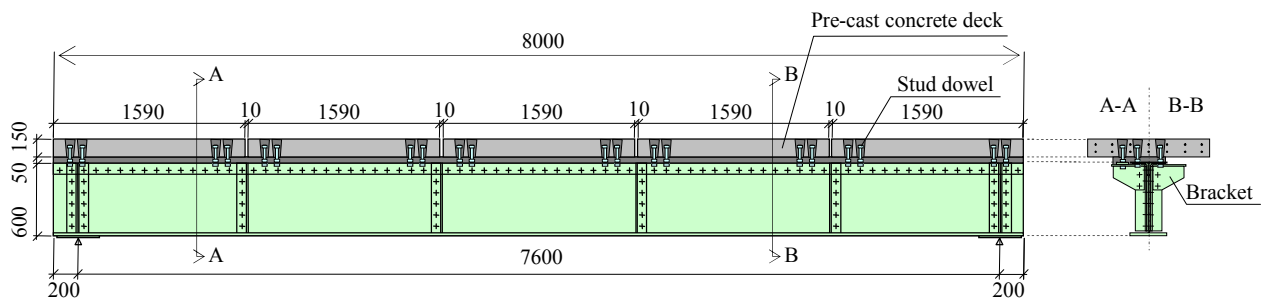
Fig. 5-6 Test specimen for impact hammer test

Fig. 5-6 shows the test specimen. The specimen consists of a steel girder with 7.6 m span and five pre-cast concrete decks with filler mortar between the deck and the girder. Simplifying the relationship between on-girder vibration and girder vibration, a one-girder specimen was applied to this test.

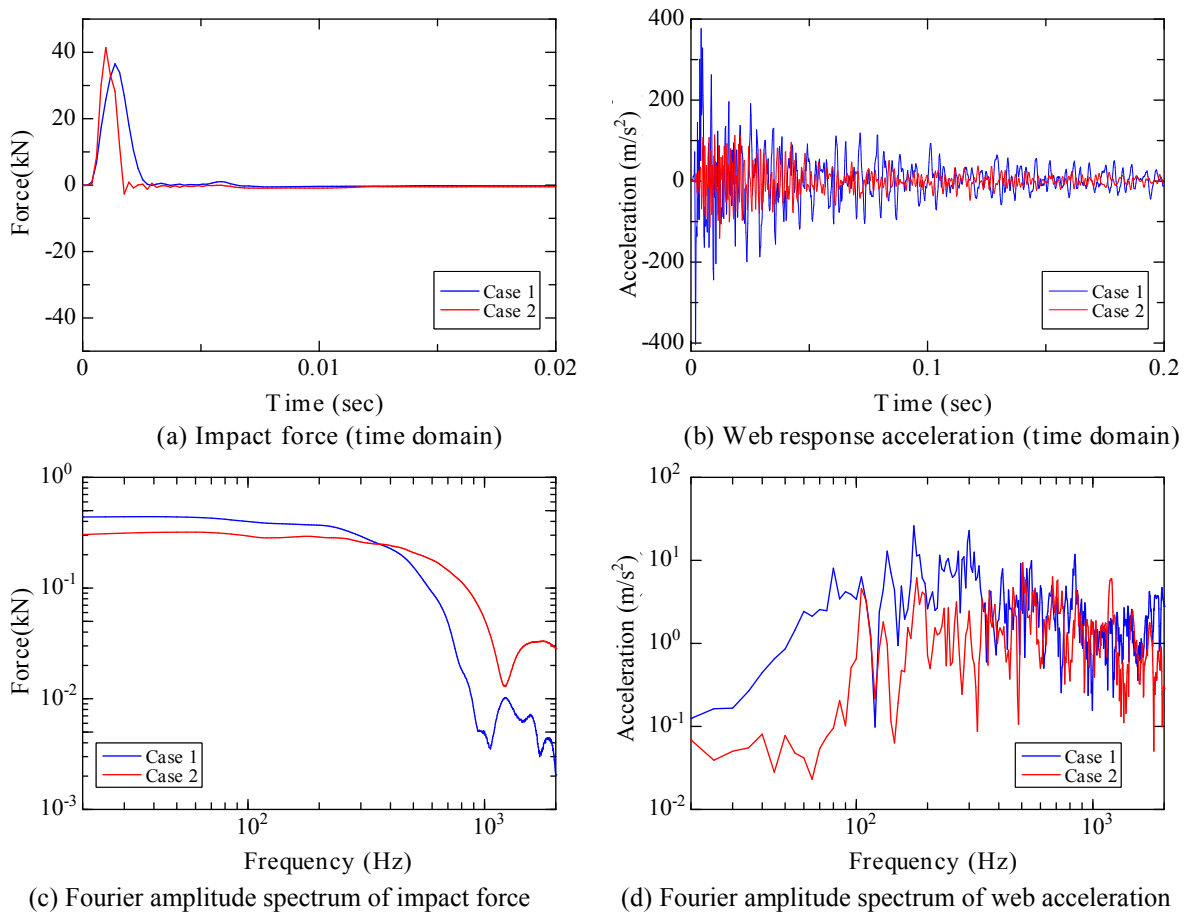
Fig. 5-7 Measured data of impact force and web acceleration

Fig. 5-7 shows examples of measured data of the impact force and the web acceleration in time domain and in frequency domain (Fourier power spectra), as standard data among the five-time test, obtained in Case 1 (before deck installation, on-girder impact) and Case 2 (after deck installation, on-girder impact). The impact force has a form of pulse wave, as shown in **Fig. 5-7 (a)**. The web acceleration has a form of damped free vibration, as shown in **Fig. 5-7 (b)**. The spectrum of the impact force has a flat form, as shown in **Fig. 5-7 (c)**. The spectrum of the web acceleration has large value between 70 and 400 Hz and has its peak at 175Hz.

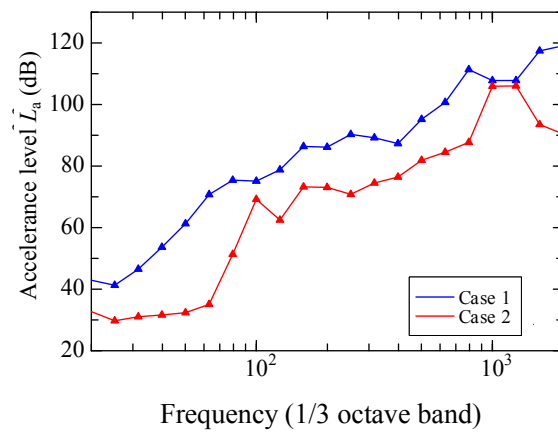
Fig. 5-8 Acceleration response function (power average)

Using the obtained spectra, the power-average of the response function of the web acceleration (hereinafter called ‘accelerance’) was calculated according to Eq. (1) ~ (3). **Fig. 5-8** shows the calculated accelerance in 1/3 octave band. The vertical axis shows accelerance level of Eq. (3). As shown in the figure, the accelerance level of Case 2 (after deck installation, on-girder impact) is reduced by more than 10 dB comparing with Case 1 (before deck installation, on-girder impact) through the most of the frequency between 20 and 2000 Hz, the general range of structure-borne noise. From the obtained response functions, the all path levels were obtained as shown in **Table 3**. The all path levels were calculated as summation of power spectrum values over the frequency domain of 20~2000Hz. In Case 2, the all path level of the accelerance reduced by 12.9 dB and that of the noise response function reduced by 8.4 dB from that in Case 1. Comparing with the measured result of the web acceleration level by installing rubber dampers⁴⁸⁾, the deck installation can reduce the web vibration as much as the rubber dampers. It is thought that this is because the propagation of the on-girder vibration into the steel girder was reduced by the concrete deck (Effect (i)).

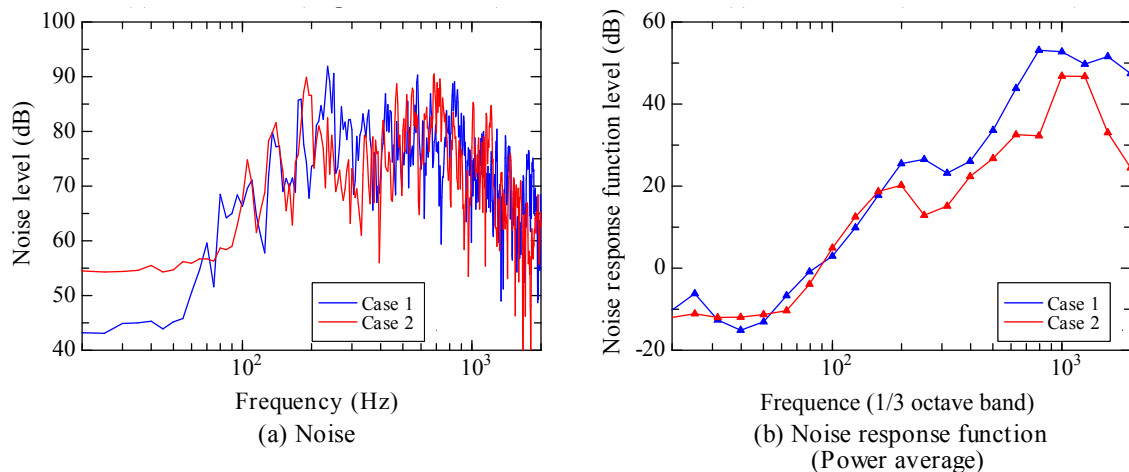
**Fig. 5-9 Noise level and noise response function****Table 5-3 All path level of noise response function (On-girder impact test)**

Fig. 5-9 shows examples of measured data of noise level at the 2.5 m distance from the web in frequency domain and power-averaged noise response function, obtained in Case1 (before deck installation, on-girder impact) and Case2 (after deck installation, on-girder impact). The spectrum shows large value between 100 and 1000 Hz. **Fig. 5-9** (b) shows the level of noise response function, calculated according to Eq. (4)~(6). The noise response function is reduced in the range from 200 Hz but it is not reduced in the range from 20 to 200 Hz. As shown in **Table 5-3**, the all path level over 20~2000Hz can be reduced by 8.4 dB.

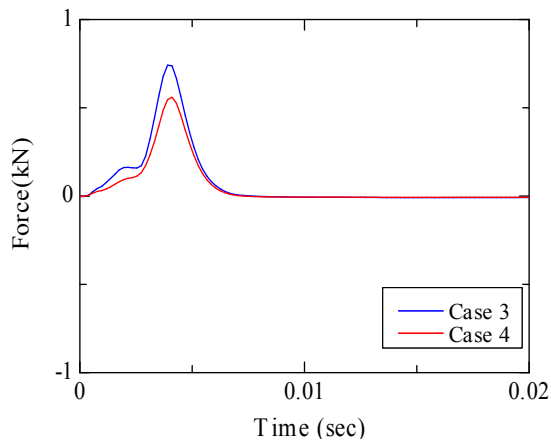
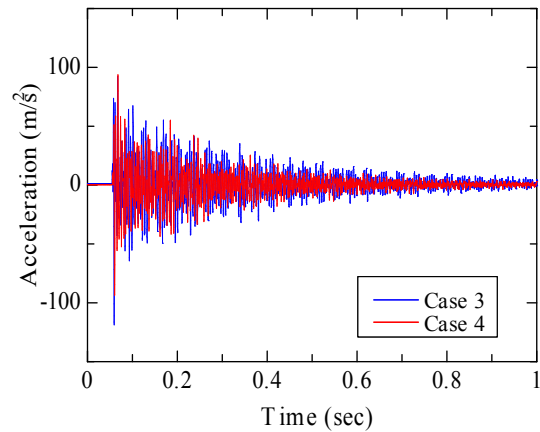
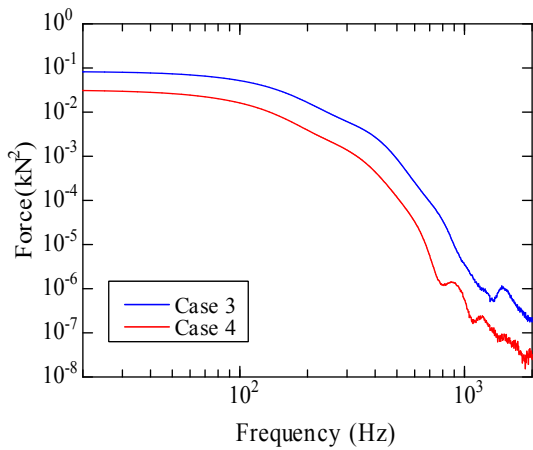
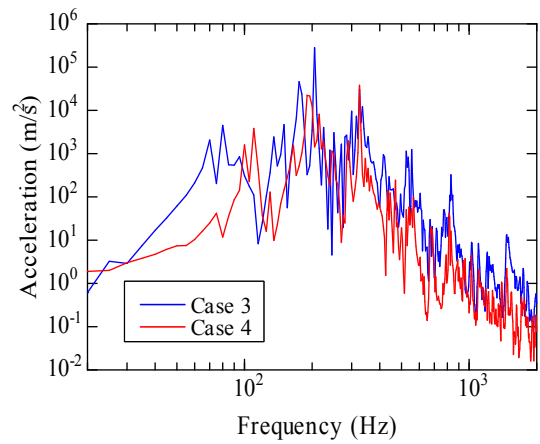
Fig. 5-10 Measured data of impact force and web acceleration

Fig. 5-10 shows examples of measured impact force and web acceleration in Case3 (before deck installation, web impact) and Case4 (after deck installation, web impact). As shown in **Fig. 5-10** (d), the spectrum of the web acceleration shows a shift of its peak frequencies into higher frequencies. For example, one of the peaks of the spectrum at 80 Hz in Case 3 can be seen at 110 Hz in Case 4. Such frequency change can be seen in the range from 80 to 200 Hz. It is because the stiffness of the upper end of the web was increased by the concrete deck.

Table 5-4 shows the damping coefficients of the web acceleration, calculated according to Eq.(7)~(8) from the web acceleration in time domain shown in **Fig. 5-10** (b). From the results, loss factor η of the web acceleration can be increased from 0.00427 to 0.00749 by the deck installation. However, comparing with the loss factor η of the rubber damper on the web is 0.05~0.4^{47), 48)}, the damping effect of the concrete deck is much smaller.

Considering these results, it can be said that the deck installation changes the response frequency of the web vibration and increases the damping property but neither of the effects does not lead to decrease of the web vibration. In other words, the above mentioned Effect (ii) and Effect (iii) are negligibly small.

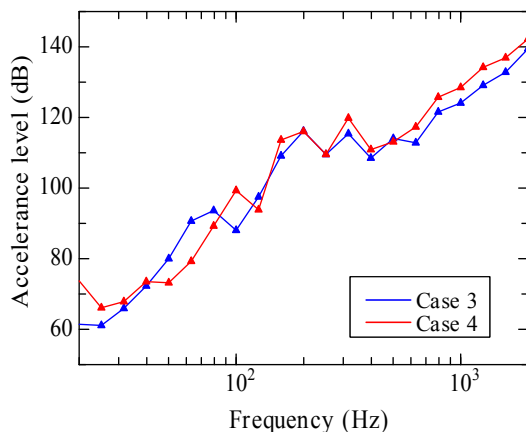
Fig. 5-11 Acceleration response function (power average)

Fig. 5-11 shows the acceleration response function (accelerance) of the web. **Table 5-5** shows the all path level of accelerance over 20 to 2,000 Hz. The accelerance of the web cannot be reduced by installing concrete deck.

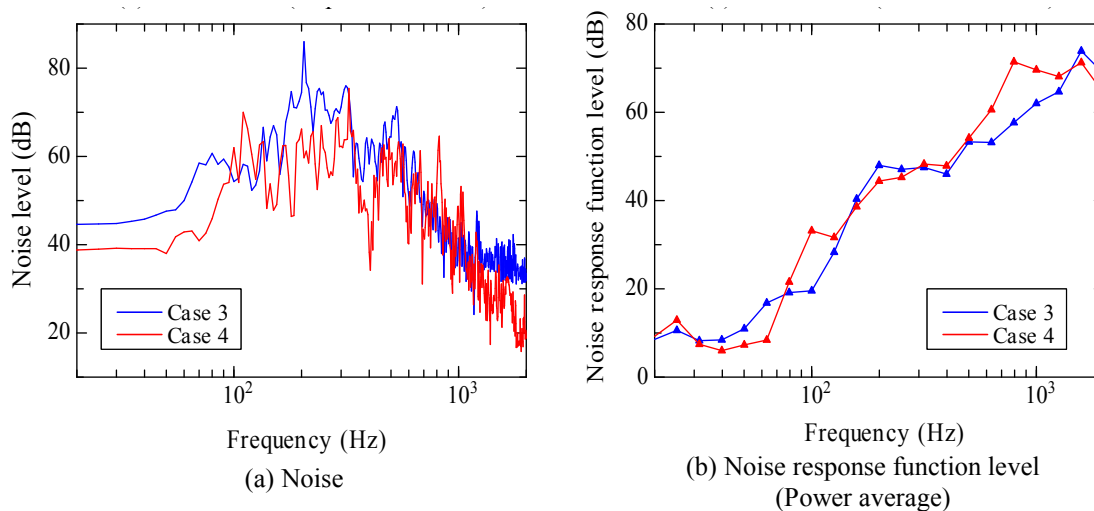
Fig. 5-12 Noise level and noise response function

Fig. 5-12 shows the noise level near the web and the noise response function of Case 3 and 4. **Table 6** shows the all path level of the noise response function. As shown in **Fig. 5-12 (a)**, the spectra of the noise level show change of response frequency. However, as shown in **Fig. 5-12 (b)**, the noise response function was not decreased.
