# **Damage Limit States for Infill Walls Subjected to In-Plane Cyclic Loading**

A thesis submitted in partial fulfilment of  
the requirements for the Degree of  
Doctor of Engineering  
by

**Xiang Fu**

Graduate Major in Urban Design and Built Environment  
Departments of Architecture and Building Engineering  
School of Environment and Society  
Tokyo Institute of Technology  
Tokyo, Japan

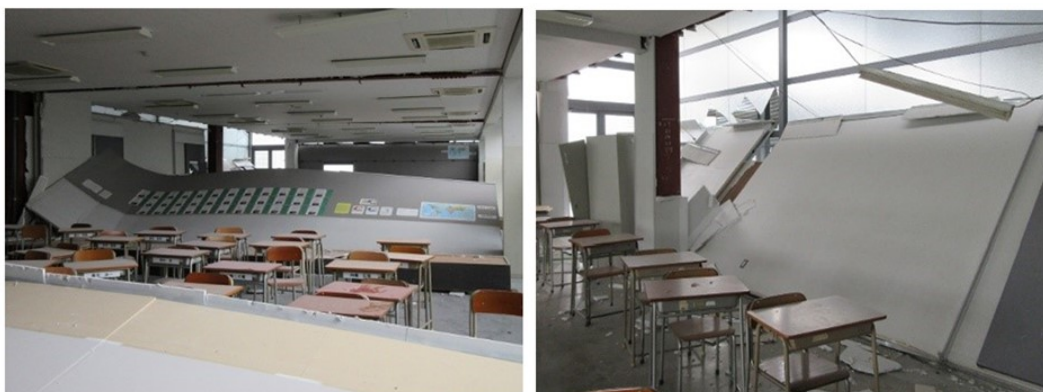
Fig. 1-1. Damage of non-structural LGS wall during Kumamoto earthquake[1-4].

On the other hand, non-structural walls are usually used to separate a room. For non-structural walls, although their load-bearing capacity is not needed, buildings may no longer be functional for access or may even need to be demolished as a result of the damage of these non-structural components in earthquakes, even though the structural components remain intact (Fig.1-1). Such damage may prove

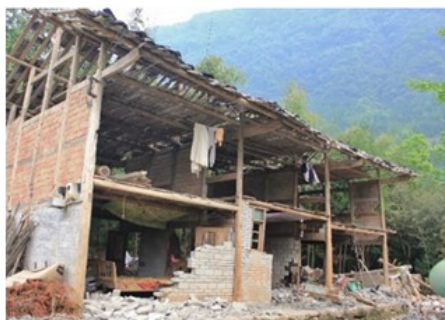
Fig. 1-2. Damage to masonry-infilled timber frame after 2013 Lushan earthquake in China[1-18].

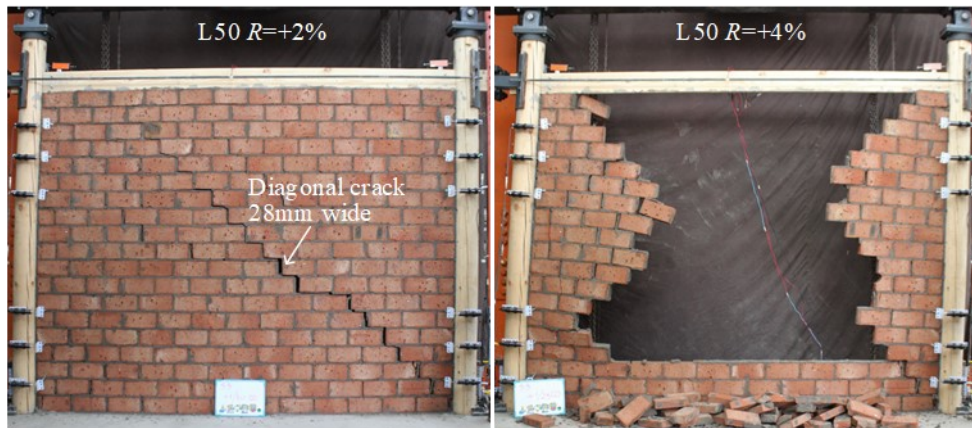
Figure 3-17. Shear cracking and collapse of masonry infill in specimen L50.
