| Title | Wind-induced Response Characteristic Evaluation of High-rise Seismic Isolated Building Based on Observed Records |
| Citation | Proceedings of the 14th International Conference on Wind Engineering,<br>, , |

# Wind-induced Response Characteristic Evaluation of High-rise Seismic Isolated Building Based on Observed Records

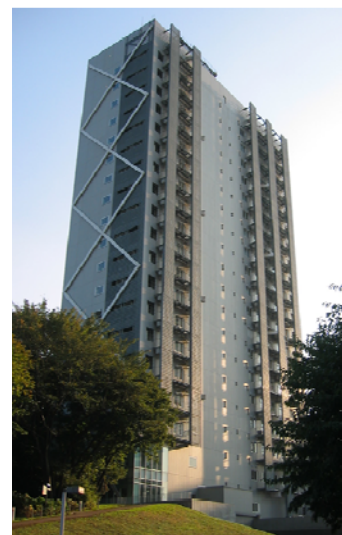
Figure 1. External appearance of 20-story high-rise seismic isolated steel building ( J2-building )

20-story high-rise seismic isolated steel building (91.4 m) as shown as in Figure 1 was constructed at Tokyo Institute of Technology Suzukake-dai campus located in Yokohama Japan in 2005, and a long-term monitoring to the wind velocity and the response of building has been executed. This paper presents about a long-term dense monitoring system of this high-rise seismic isolated building, and discusses about the wind-induced response characteristics of this high-rise seismic isolated building based on observed records.

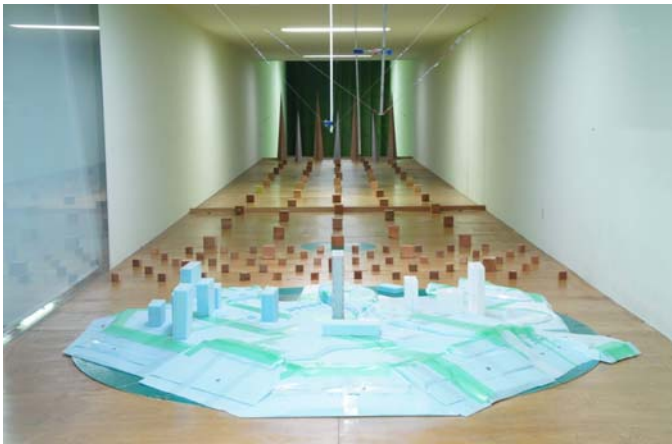
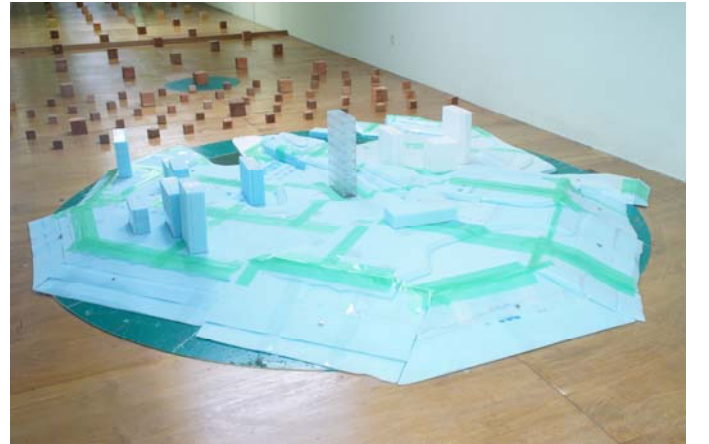
Figure 22. Situation of wind tunnel experiment

where,  $j$  : step number every ten minutes,  $\rho$  : the air density,  $A^{(j)}$  : projected area of building at step  $j$ ,  $C_{DX}^{(j)}$  : X direction's wind force coefficients at  $j$  step's wind direction which are obtained from the wind tunnel experiment. The wind tunnel experiment are carried out by using the exposure category III flow, and the building surroundings are reproduced as shown in Figure 22. Figure 23 illustrates the relation between the X direction deformation of isolation layer obtained from the observer records  $\delta_{MX}$  and the X direction static shearing force  $Q_{MX}^{(j)}$  calculated by Eq. (2). In addition, the designed stiffness of the isolation layer <sup>[1]</sup>
